Re: Seneca County
Fostoria Mobile Estates
Sewerage

On June 8, 2011, an inspection was conducted of the wastewater treatment plant (WWTP) serving Fostoria Mobile Estates. Observations and recommendations noted during the inspection are as follows:

Fostoria Mobile Estates MHP, Seneca Co.

pictures taken by M.B.Cohen, 06/08/2011

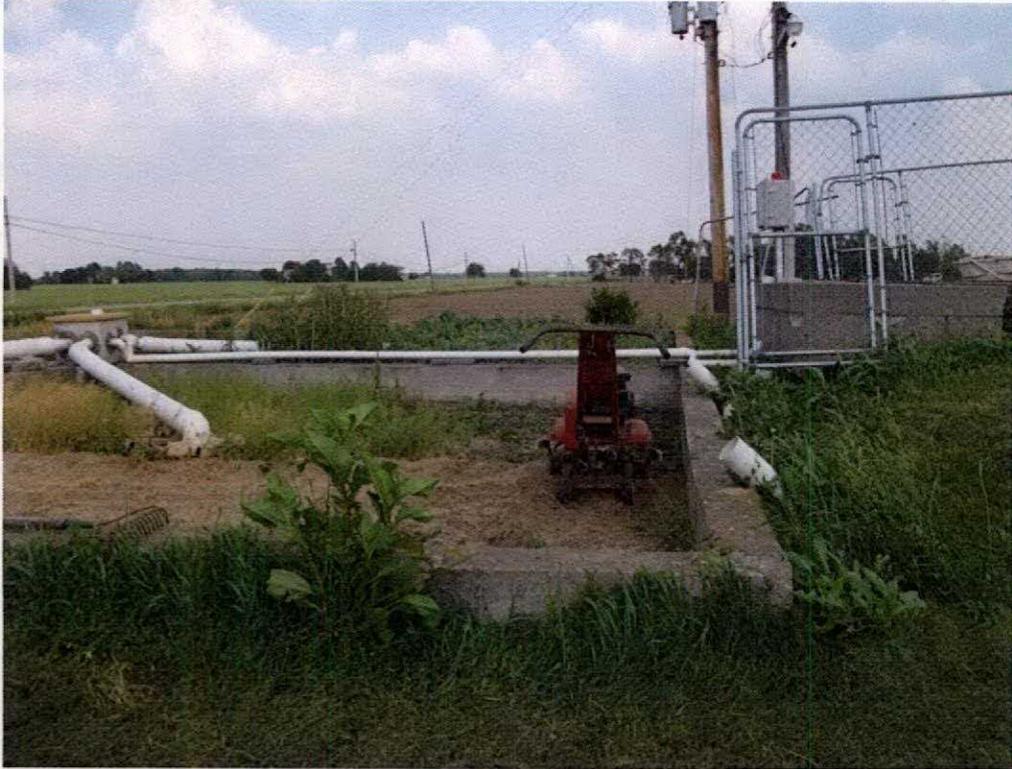
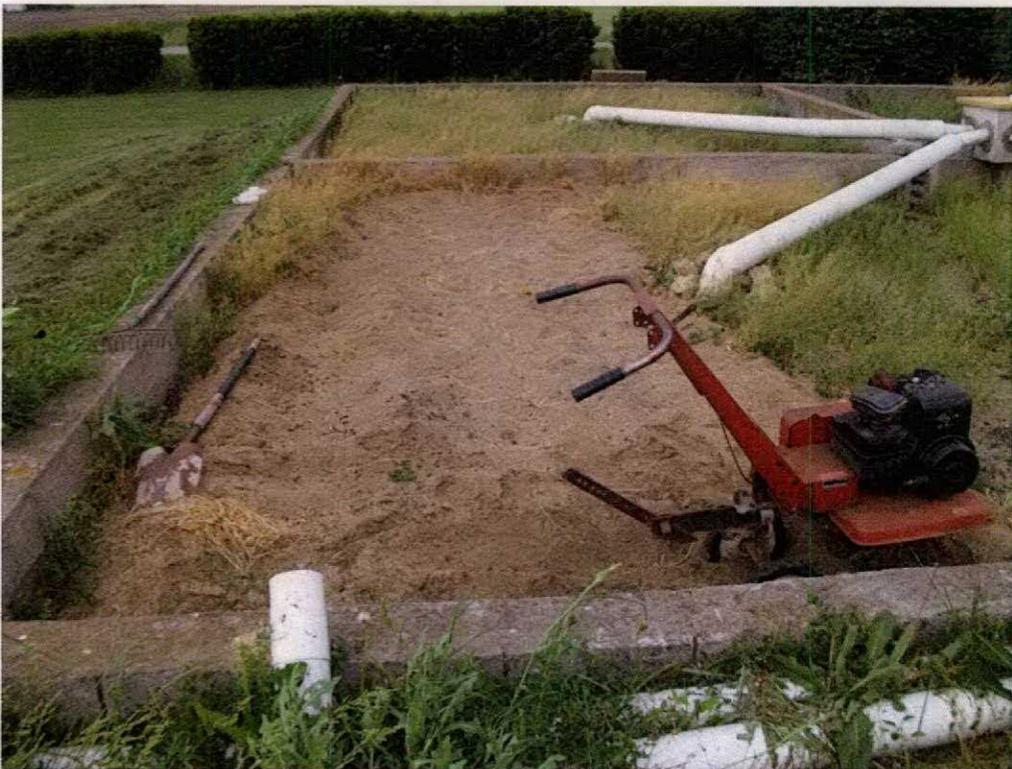
6. The effluent from the clarifier had a turbid grey color, with visible solids carry over.
7. There was no flow to the sand filters and all four (4) of the sand filter beds were observed to be dry with an accumulation of some dried solids and weed growth.

Sand filters with weeds, dried sludge and garden tiller. The filters were not in use and were being bypassed at time of inspection.

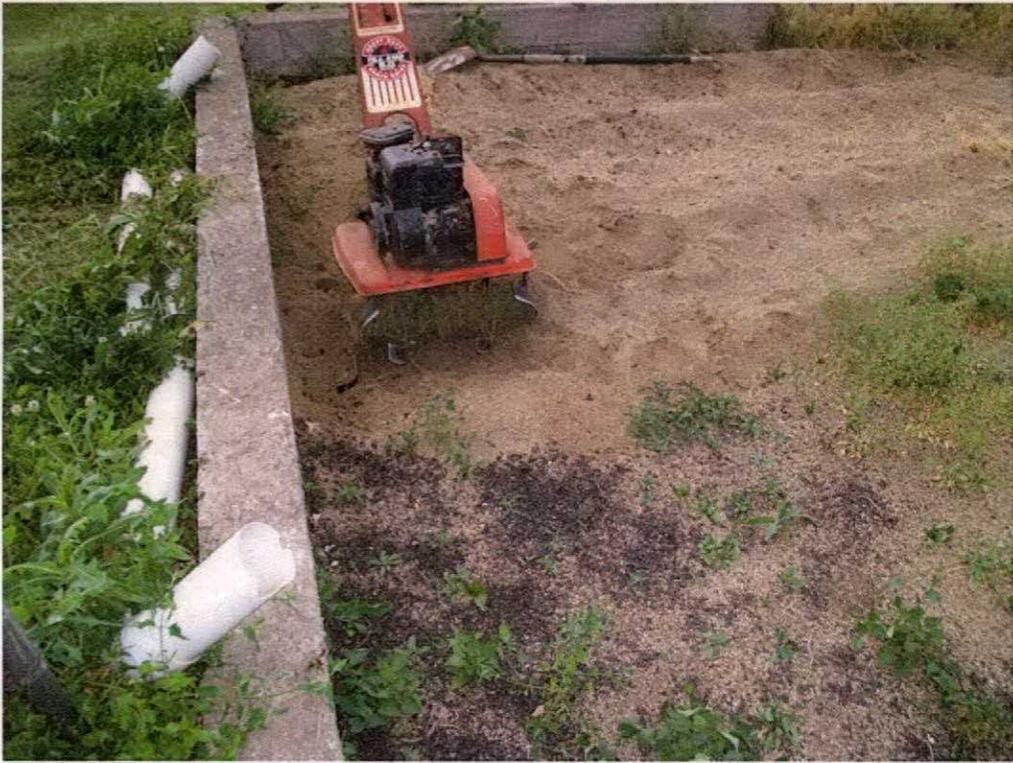
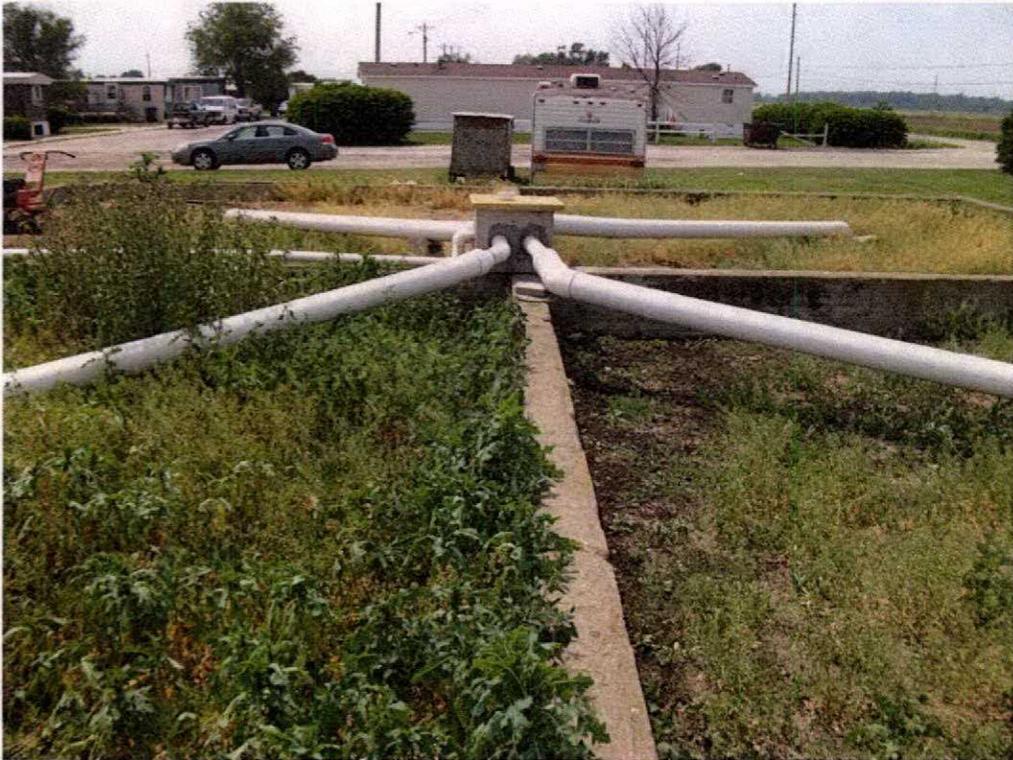
Sand filters with weeds, dried sludge and garden tiller. The filters were not in use and were being bypassed at time of inspection.

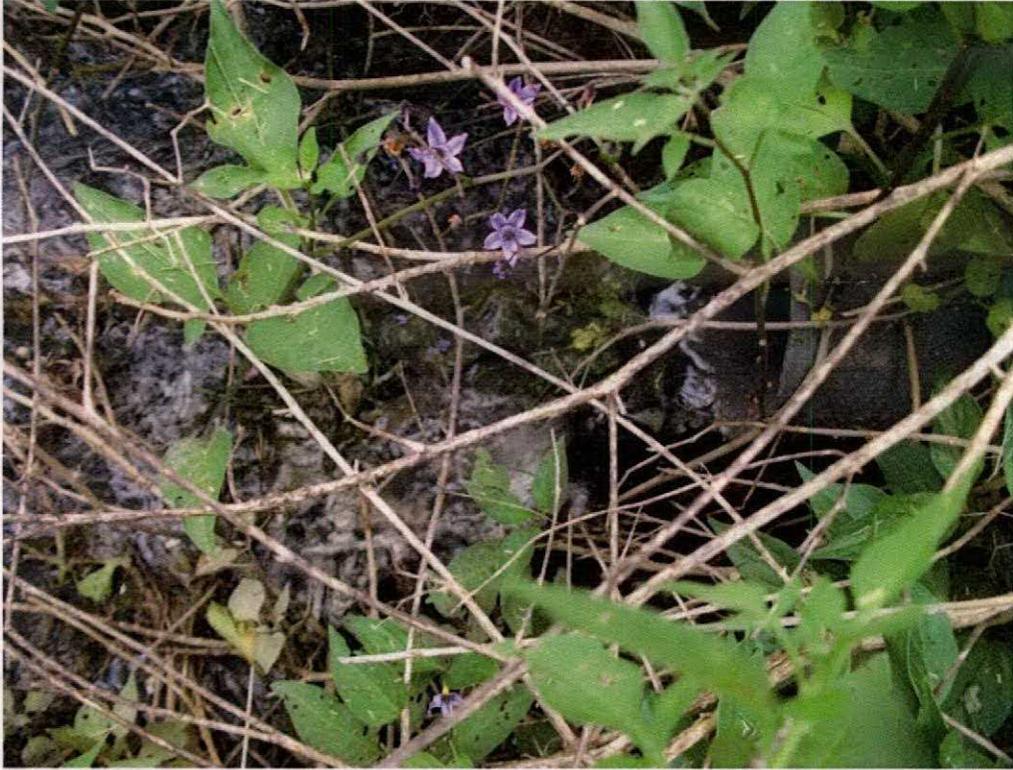
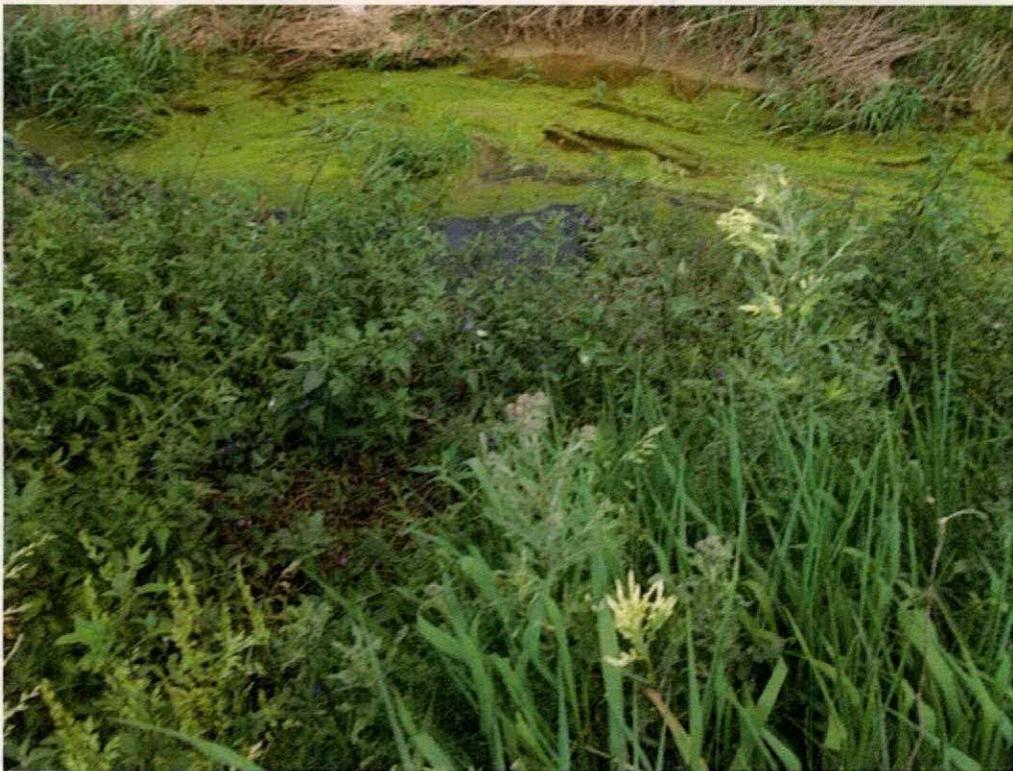
8. The facility was observed discharging through the dosing tank bypass pipe outlet to the ditch on the east side of the tank. The ditch east of the WWTP at the discharge location was dark grey and septic.

Dosing tank bypass pipe discharging into ditch on the east side of the WWTP. Ditch is black and septic.

9. The bypass discharge is not acceptable. The bypass and/or overflow pipes located within the sand filter dosing lift station are to be physically eliminated. There are to be no discharges other than the intended discharge to the sand filters.

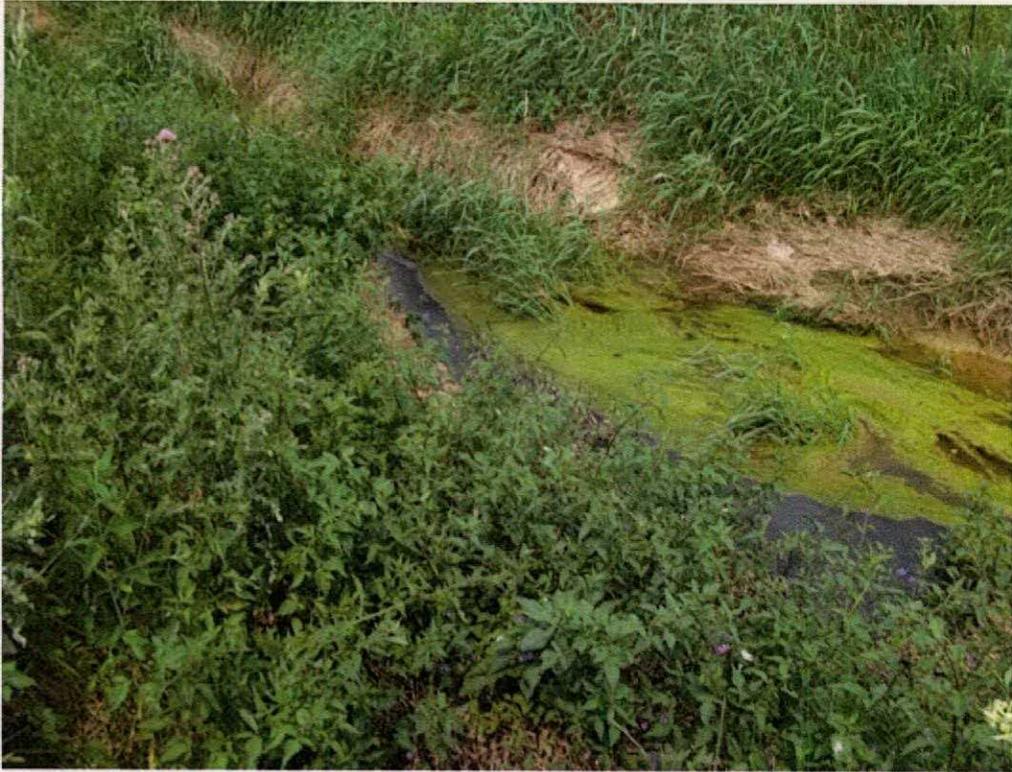
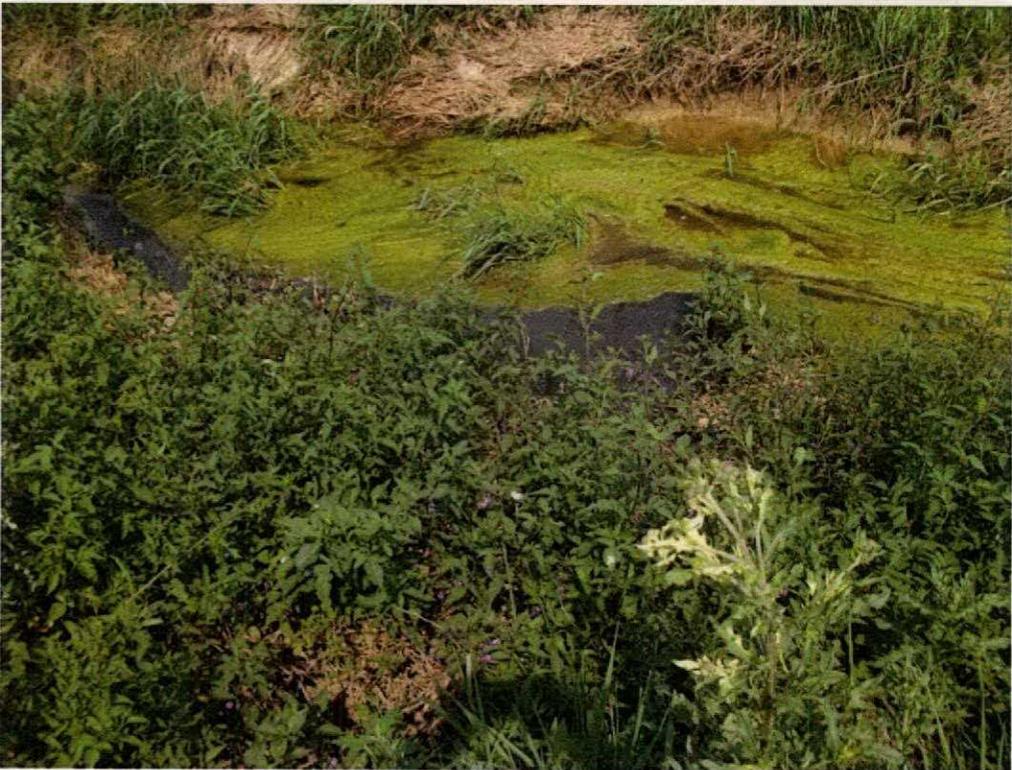
Ditch is black and septic where dosing tank bypass pipe discharges into ditch on the east side of the WWTP.

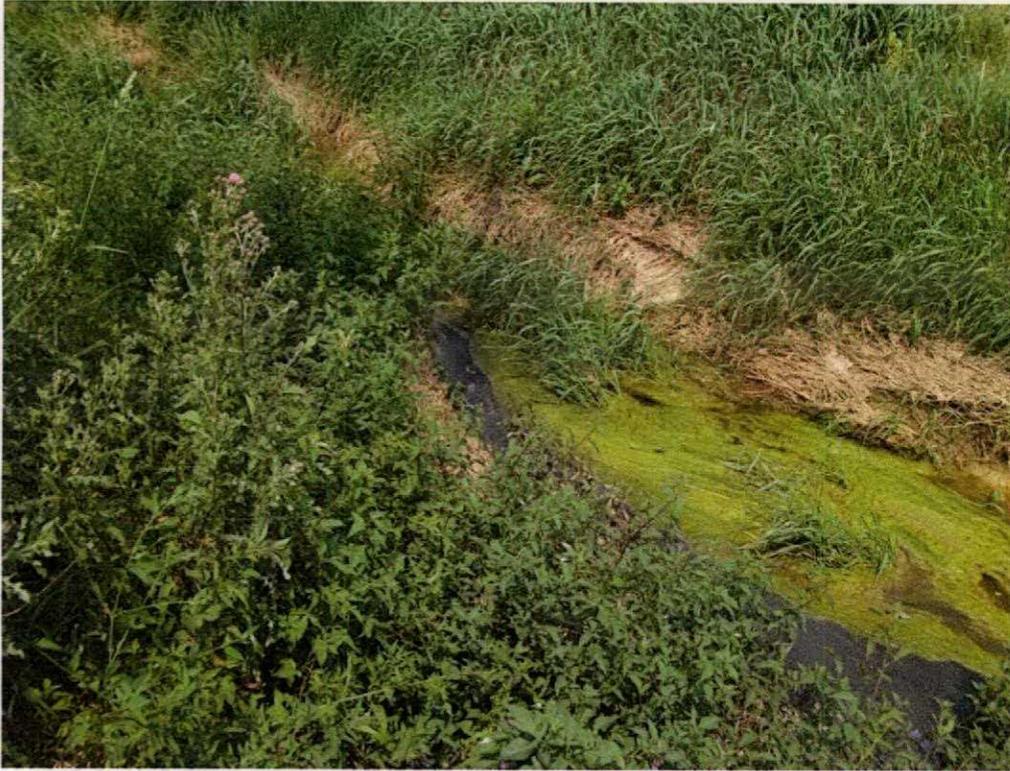
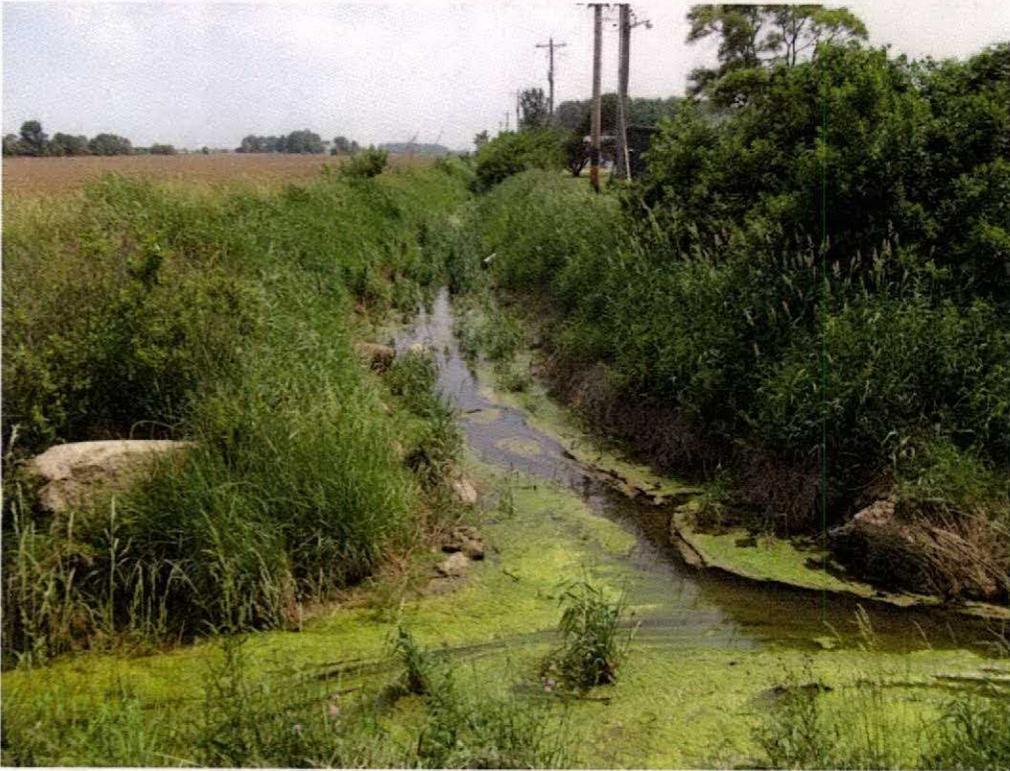
Ditch is black and septic where dosing tank bypass pipe discharges into ditch on the east side of the WWTP.

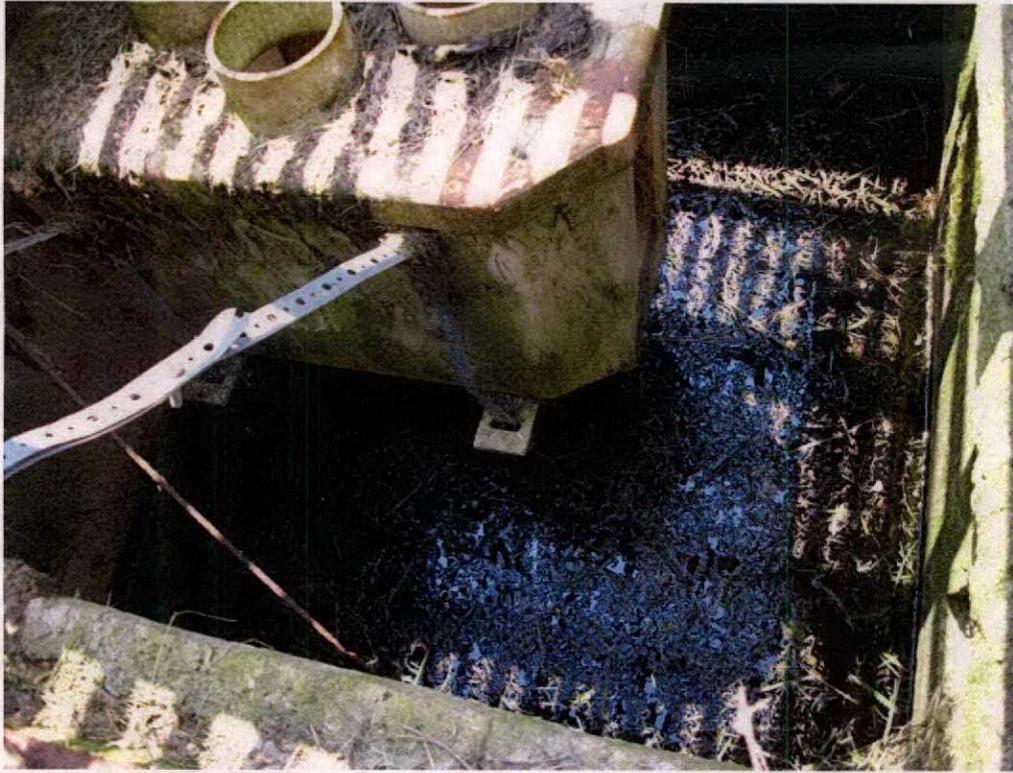
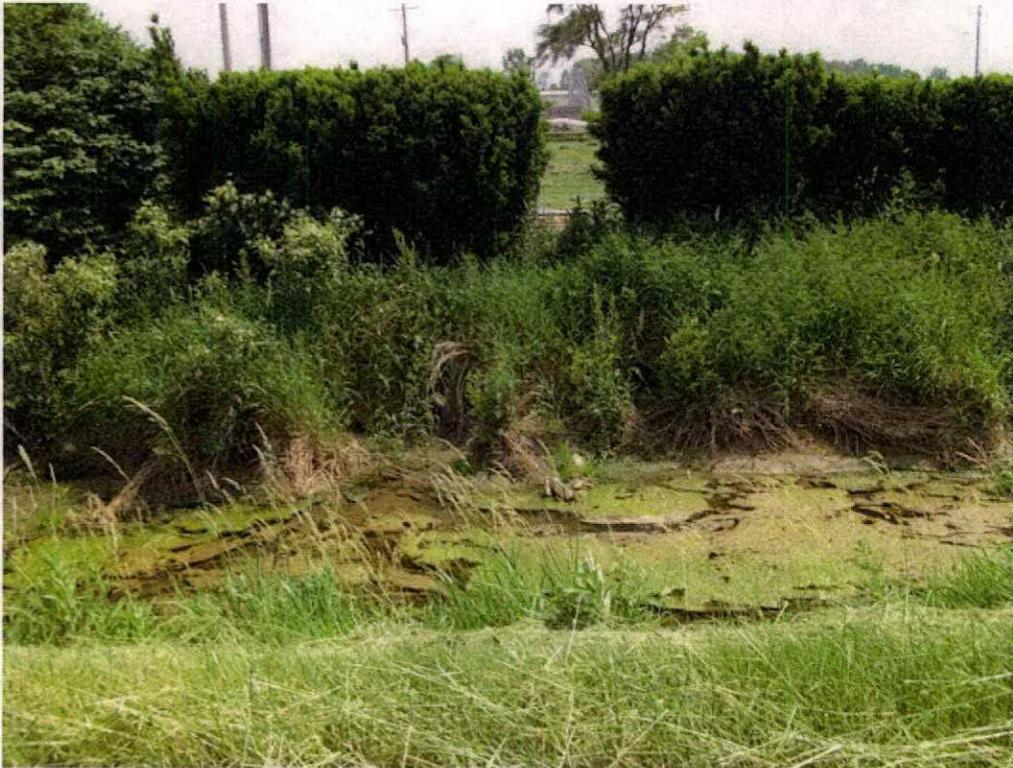
10. There was no flow to the chlorine contact tank, and the water level in the tank was observed to be very low.
11. Grating over some of the tanks was not locked.

No flow through chlorine contact tank, no disinfection. Water level in tank below chlorination unit. No discharge from chlorine tank to ditch north side of WWTP. page 6 of 6

12. This facility is not fenced and the open sand filters and unlocked tanks pose a safety hazard. It is noted that portions of fencing have been provided along either side of the tanks, but do not restrict WWTP access.
13. Chlorination/disinfection must be provided from May through October.
14. Pictures taken at the time of the inspection are enclosed.
