State of Ohio Environmental Protection Agency

Re: Construction Storm Water Inspection at Van Der Burg Dairy LLC

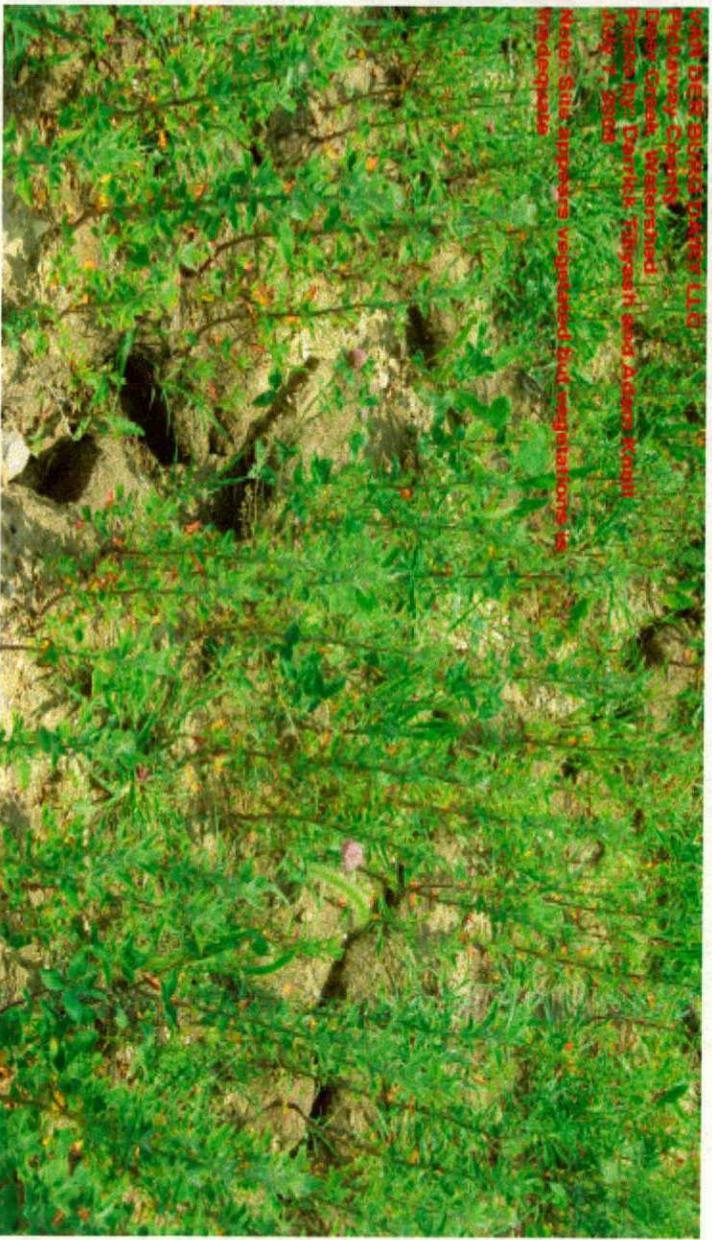
Figure 1 Inadequate vegetative cover

VAN DER BURG DAIRY LLC
Pickaway County
Deer Creek Watershed
Photo by: Darrick Tihyash and Adam Knapp
July 7, 2008
Note: Site appears vegetated but vegetation is inadequate

- Upon inspection it appeared that this site has been abandoned for some time. The lack of activity and inadequate vegetative cover is resulting in significant erosion throughout the entire site (See Photo Figure 1 and 2). This erosion is causing excess sediment to be deposited in the pond (See Photo Figure 3).
- The detention basin noted onsite must be modified to address sediment control via the installation of a temporary riser. This will allow for additional settling time for the suspended solids to settle prior to a final discharge from the site (See Photo Figure 4).
- Be aware the General Permit states that all barren areas which remain idle in excess of 21 days must be protected from erosion within seven days of the last earth disturbing activities. In addition, erosion protection must be implemented for all areas of final grade within seven days (See Photo Figure 5).

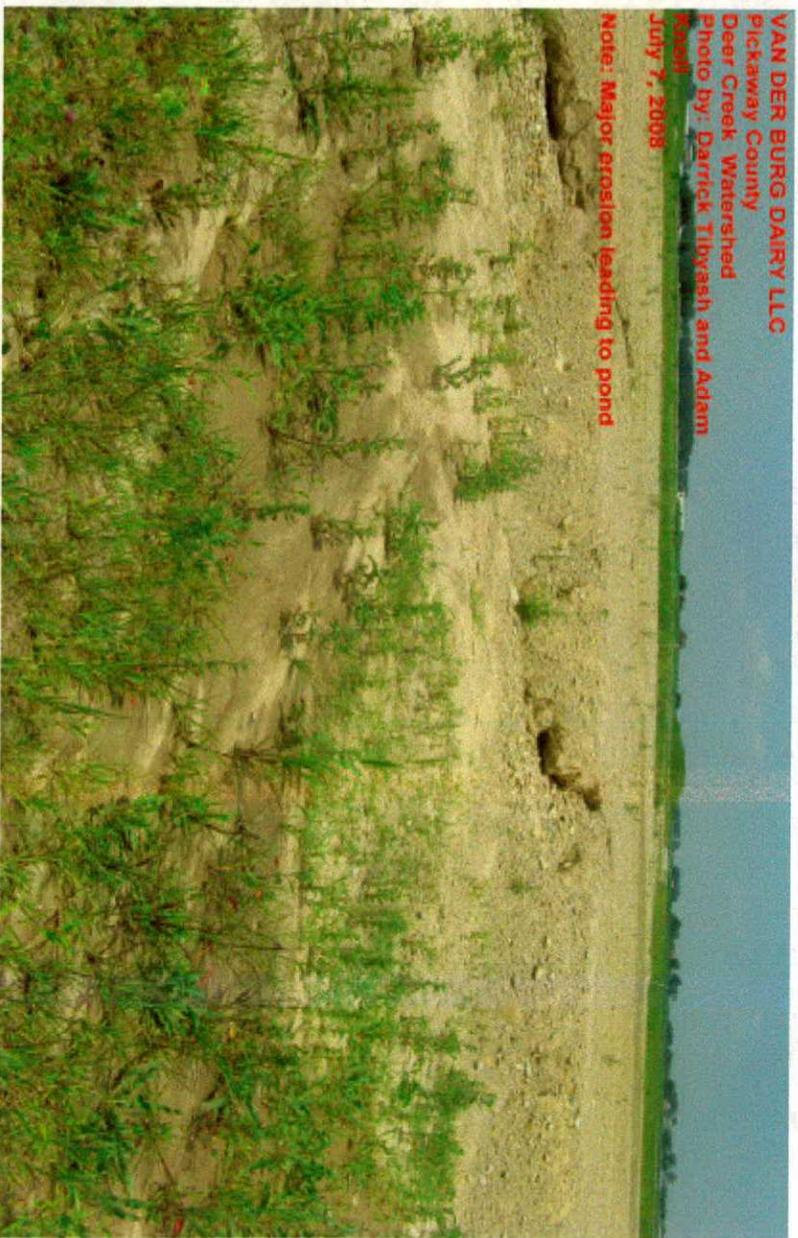
Figure 2 Major erosion noted

Note: Major erosion leading to pond
