**VINTON COUNTY  
WALDRON LUMBER COMPANY  
DHWM/SEDO  
OHR000144410**

**Re: Notice of Violation - Abandoned materials at Waldron Lumber Company**

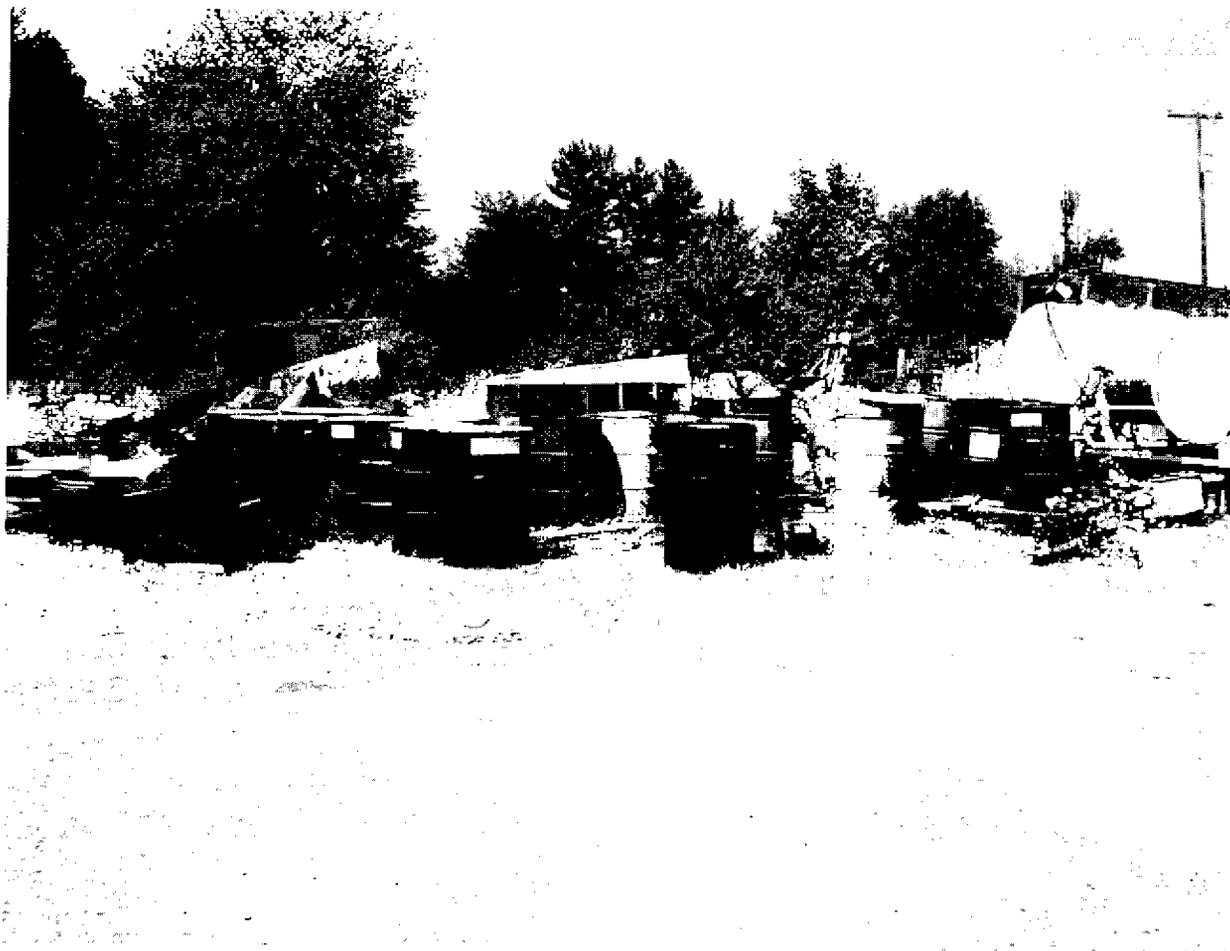
Site Photo

Waldron Lumber Company's Hamden facility ceased operations sometime between January and August of 2009. As of the date of our September 24, 2009 visit, drums, containers, and tanks of materials still remain on-site at the closed facility. Since these materials have been abandoned, they are considered to be wastes<sup>1</sup>.

**Waldron Lumber Company, Hamden Ohio.  
Drums, containers, tanks at garage/field area on west side of S.R. 93.**

- Evaluate all of the wastes left on site at Waldron Lumber Company's Hamden facility to determine if they are hazardous wastes. I have attached an inventory of the wastes we observed on-site during the September 24, 2009 inspection. *For your reference, I have enclosed several documents regarding hazardous waste determination/waste evaluation.*

- Send me documentation demonstrating that all of the wastes have been evaluated.
- Once all of the wastes remaining on-site have been evaluated, any wastes that are determined to be hazardous must be properly managed in accordance with Ohio's hazardous waste laws and regulations, and treated or disposed of by a permitted hazardous waste treatment, storage, and disposal (TSD) facility. Documentation of the final disposition of the on-site wastes (i.e., manifests, bills of lading, etc.) must be submitted to this office for review. *I have enclosed a list of permitted commercial TSD facilities in Ohio and a list of commercial used oil recyclers for your use in this matter.*
