**RE: Wilmington Sanitary Landfill
Notice of Violation**

On March 29, 2010, I conducted an inspection of Wilmington Sanitary Landfill (Facility) located in Clinton County. During the inspection, I was accompanied by Don Maher, Superintendent of Sanitation for the City of Wilmington. This inspection was conducted to determine compliance with Ohio EPA's Solid Waste Regulations and the Revised Alternative Daily Cover Temporary Approval letter from Ohio EPA, dated October 13, 2009. The working face during this inspection was located in the central portion of the west expansion area. The findings observed were also documented by photographs. Ohio EPA records show that construction and operation of the Facility is authorized by Permit to Install #845474, issued January 8, 2009.

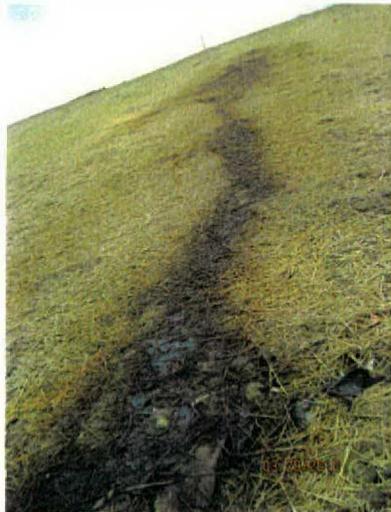
2. Leachate outbreaks were observed on the southern and western slopes of the west expansion area (see Figures 2 and 3). Prior to the inspection, the operator indicated that he had been working to correct an outbreak on the southern slope the previous week. Despite his efforts to correct this problem, the failure to properly contain, manage, investigate and correct the outbreaks was in violation of OAC Rule 3745-27-19(K)(1), which states:

Figure 2. Leachate running down southern exterior slope

Additionally, leachate outbreaks are addressed in the PTI #05-3708 Narrative, section 8.5.2 (page 51). **Failure to properly manage and correct a leachate outbreak is a violation of the PTI which states in part:**

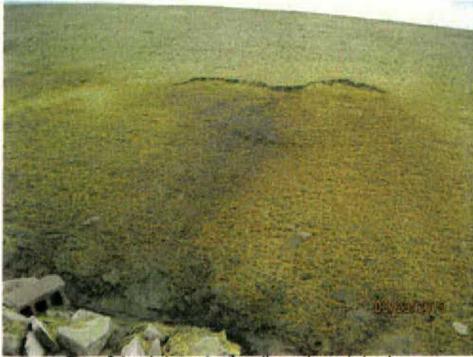
Figure 3. Leachate running down the western exterior slope
