State of Ohio Environmental Protection Agency

Northeast District Office

RE: **NOTICE OF VIOLATION
PARTIAL INSPECTION
A&L SALVAGE, LLC C&DD LANDFILL**

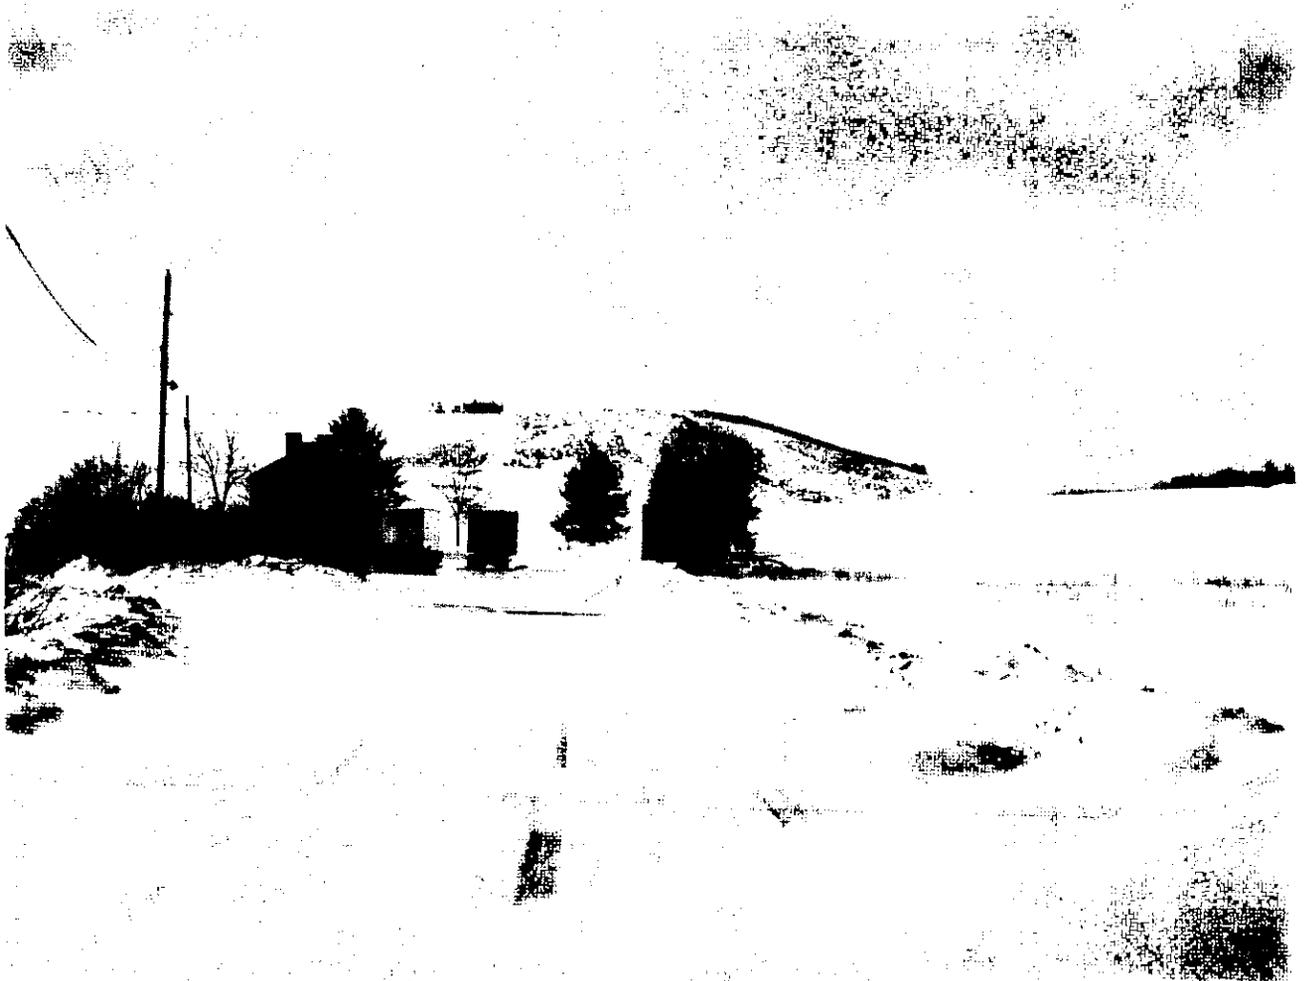
2. **Weekly Cover.** During this inspection, debris in one small portion of the facility working face was being covered with brown shale. It is estimated that this portion of the facility working face constituted less than 10% of the total facility working face. Covering of this portion of the facility working face was completed during the course of the inspection. The rest of the facility working face was not covered with soil or weekly cover on this occasion. A&L has repeatedly maintained that ALL exposed debris is covered with soil/weekly cover every Sunday, and that debris disposal at the facility working face is resumed on top of the weekly cover on Monday mornings.

A&L is in violation because it has failed to cover all disposed combustible debris on a weekly basis. Failure to cover all disposed combustible debris on a weekly basis is a violation of the following:

The following photograph shows where weekly cover was applied on Sunday February 18, 2007. The specific area where weekly cover was placed on this date is depicted as the thin brown strip on the upper right portion of waste placement near the middle of the picture. The rest of the facility working face which did not have weekly cover applied is depicted as the partially snow covered area extending from right to left from the brown strip on the upper right portion of waste placement near the middle of the picture to an area just behind the house on the left side of the picture:

- a. **OAC Rule 3745-400-11(H)(1)**: *“The owner or operator shall operate the facility in a manner that prevents fires by doing one of the following...Covering all disposed combustible debris on a weekly basis with soil, clean hard fill, or other material which is noncombustible. For the purposes of this rule, covering means to apply noncombustible material in a manner that combustible debris is not visible.”*
