**Re: Creative Housing XIII, Franklin County**

This letter is written in follow-up to a construction storm water inspection that I conducted at the Creative Housing XIII project that is located at the end of Lamplighter Drive, in Grove City, Ohio. The inspection was conducted on September 16, 2011. The purpose of the inspection was to evaluate compliance with the General Storm Water Permit Associated with Construction Activities.

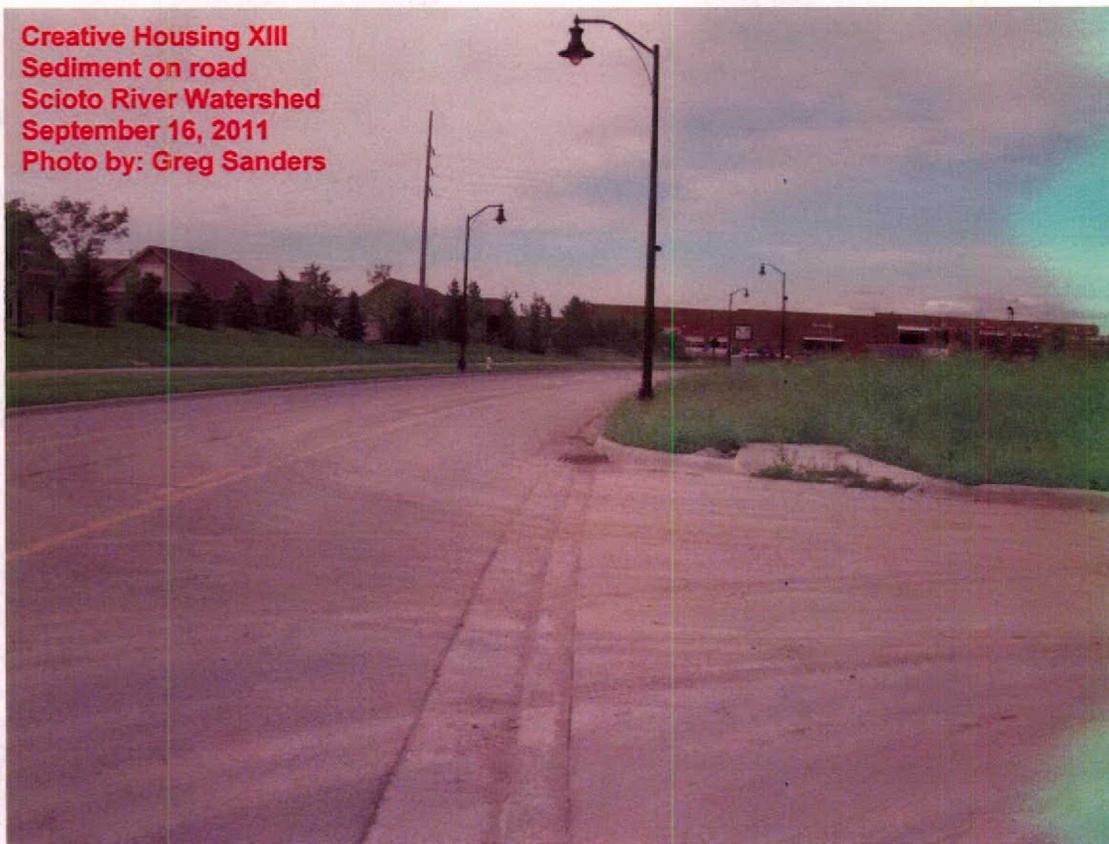
**Creative Housing XIII**  
**Sediment on road**  
**Scioto River Watershed**  
**September 16, 2011**  
**Photo by: Greg Sanders**

Please install erosion controls to prevent mud from being tracked on to Lamplighter Drive. Please see attached picture.
