Re: 1061 Mill Park Drive / Fairfield County

This letter is written regarding the storm water inspection I conducted of the construction activities at the project located at 1061 Mill Park Drive, on September 10, 2010. I understand this site is currently covered under the General Storm Water Permit Associated with Construction Activities. Based on my site inspection and the conditions set forth in the General Permit, the following items must be addressed:

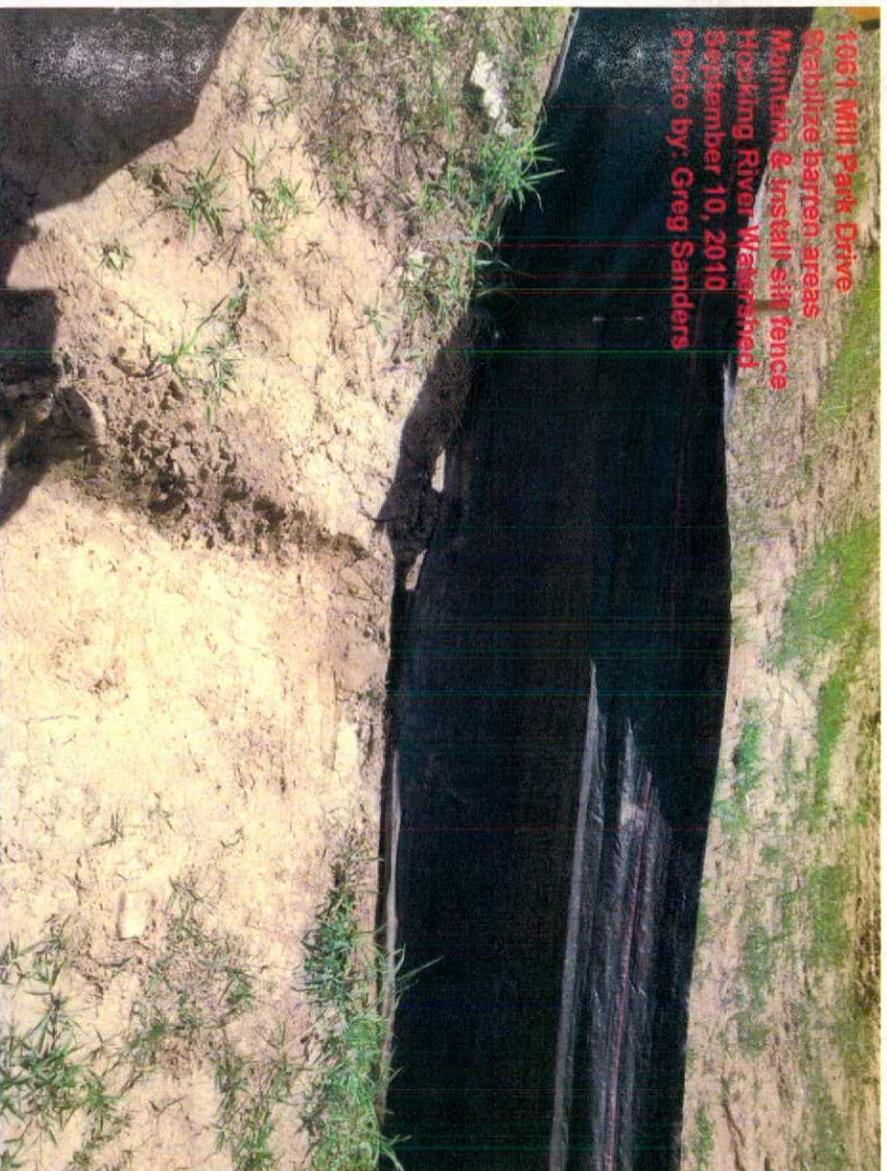
1061 Mill Park Drive
Stabilize barren areas
Maintain & install silt fence
Hocking River Watershed
September 10, 2010
Photo by: Greg Sanders

The project site had several large barren areas that appeared to be at final grade and were not stabilized. Please see attached pictures. Please be aware the General Permit mandates specific permanent and temporary stabilization requirements. All disturbed areas which remain idle in excess of 21 days must be protected from erosion within seven days of the last earth disturbing activities. All areas of final grade must be protected within seven days. All earth disturbing activities should be clearly logged in your inspection reports to ensure the 21 day / seven day requirement is not violated.

Silt fence appeared to be installed along Mill Park Drive but not along the sides of the building. Silt fence was not maintained along Mill Park Drive. Silt fence was being used as a check dam in the ditch, however, the silt fence was not installed in the ground to be effective. The General Permit requires the permittee to conduct inspections of all sediment and erosion controls every seven days or within 24 hours of a rain event equal to or greater than 0.5 inches. A log of the inspections and resulting corrective actions must be maintained on site available for review. All earth disturbing activities must be clearly documented in your inspection reports to ensure the temporary or permanent stabilization requirements are not violated. Please see attached pictures.

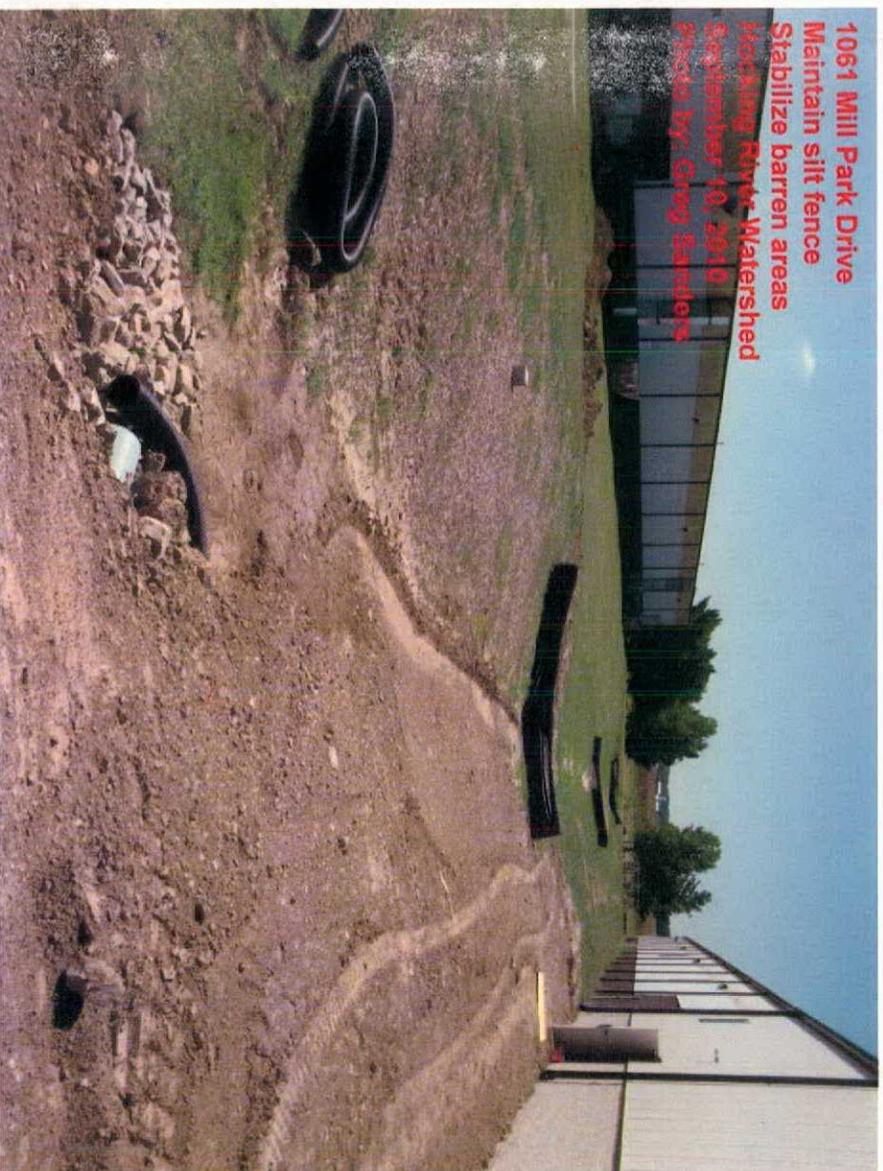
1061 Mill Park Drive
Maintain silt fence
Stabilize barren areas
Hocking River Watershed
September 10, 2010
Photo by: Greg Sanders

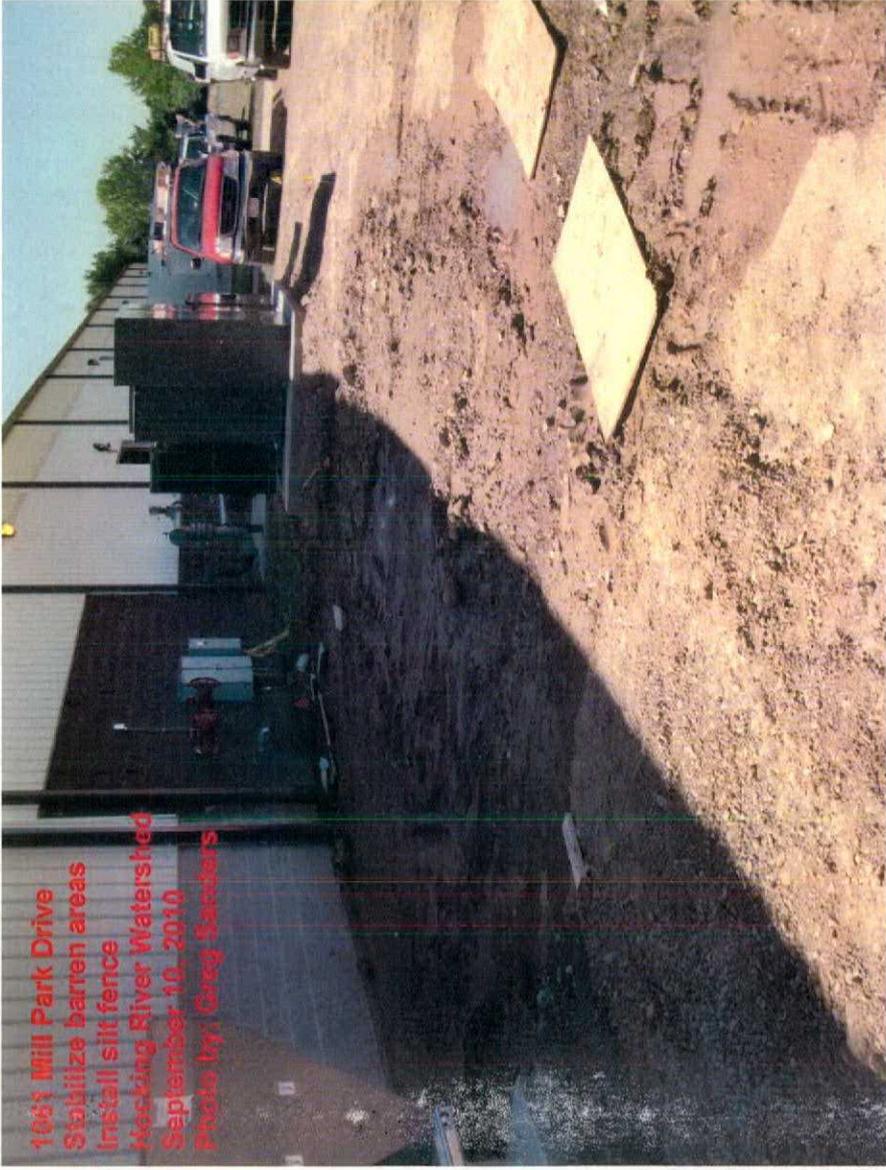
1051 Mill Park Drive
Stabilize barren areas
Install silt fence
Attocking River Watershed
September 10, 2010
Photo by: Greg Sanders

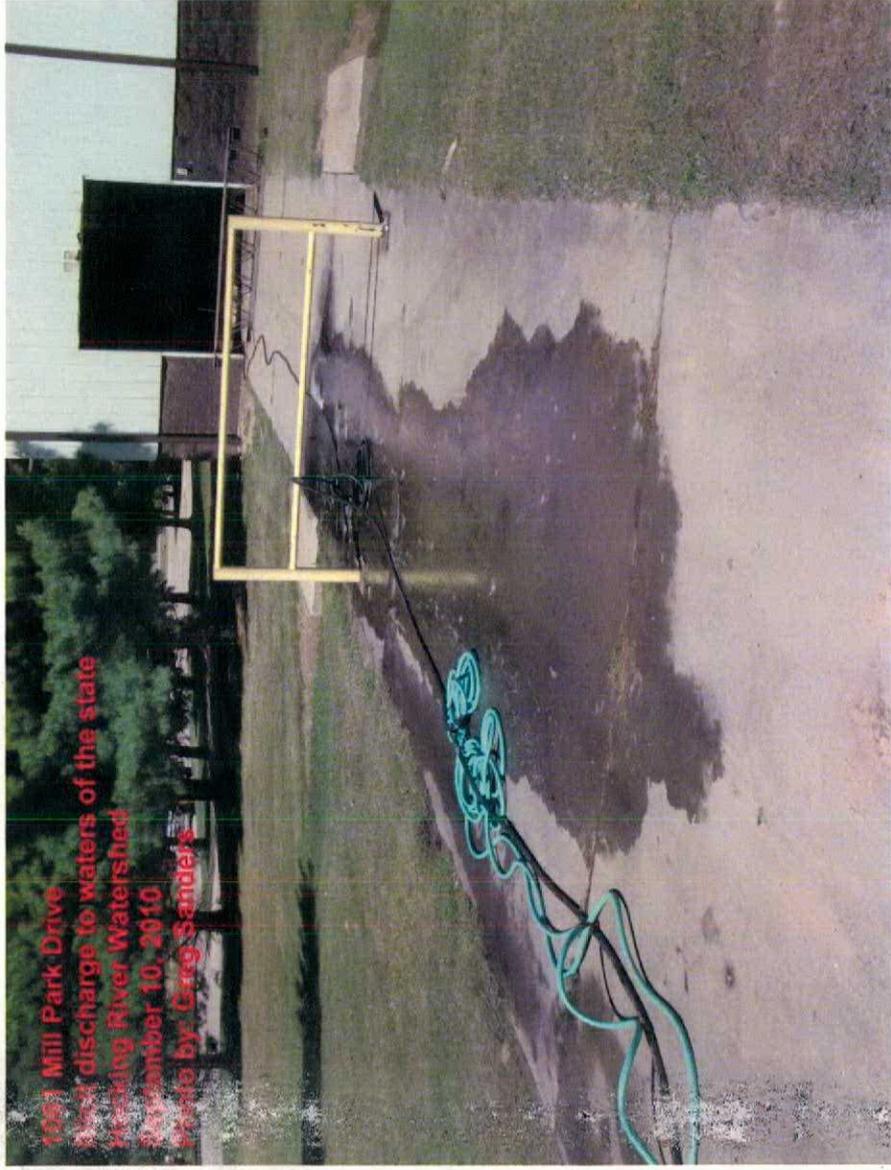
1051 Mill Park Drive
Best discharge to waters of the state
Attocking River Watershed
September 10, 2010
Photo by: Greg Sanders

During the site visit, it was noted that a large amount of water from the testing of the fire suppression system was discharged across a barren area and the sediment was being discharged to a storm water drain on the adjacent property. The discharge of sediment off-site is a violation of your General Storm Water Permit Associated with Construction Activities. The fire suppression test water must be discharged directly to the storm water drain or a large grassy area (assuming it is clean water free of pollutants). The barren areas must be stabilized. Please see attached pictures.

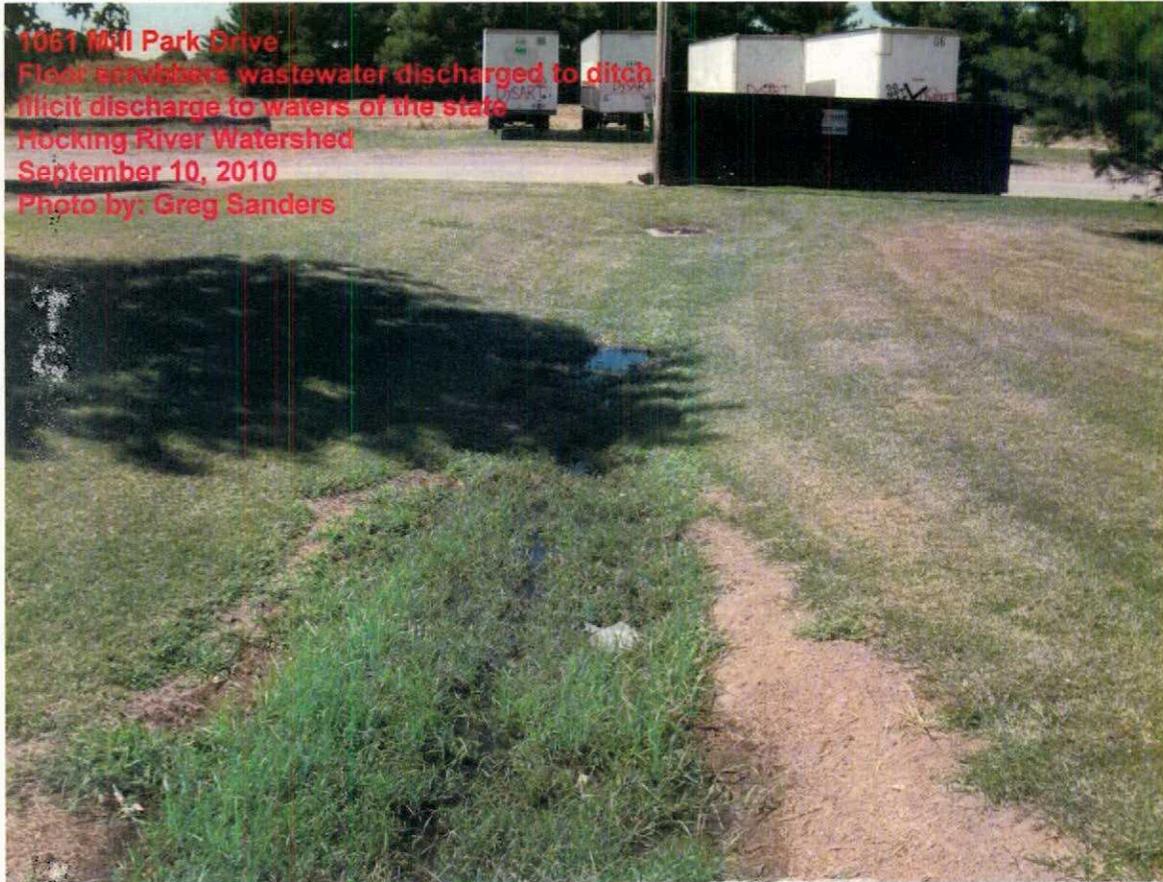
1061 Mill Park Drive
Floor scrubber wastewater discharged to ditch
Hocking River Watershed
September 10, 2010
Photo by: Greg Sanders

During the site visit, it was noted that wastewater from a floor scrubber was being discharged to a sidewalk and ditch which flowed to waters of the State. The floor scrubber wastewater appeared to contain surfactants, solvents and a lot of suspended solids. Please be aware that it is illegal to discharge pollutants to waters of the state without first obtaining a permit. A permit would not be issued for this type of activity. This is a violation of state and federal law. The explanation given at the site for the reason why industrial wastewater was discharged to waters of the state was that they had not received approval to discharge to their sanitary sewers. Please see attached pictures.
