**Re: Construction Storm Water Inspection of Ridgeview Junior High School
Fairfield County
Permit Number: 4GC03246*AG**

HK/nsm Ridgeview Junior High School 8-24-2010

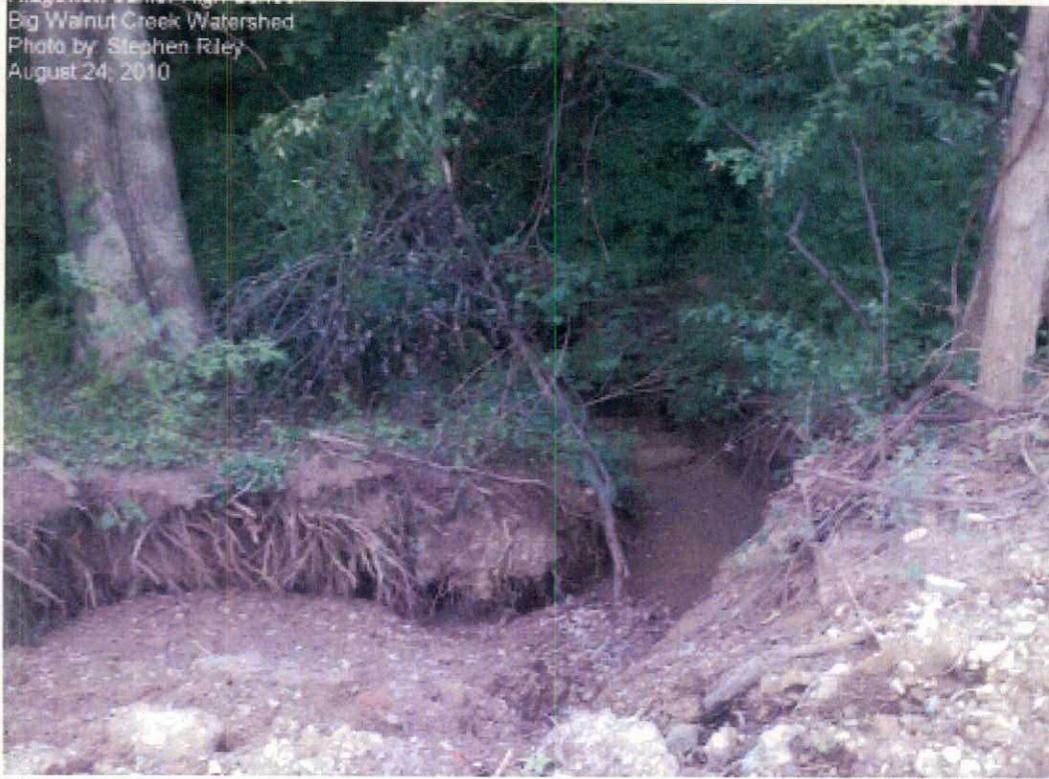
- Our staff observed an area on the backside of the school leading down to the stream where sediment discharges were evident (Figure 1). Please be aware, according to your permit conditions, sediment traps are required for areas of concentrated flow. Please emplace such measures within three days upon receipt of this letter.
- The silt fence on this site along Hill Road (Figure 2) will require maintenance or reinstallation to ensure a proper functioning condition. This general permit states that all sediment controls will be inspected and maintained every seven days or within 24 hours of a precipitation event equal to or greater than 0.5 inches. A log of inspection must be maintained on site for the agency to review.

Figure 1: Area of heavy sediment flow

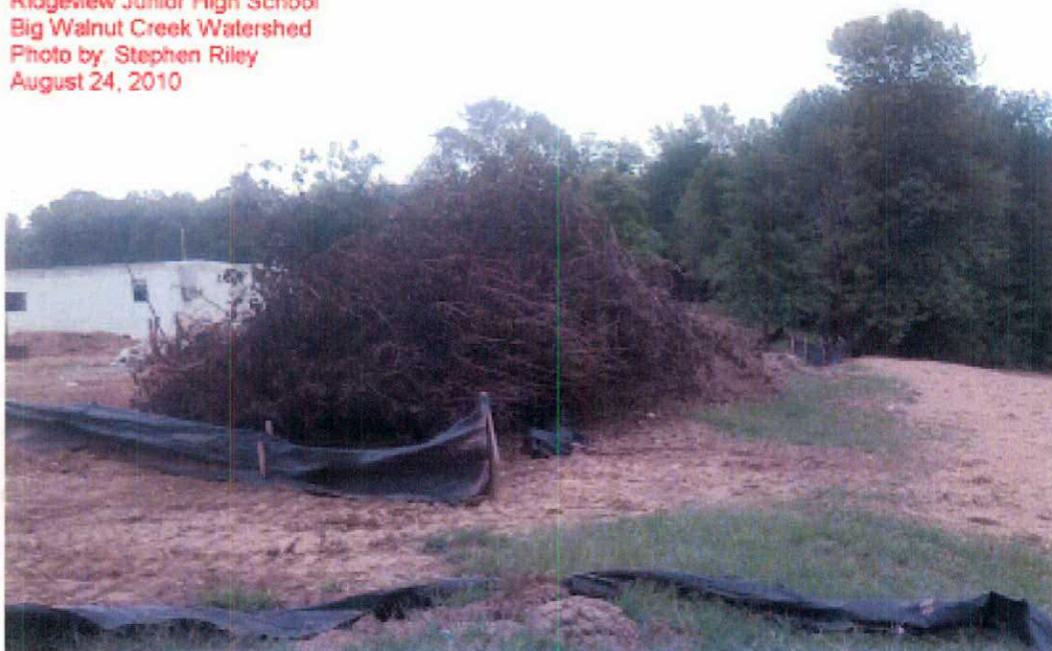
Figure 2: Silt fence along Hill Road in disrepair
