**Re: Construction Storm Water Inspection at Chabad House / Franklin County
Permit Number 4GC02989*AG**

This letter is written in follow-up to a construction storm water inspection conducted by Stephen Riley and Abigail Tamkin of Ohio EPA at Chabad House located at 6220 Dublin Granville Rd, New Albany, Ohio on July 14, 2010. The purpose of the inspection was to evaluate compliance with the General Storm Water Permit Associated with Construction Activities. Based on the site inspection and the General Storm Water permit, the following items were noted;

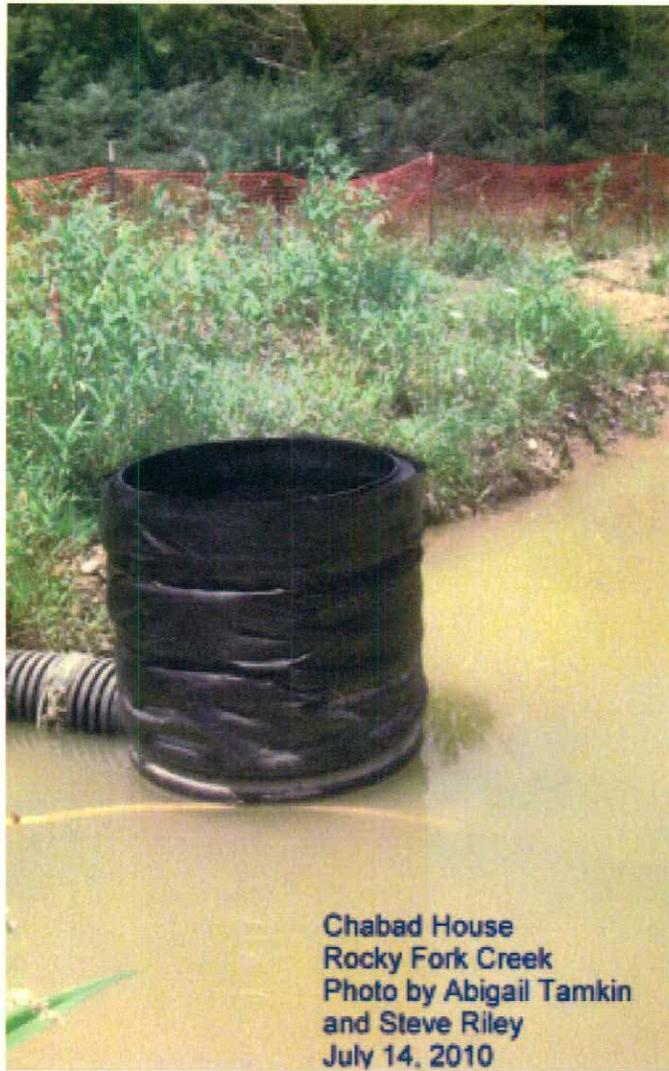
- The centralized retention pond lacks proper outlet structure designed for sediment control. Failure to implement effective sediment controls is a direct violation of your General Storm Water Permit. Corrective measure must be taken to install a modified outler structure such as a temporary riser or equivalent within seven days of receipt of this letter, to avoid the potential of escalated action (Figure 1).
- Please establish a proper concrete washout pit in order to minimize contamination threats to waters of the state (Figure 2).

Figure 1: Outlet structure without proper controls

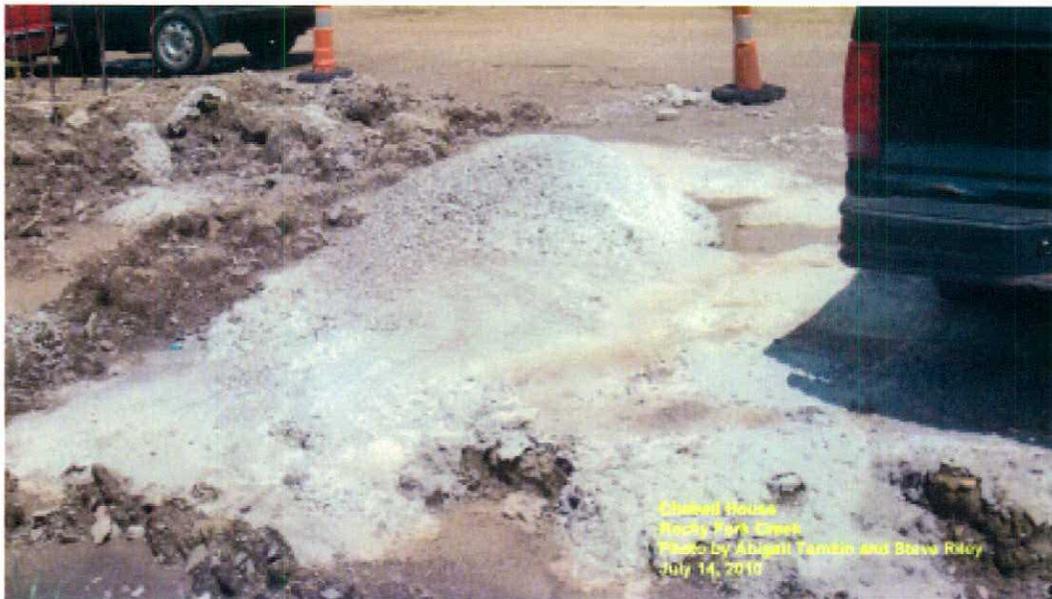
Figure 2: Improperly constructed concrete washout pit
