**Re: Construction Storm Water Inspection at FRA-270-24.14 PID - 81737  
Permit Number 4GC02955\*AG**

This letter is written in follow-up to a construction storm water inspection conducted by Stephen Riley and Vinod Tujalpuram of Ohio EPA at I-270 OVER NS/CSXRR **PID - 81737** Columbus, Ohio, on July 1, 2010. The purpose of the inspection was to evaluate compliance with the General Storm Water Permit Associated with Construction Activities. During the inspection, the following items were noted:

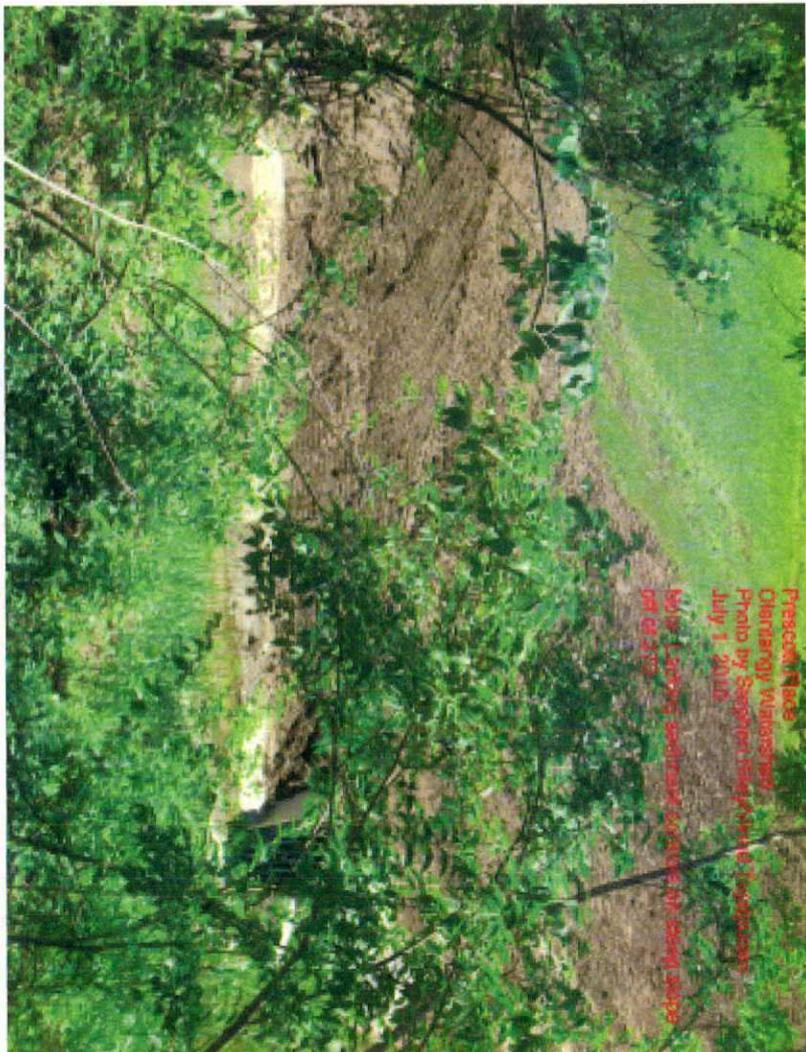
- During the inspection, our inspection staff noted the lack of sediment and erosion around the road side ditch on the north side of 270 near the bottom of the slope. (See Figure 1)
- Corrective measures must be taken to implement sediment and erosion controls in this area.

Photo 1: Lack of sediment controls at steep slope  
08/01/2010

Figure 1: Lack of sediment controls at bottom of slope
