**Re: Storm Water Inspection at Memorial Dr & Pierce Ave Mass Fill  
Fairfield County  
Permit #: 4GC02279\*AG**

This letter is written in follow-up to a construction storm water inspection by Amber Miller and Heather Nichols, of the Ohio EPA, at Memorial Dr & Pierce Ave Mass Fill located at the corner of Pierce Avenue and State Route 33 in Lancaster, Ohio on July 9, 2009. The purpose of the inspection was to evaluate compliance with the General Storm Water Permit Associated with Construction Activities. During the inspection, we noted the following:

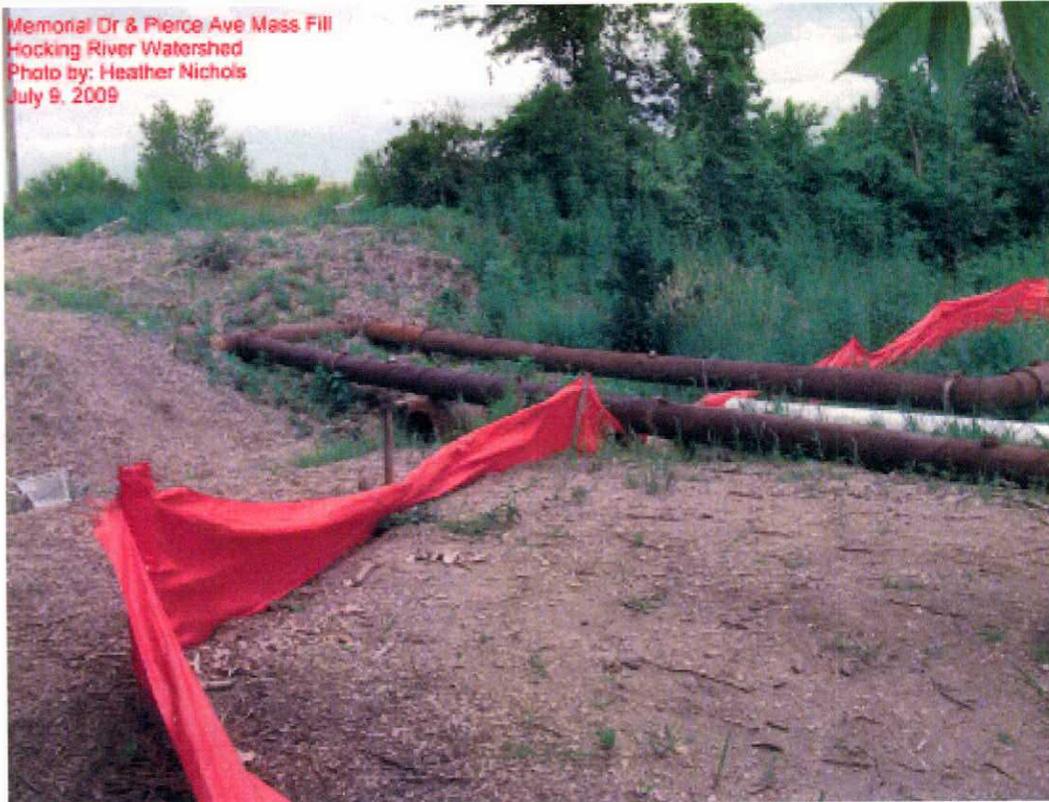
Figure 1: Repair silt fence

- Upon inspection it was noted that the perimeter silt fence along the west side of the site has failed and will require repair (See Figure 1).
- Please be aware that the General Permit indicates that all sediment controls will be inspected and maintained every seven days or within 24 hours of a precipitation event equal to or greater than 0.5 inches. A log of inspection must be maintained on site for the agency to review.
- Be aware the General Permit states that all barren areas which remain idle in excess of 21 days must be protected from erosion within seven days of the last earth disturbing activities. In addition, erosion protection must be implemented for all areas of final grade within seven (7) days.
