**Re: East Village, Phase 2 / Franklin County  
Permit Number: 4GC03028\*AG**

This letter is written regarding the storm water inspection that I conducted at **East Village, Phase 2** project located at 253 East 12<sup>th</sup> Avenue in Columbus, Ohio on February 3, 2011. The inspection was a follow-up to a previous complaint inspection. The Agency understands that these construction activities are currently covered under the General Storm Water Permit Associated with Construction Activities. Based on the site inspection and the General Storm Water Permit, the following items were noted;

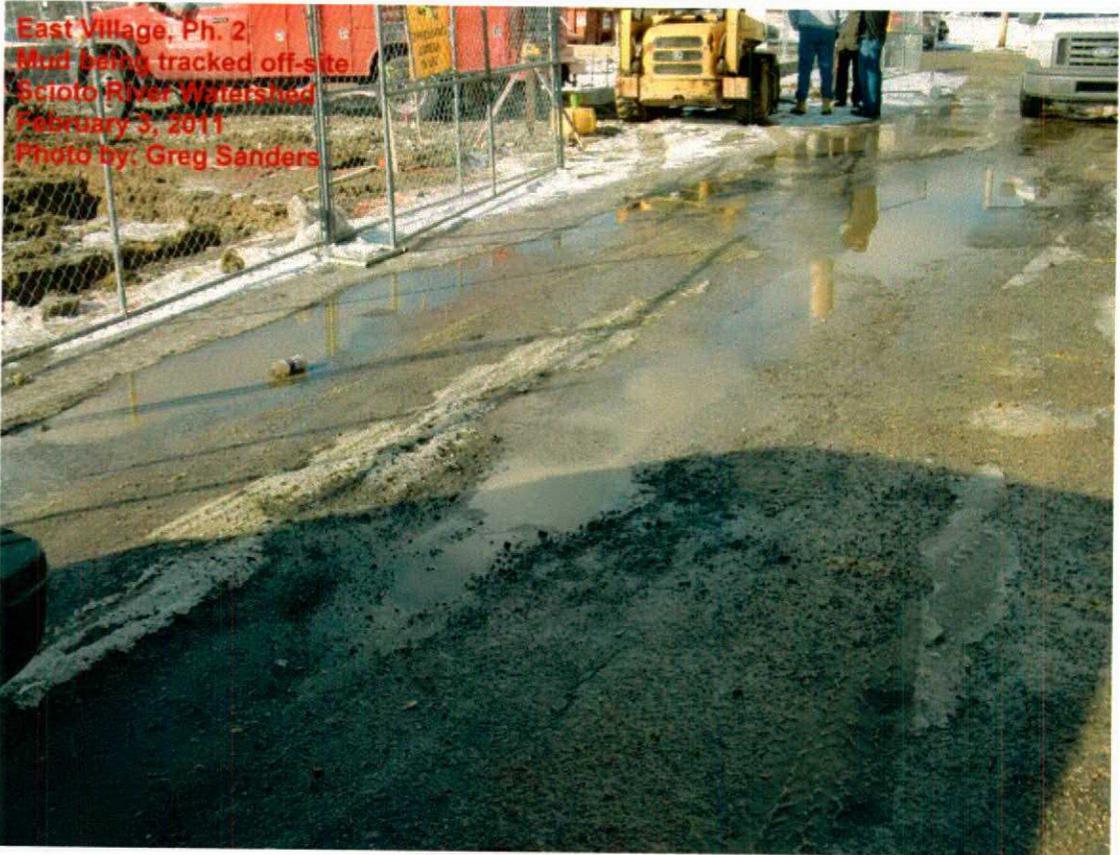
East Village, Ph. 2  
Mud being tracked off-site  
Scioto River Watershed  
February 3, 2011  
Photo by: Greg Sanders

- The previous turbid discharge was corrected. There was still flow from the waterline break. However, the discharge was no longer turbid due to erosion controls that were put in place.
- The site had silt fence installed on the "downslope" side of the development.
- Please be aware that the general permit states that all sediment controls will be inspected and maintained every seven days or within 24 hours of a precipitation event equal to or greater than 0.5 inches. A log of inspection must be maintained on site for the agency to review.
- Please provide additional controls at the construction entrances to prevent mud from being tracked off of the site. Gravel had been placed at the construction entrances. However, it was not adequate from preventing mud from being tracked off-site. Continue to use a sweeper or bobcat to keep mud off of the streets. Please see attached pictures.

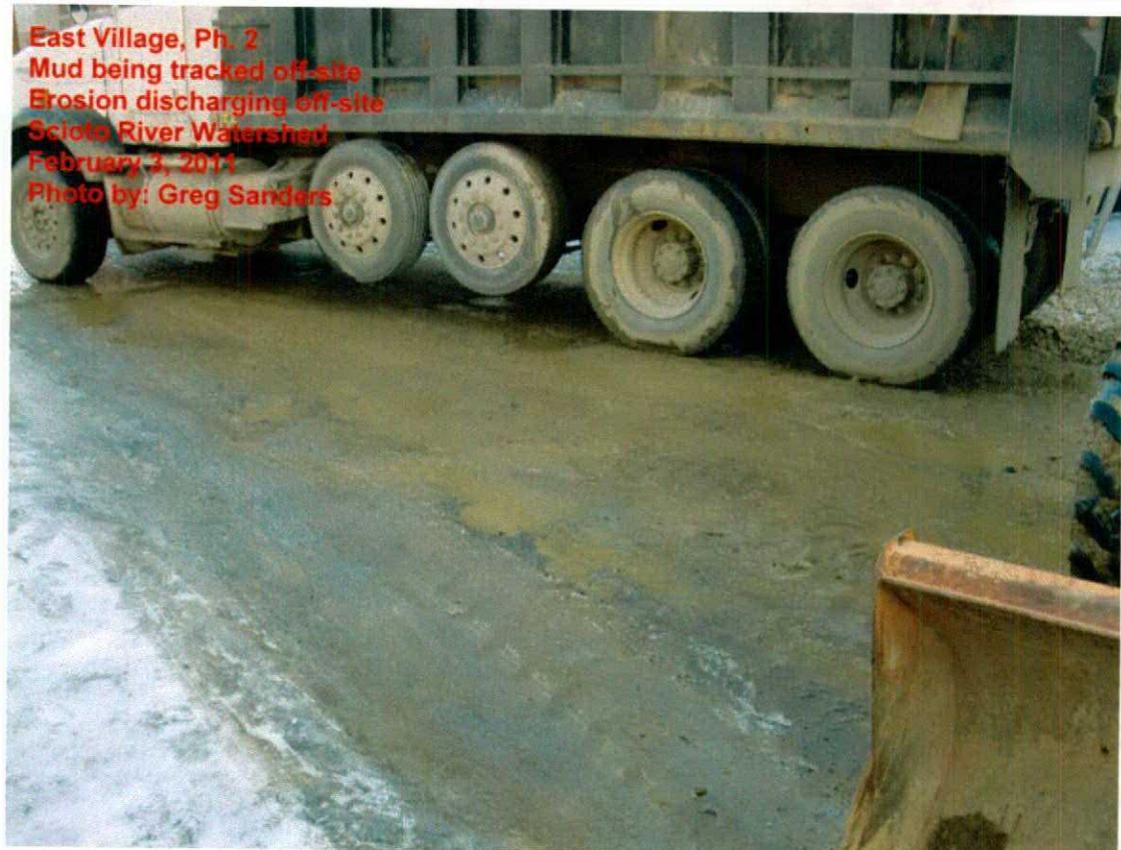
East Village, Ph. 2  
Mud being tracked off-site  
Erosion discharging off-site  
Scioto River Watershed  
February 3, 2011  
Photo by: Greg Sanders
