WESTERVILLE PLANT #13

August 10, 2011

**Re: Industrial Storm Water Inspection at Westerville Plant #13 / Franklin County
Permit #: 4GR00316*DG**

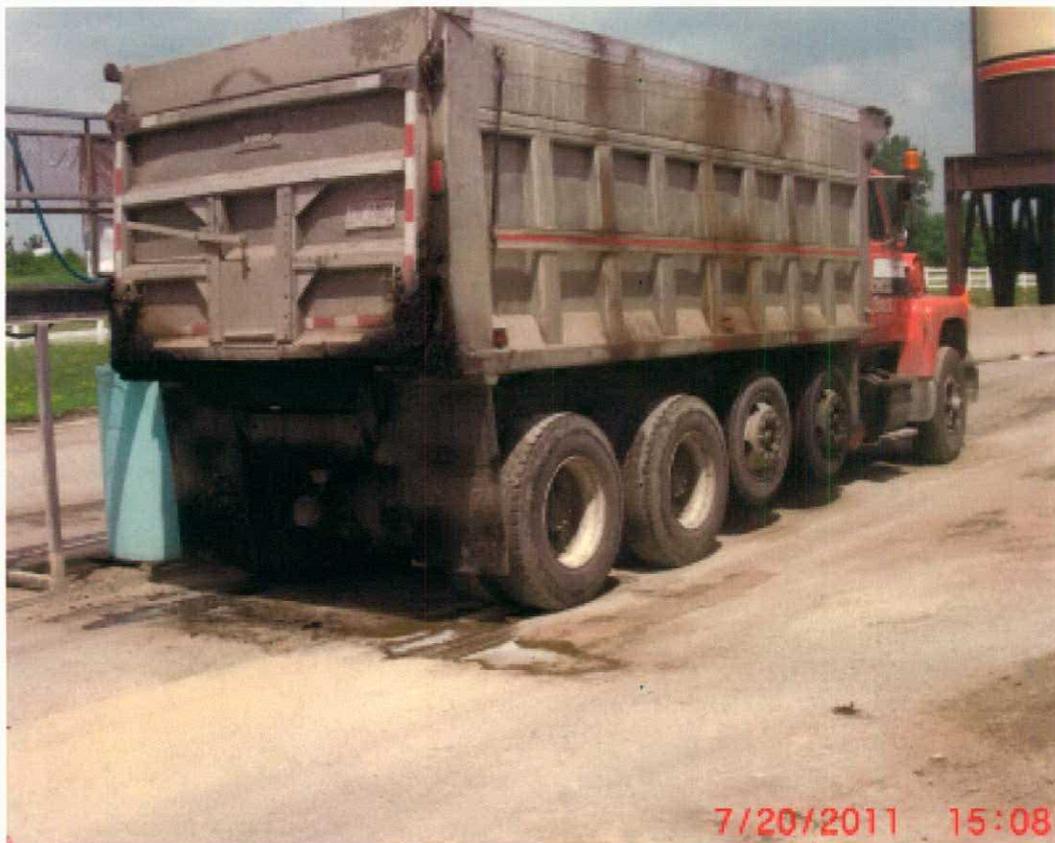
- Secondary containment should be considered for the loading and unloading area for emulsions located at this facility.
- I noted a staging area prior to the loading of asphalt for all dump trucks. This station included a material which provides a coating to the truck bed prior to loading. Containment measures should be provided for this material in the event of over spray or leakage from the truck bed. During the inspection we observed over-spray on the ground from the application process.

Figure 1: Overspray on ground from coating process

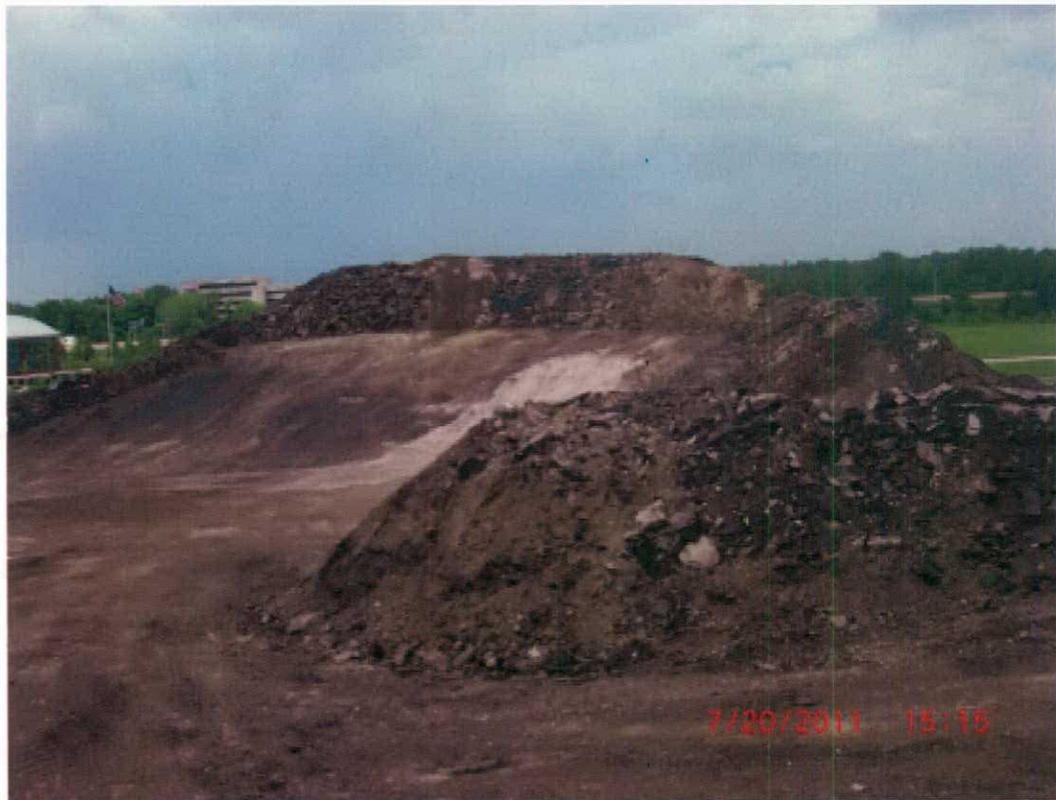
- I remain concerned regarding the runoff associated with the large storage piles of recycled asphalt (See Photo Figure 2). This was brought to your attention in previous inspection reports dated February 22, 2008 and March 4, 2009 (enclosed). I received your response indicating there were adequate buffers to minimize potential pollution to Alum Creek. Based on my site observations, I noted two discharge swales

on the eastern and western ends of the piles. These discharge swales provided direct pathways to a small tributary to Alum Creek. At this time I am notifying you I will be conducting sampling of this storm water run-off to evaluate potential impacts to the tributary in the event you wish to split samples.

Figure 2: Large Recycle Asphalt Pile
