NEW ALBANY CARE CENTER

**Re: Construction Storm Water Inspection at New Albany Care Center  
Franklin County  
Permit Number: 4GC03468 \*AG**

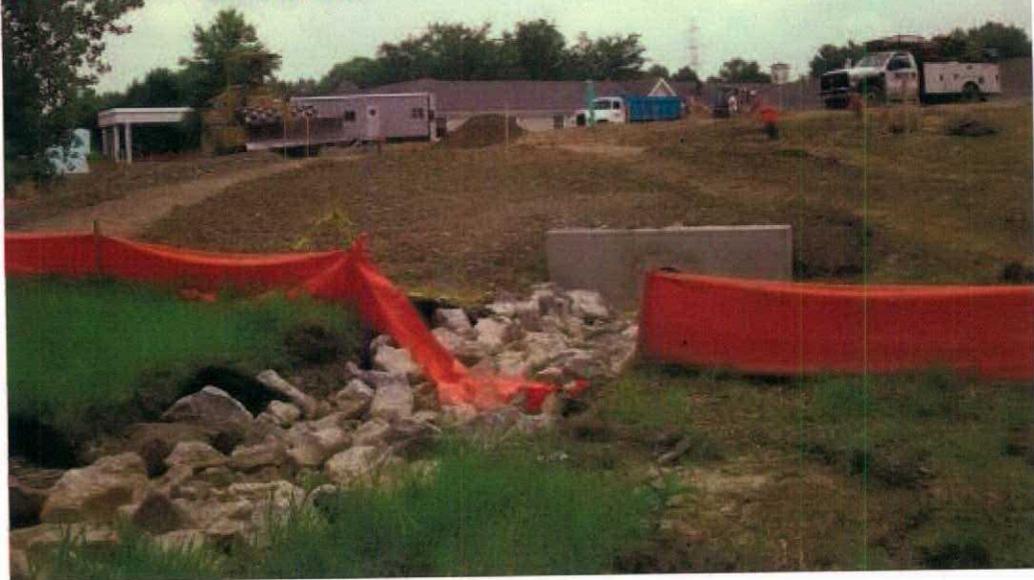
Figure 1

Centralized Sediment Outfall

- Our staff noted a storm water outfall installed to drain water from the site. At this time erosion control was properly maintained below the outfall (see Figure 1)
- Please ensure that all offsite drainage is routed through the outfall and is not escaping through perimeter barriers fence to minimize offsite sediment transport.
- Please ensure all inlet protections are installed, specifically the inlet noted in Figure 2 are properly protected from sediment runoff.

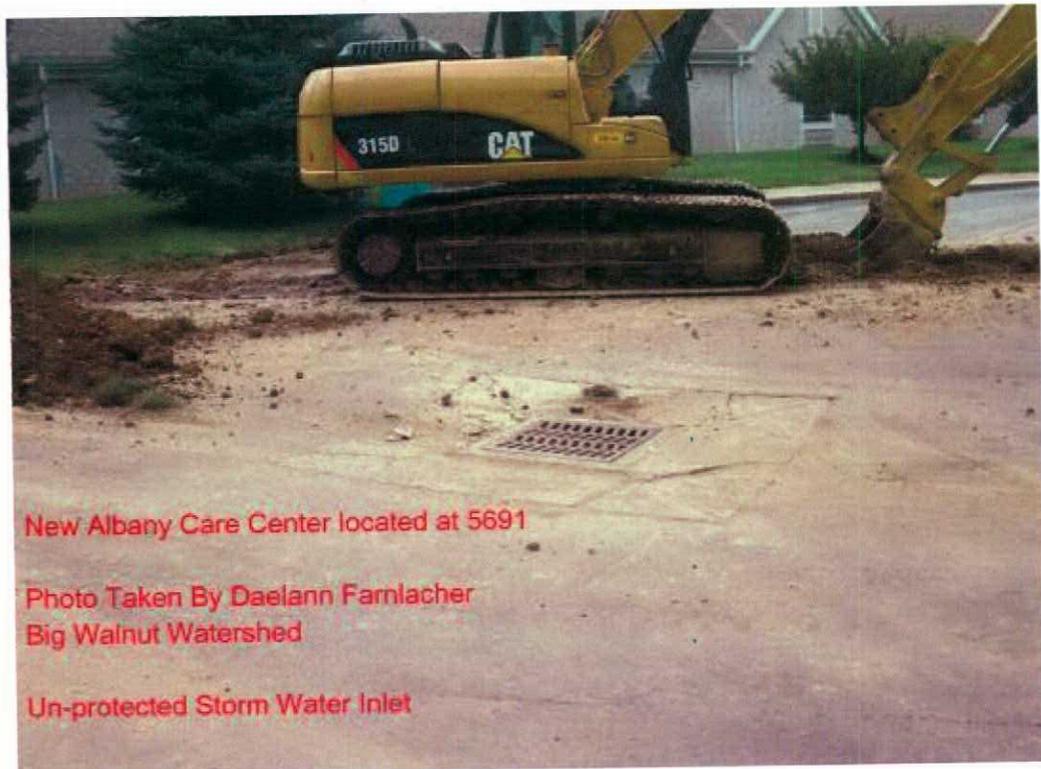
Figure 2

Un-protected Storm Water Inlet
