CLOVER GROFF RUN STREAM RESTOR PROJ PH 2

July 12, 2011

**Re: Construction Storm Water Inspection at Clover Groff Run Stream Restoration Project
Phase Two / Franklin County
Permit Number: 4GCD00073*AG**

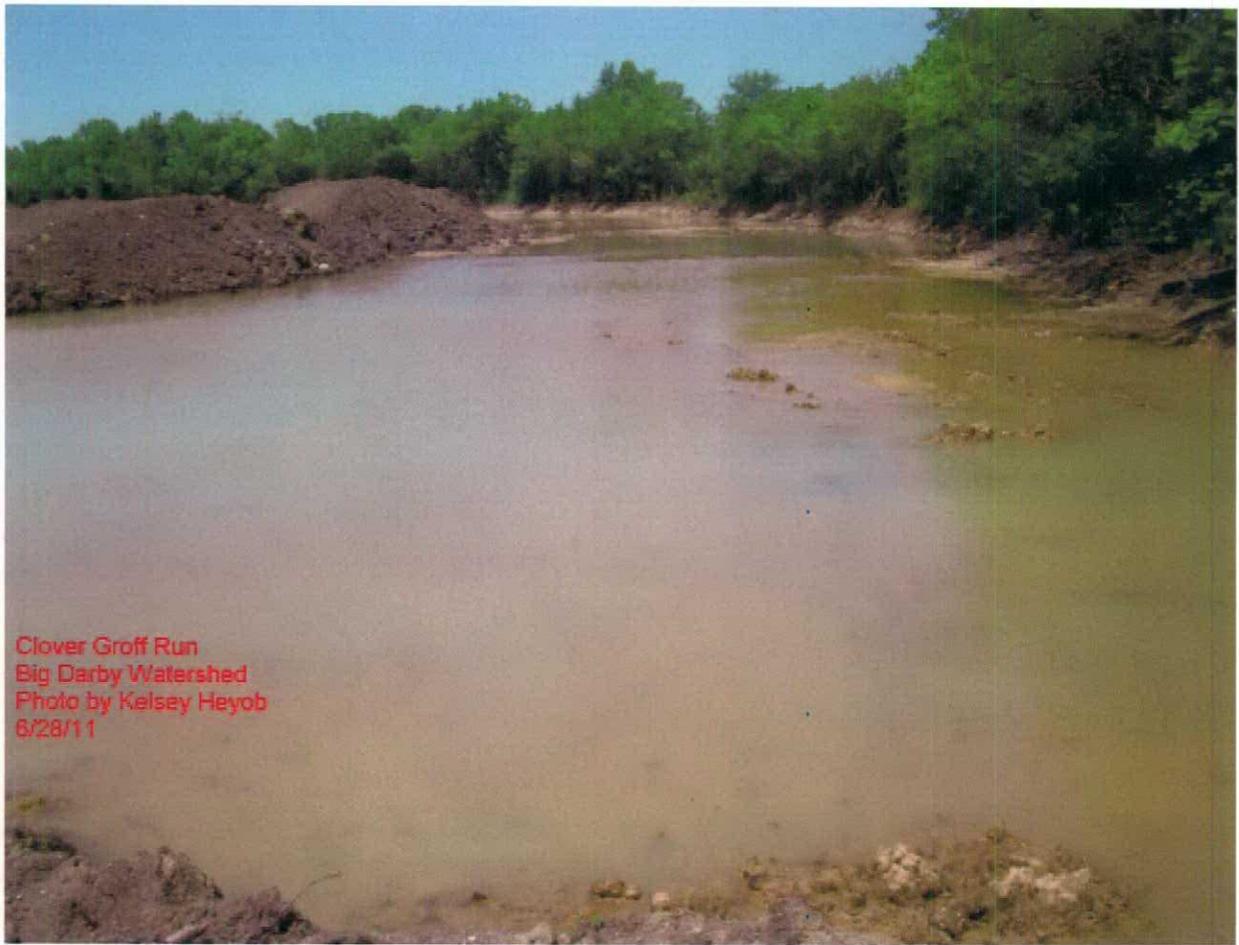
Figure 1

- Barren areas are currently contained as the floodplain is excavated. Please continue to utilize this process as a primary sediment control.
- I understand it may become necessary to dewater the excavated floodplain. Please ensure dewatering activities do not result in turbid discharges to waters of the state namely Clover Groff (see Figure 1).

Clover Groff Run
Big Darby Watershed
Photo by Kelsey Heyob
6/28/11
