GLENROSS PARK

July 11, 2011

Re: **Construction Storm Water Inspection at Glenross Park / Delaware County**
Permit Number: 4GC03518*AG

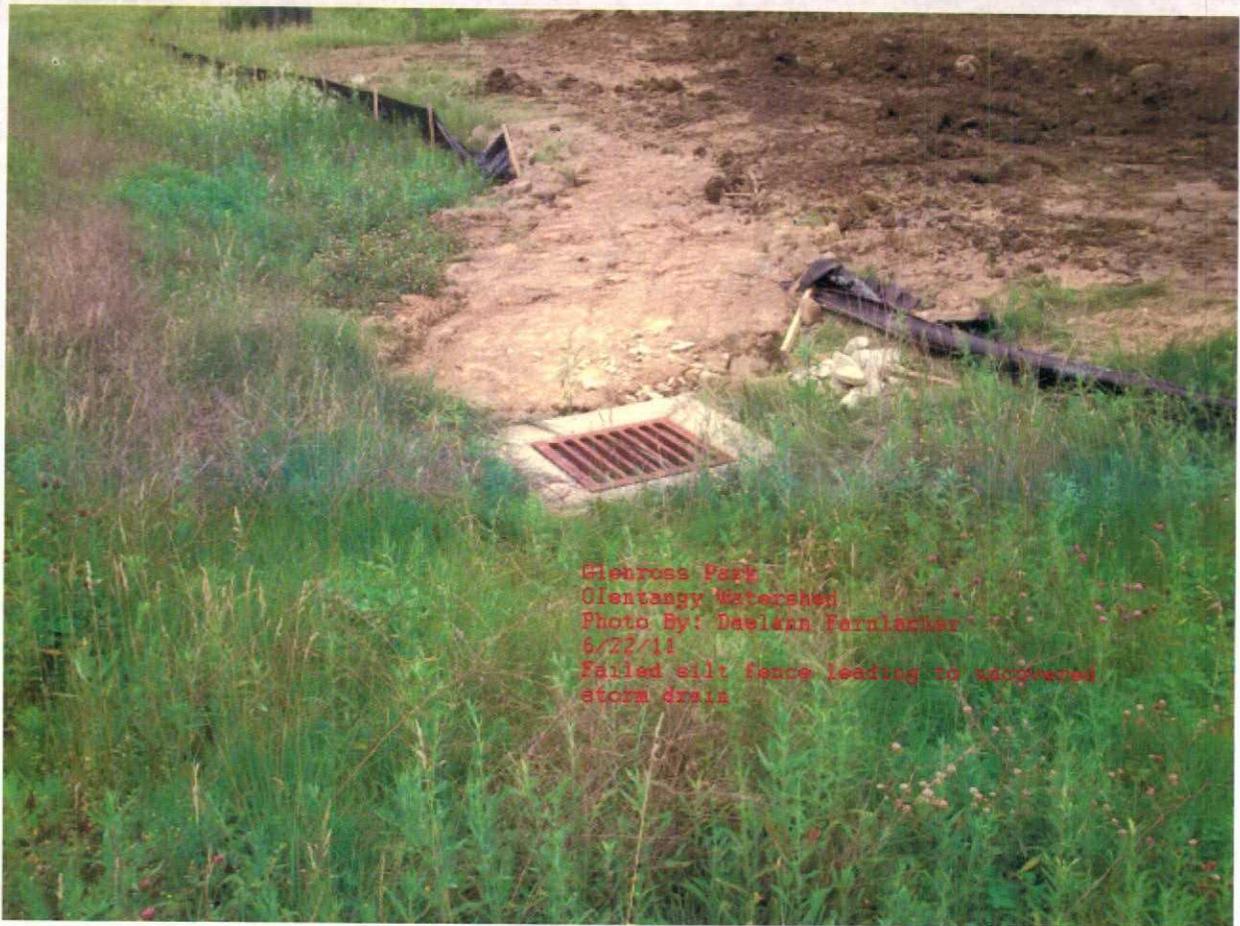
Figure 2

- Our staff observed the silt fence was down on the west side of the site and storm water runoff was draining directly into the storm drain. This is a direct violation of the general permit and must be repaired/maintained within three days of receiving this letter. (see Figure 1)
- It was noted that inlet protections were not installed, please ensure proper inlet protection measures are installed or demonstrate an approvable alternative. (see Figure 2)
- It was noted that the entrance of the site was interfering with proper barrier controls. Please provide a stabilized entrance to the site (see Figure 3).
