DELAWARE AREA CAREER CENTER

July 11, 2011

**Re: Construction Storm Water Inspection at Delaware Area Career Center  
Delaware County  
Permit Number: 4GCO00039\*AG**

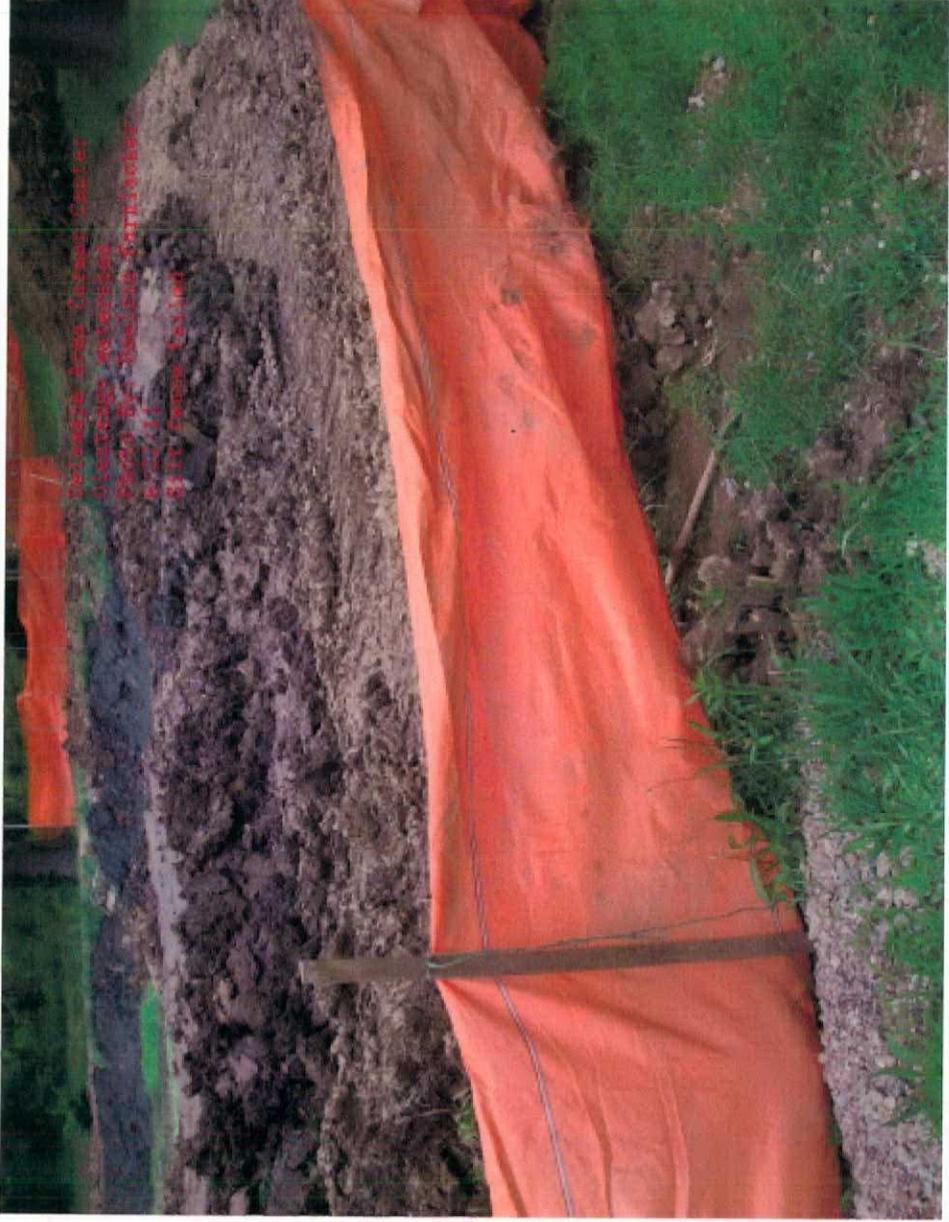
Figure 1

- Our staff noted the dewatering activities appear properly managed at the time of the inspection. Please ensure all future dewatering activities do not result in turbid discharges into waters of the state (see Figure 2).
- On the southwest side of the sediment basin, our staff noted the perimeter barrier silt fence is not properly entrenched. Silt fence must be buried four to six inches in the ground to minimize sediment runoff into waters of the state. Please perform appropriate maintenance to ensure the effectiveness of perimeter barriers (see Figure 1).

Delaware Area Career Center  
Olanchoy, Maryland  
Photo by: Stephen Frayhauser  
6/22/11  
Lundborg, sediment trap

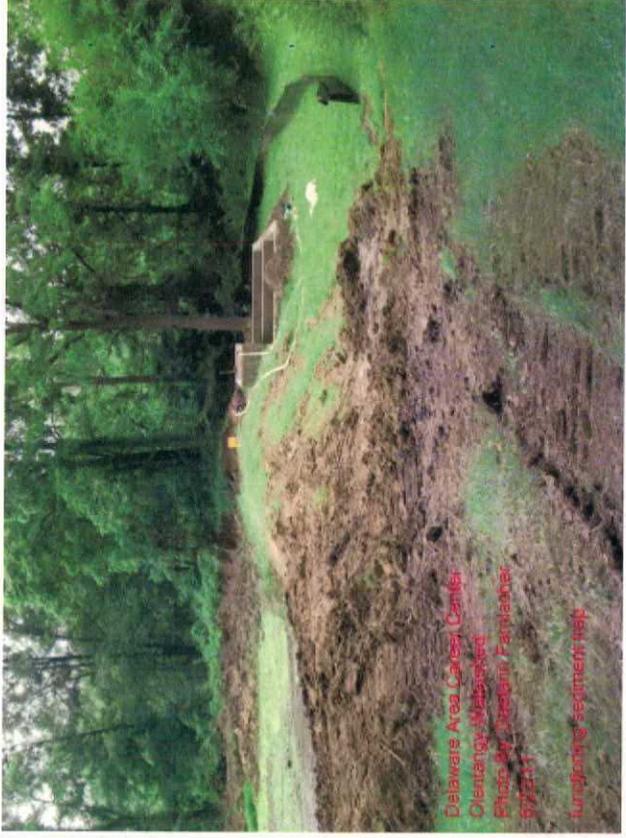
Figure 2

Delaware Area Career Center  
Olanchoy, Maryland  
Photo by: Stephen Frayhauser  
6/22/11  
Lundborg, sediment trap
