**Re: SUMCO Corporation – Cincinnati – Lower Little Miami – IU Inspection
CEI - OH0105783; 1IN00174*ED
NOTICE OF VIOLATION**

NPDES Compliance Inspection Report

Pretreatment Compliance Inspection Report

INDUSTRIAL USER INSPECTION CHECKLIST

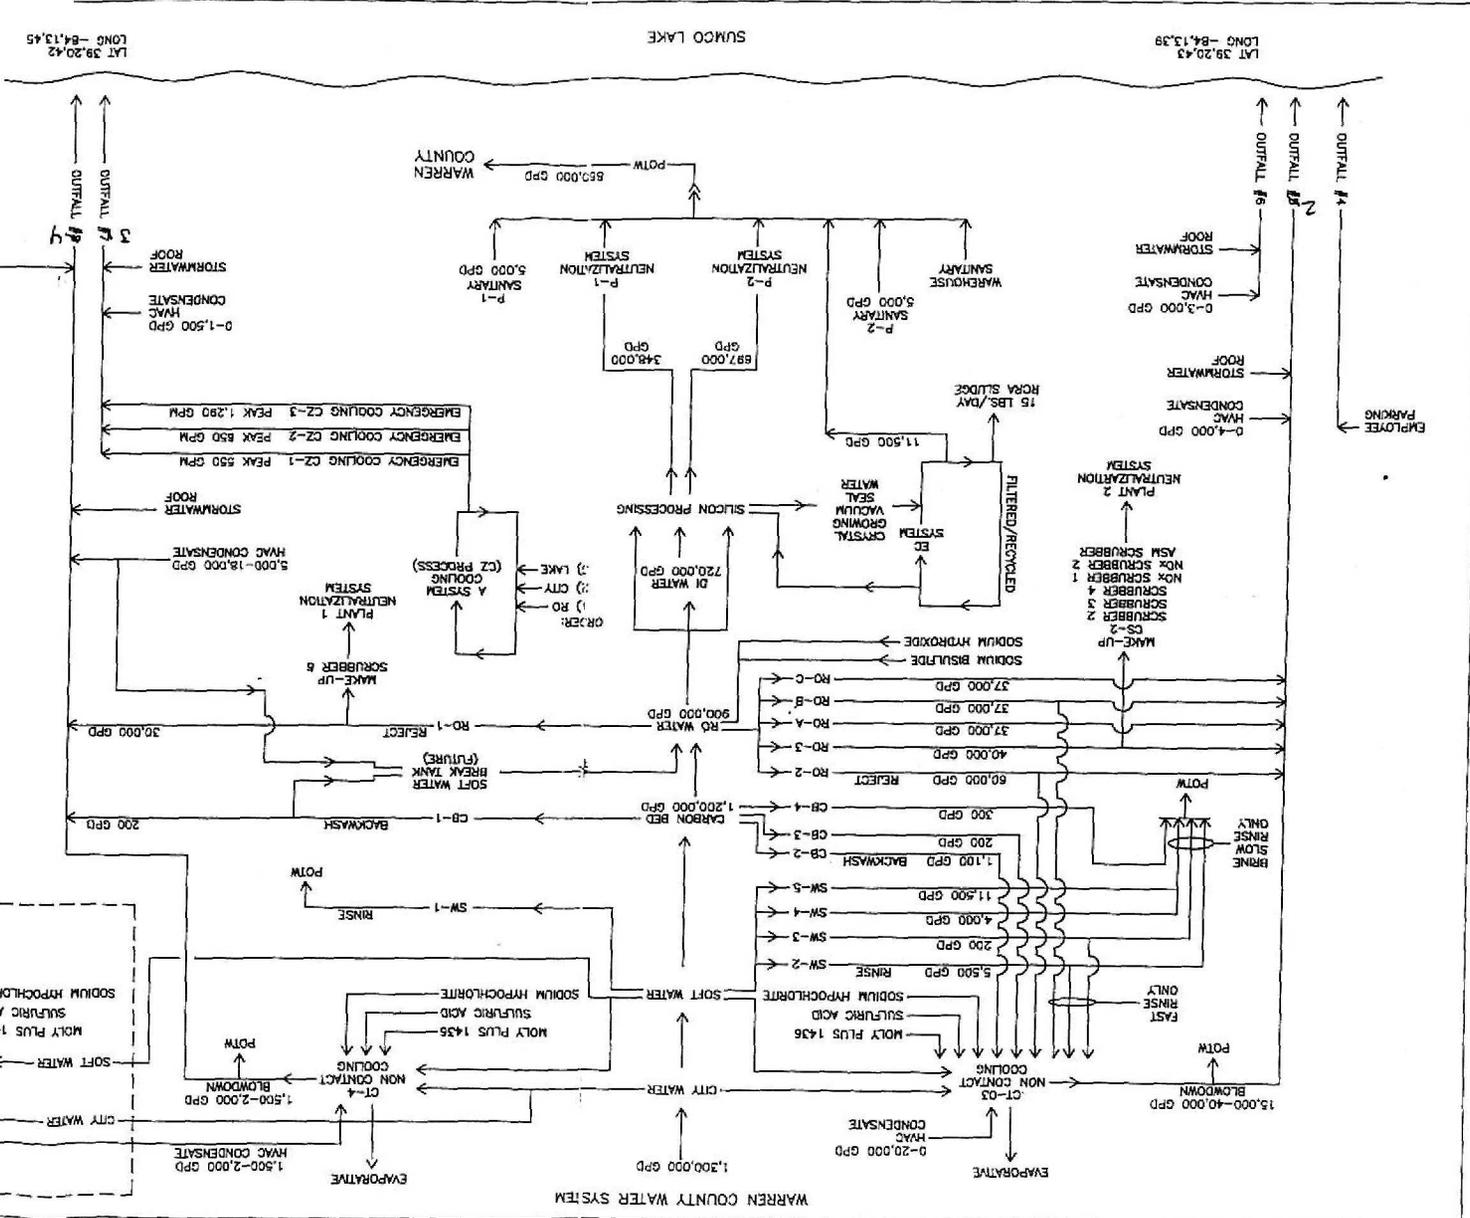
WARREN COUNTY WATER SYSTEM

13. Provide a schematic diagram and description of the wastewater treatment system:

See attached schematic.

The pH adjustment is done with the addition of acid and caustic. There is a three stage system for Plant 2 (approximately 75% of the flow), and a four stage system for Plant 1 (approximately 25% of the flow). The arsenic treatment system is currently operating.
