State of Ohio Environmental Protection Agency

RE: MEDINA COUNTY  
ROCKY RIVER BASIN  
LIVERPOOL TOWNSHIP  
THE BOEHM PRESSED STEEL COMPANY

On August 17, 2009, Ohio EPA conducted an inspection of the Boehm Pressed Steel Company, located at 5440 Wegman Drive, Liverpool Township, Medina County (site). During the inspection, I was accompanied by Wayne R. Norton, Accounting Manager. Ohio EPA records indicate that the site is covered by General National Pollutant Discharge Elimination System Permit for Storm Water Associated with Industrial Activity (General Storm Water Permit), permit No. 3GR01156\*DG.

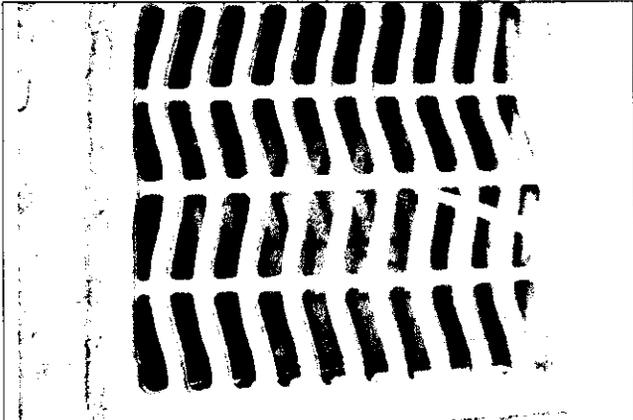
**Figure 1** – Concrete washing activities were discharging pollutants into the storm sewer system serving the site.

Within thirty days of receiving this inspection letter, BMPs addressing the above potential pollutant sources must be implemented and a copy of the site's SWP3 must be submitted for review. Should you have any questions regarding this matter, please contact me at your earliest convenience at (330) 963-1118.
