RE: Lake County
Grand River Watershed
City of Mentor
Mentor Lagoons & Nature Preserve Marina

On January 14, 2010, I performed a compliance inspection of storm water best management practices at the above referenced site. While on site, I spoke with Dave George, marina manager. We were accompanied on our inspection by Brian Ashurst of the City's engineering department. Our records indicate that this facility is authorized to discharge storm water under the Ohio EPA General Storm Water National Pollutant Discharge Elimination System (NPDES) Permit for Industrial Activities Associated with Marinas #3GRM00008*AG.

MENTOR LAGOONS MARINA
City of Mentor Lake County
Operator: City of Mentor

Photos Taken: January 14, 2010
By: Dan Bogoevski, DSW-NEDO

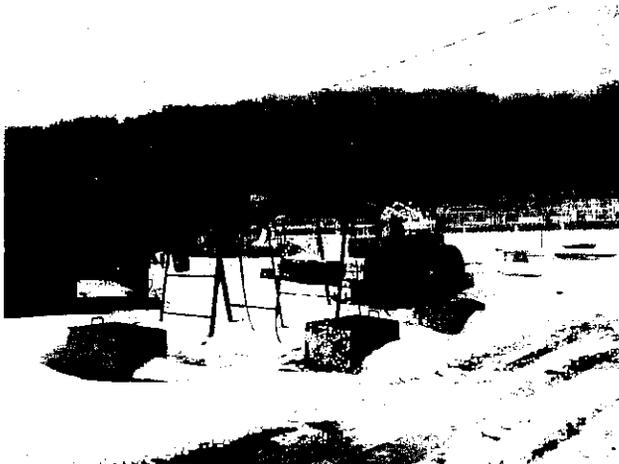
Fig 3 (LEFT). No secondary containment has been provided around the diesel fuel and unleaded gas tanks. No spill kit is available nearby to respond to a spill should one occur. The marina needs to consider implementation of these BMPs.

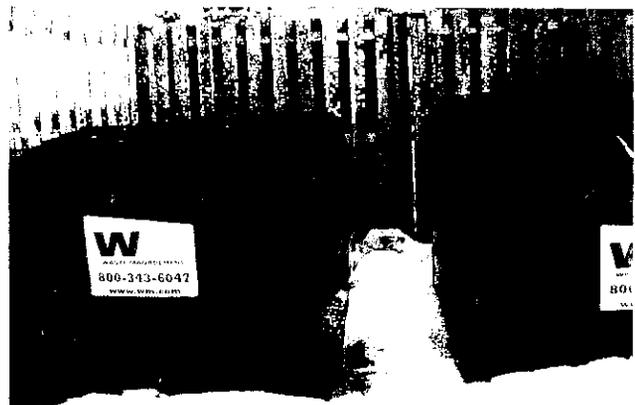
Fig 4 (RIGHT). Dumpsters must remain shut when not adding or removing materials from them. Also, be sure that your routine facility inspections include this area to assure that trash is placed in the dumpster and not around it. Note that there is a bag of trash behind the dumpster that was likely generated during the boating season of 2009, yet is still on the ground in January 2010.
