State of Ohio Environmental Protection Agency

Re: Fulton County
Fulton County Landfill
Industrial Waste

May 4, 2010

On April 29, 2010, Mr. Ryan Gierhart of Ohio EPA conducted an inspection of the Fulton County Landfill and its leachate collection system. Mr. Ziad Musallam, P.E., Fulton County Sanitary Engineer, was present during the inspection. The area around markers L-9, L-10, L-12, L-14, and L-14-1 had signs of visible leachate outbreaks. The area around markers L-3 and L-5-1 were wet. The flow of leachate to Waters of the State is prohibited by Ohio Revised Code Chapter 6111.04 and the Director's Final Findings and Orders (DFFOs) issued to you on July 9, 2002.

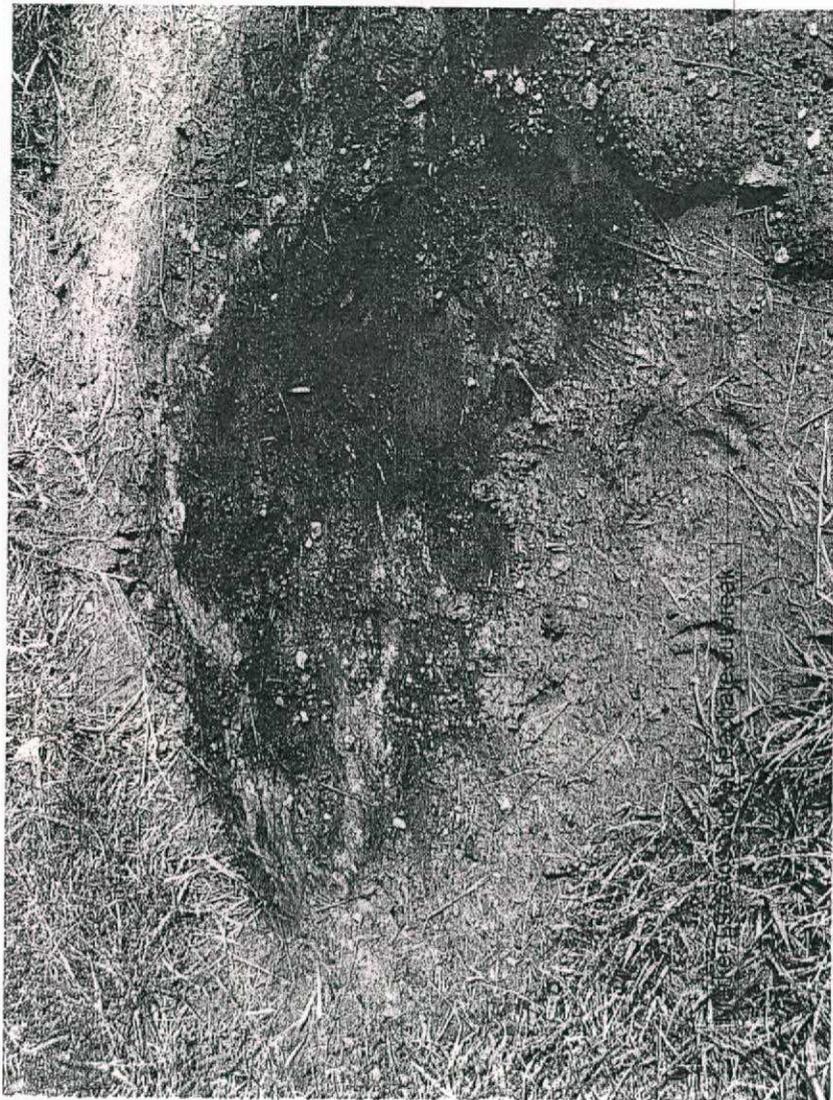
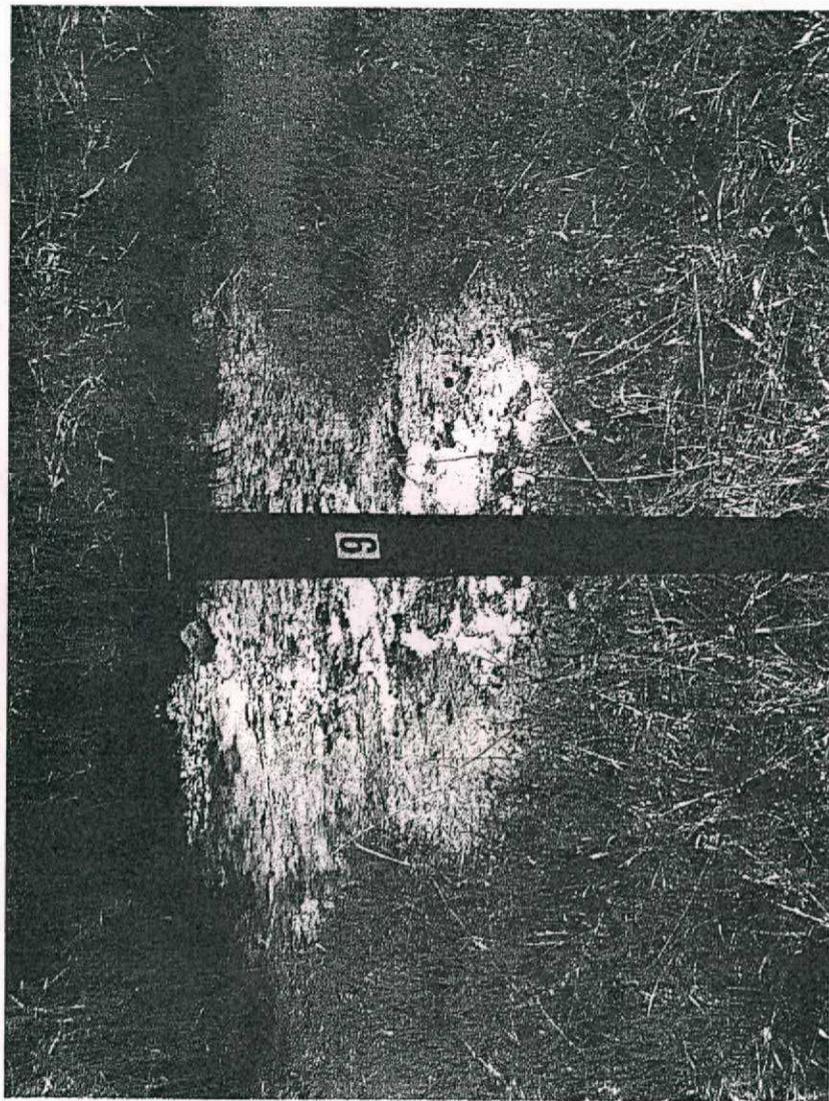
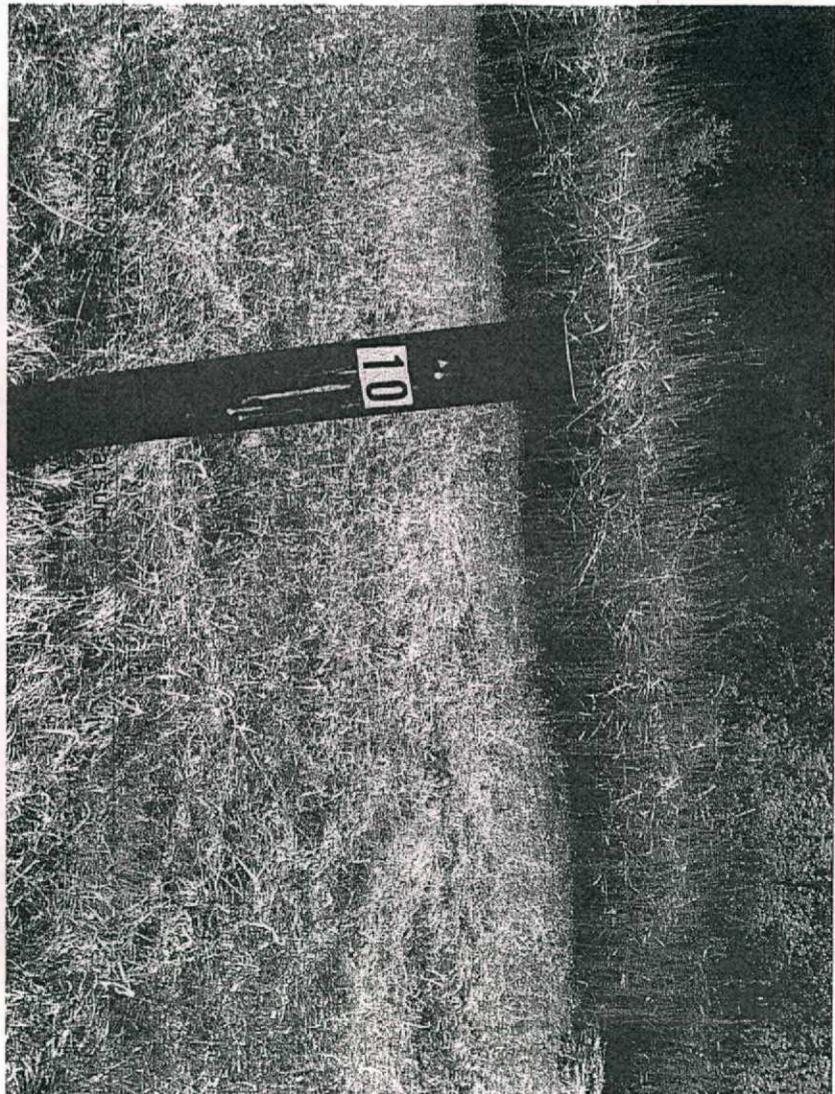
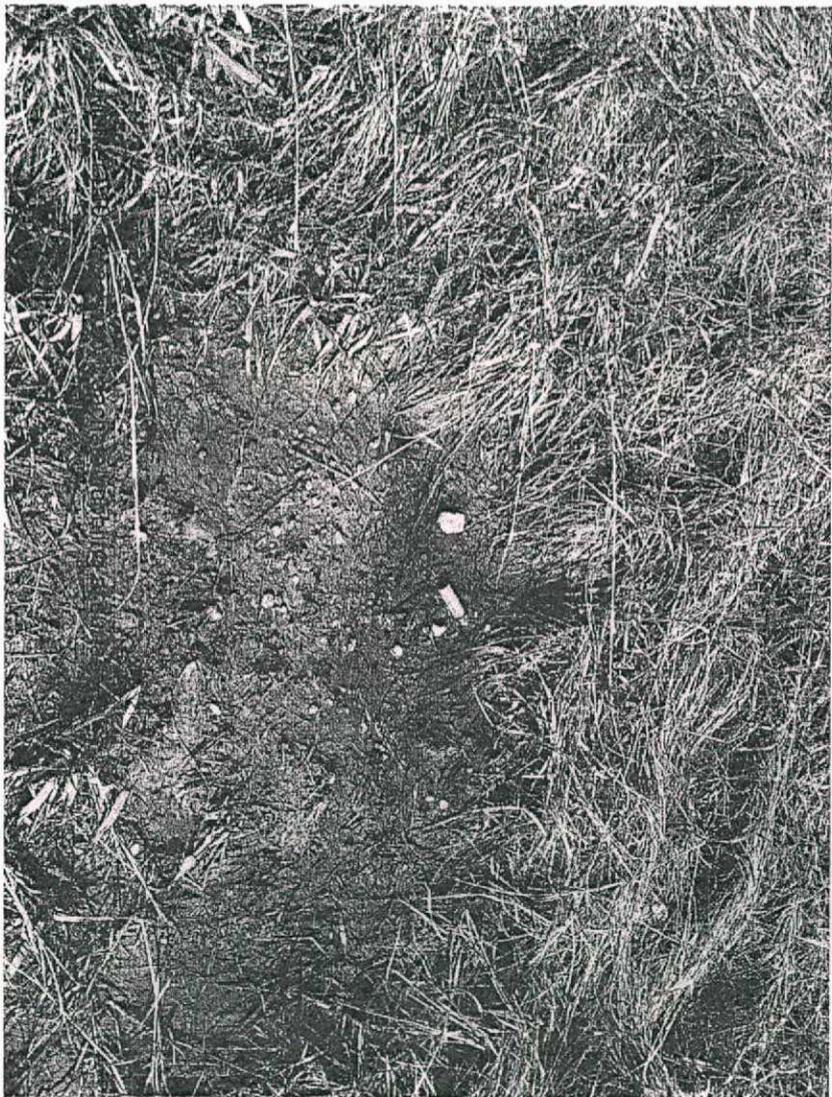
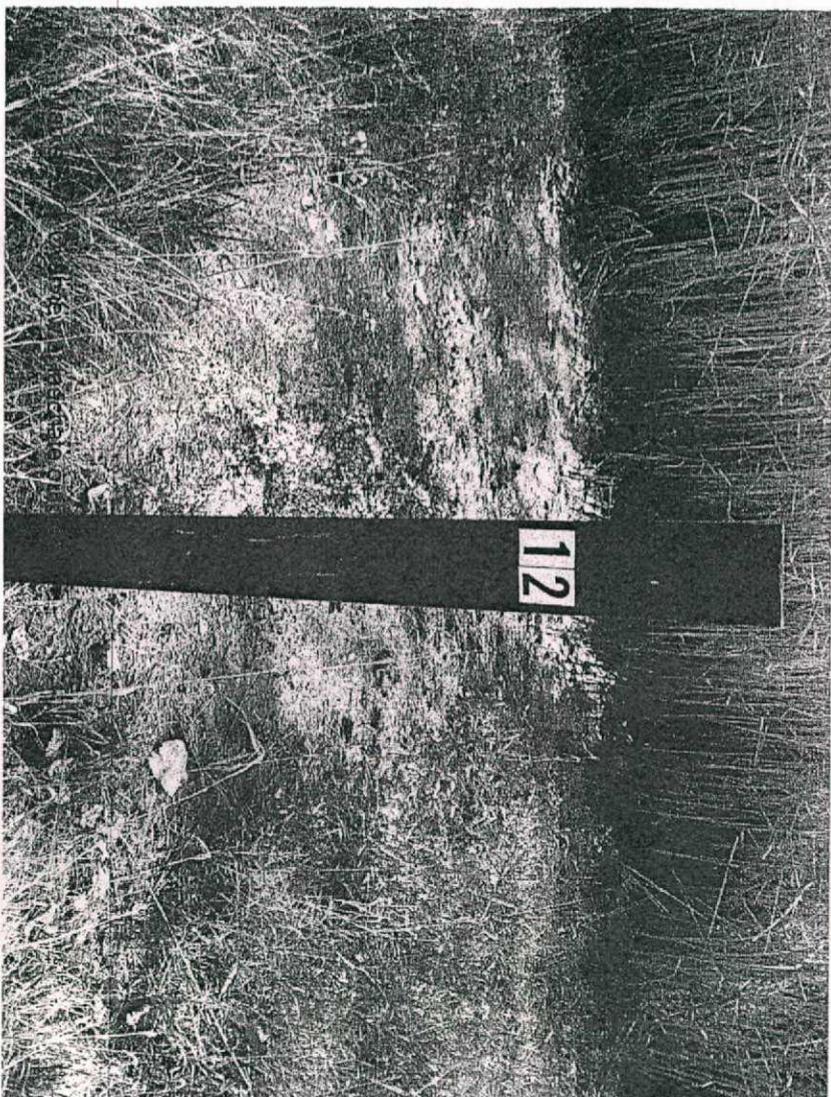
Pictures of the outbreaks, as observed during the inspection, are included. If you have any questions or concerns please contact Mr. Ryan Gierhart at (419) 373 - 3053.

From our observations during the inspection, it is still apparent that the leachate level is not adequately low enough in the collection well to prevent outbreaks. The County needs to continue hauling leachate from the collection well more frequently or in larger volumes to abate the outbreaks, especially after precipitation/runoff events.

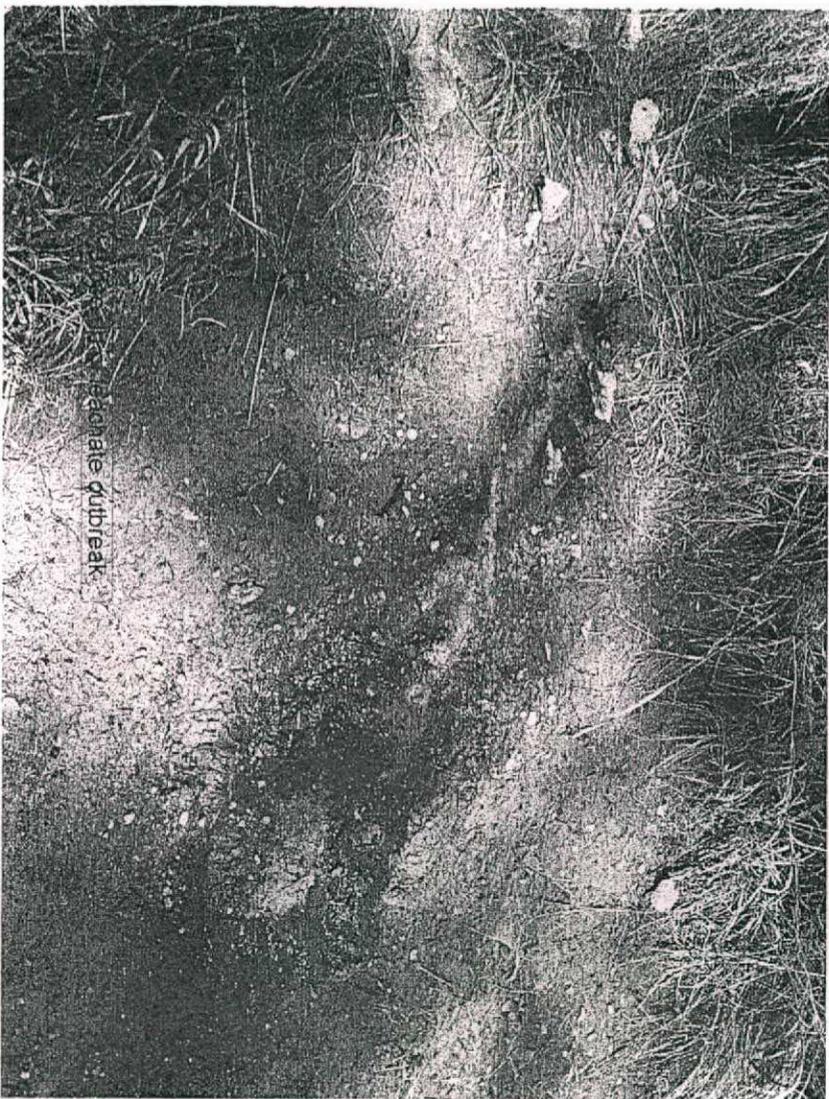
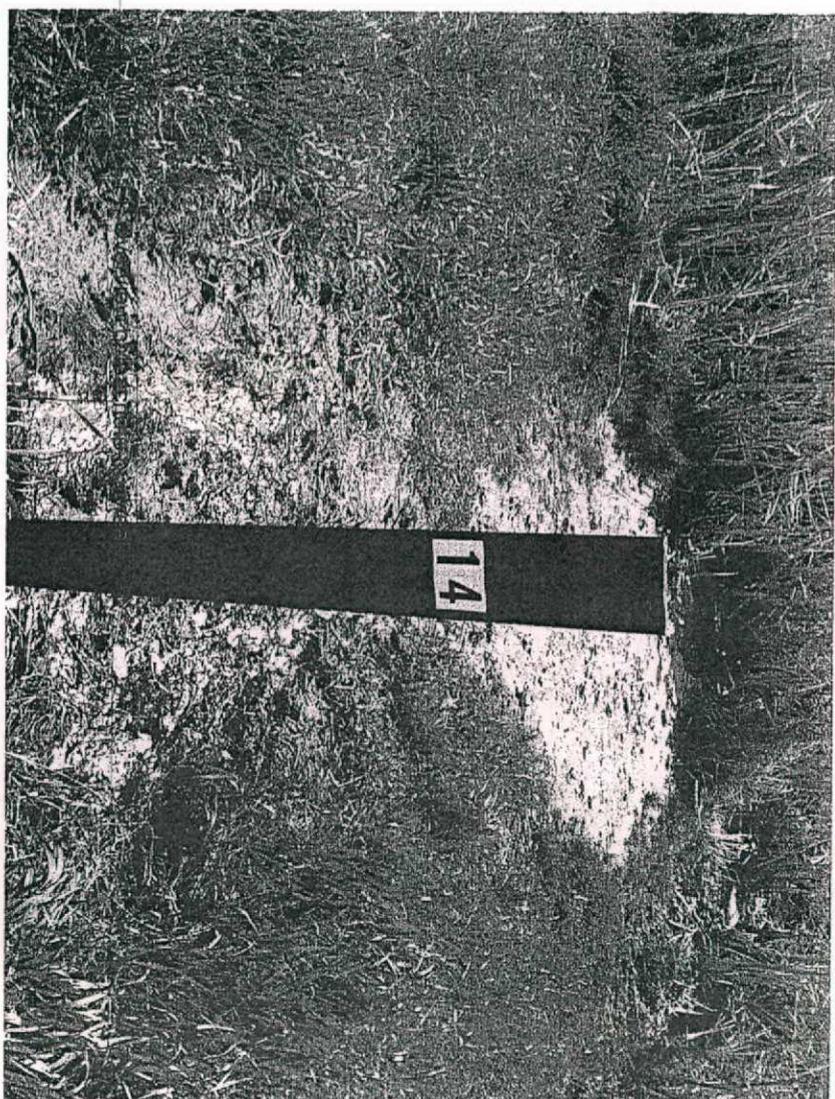
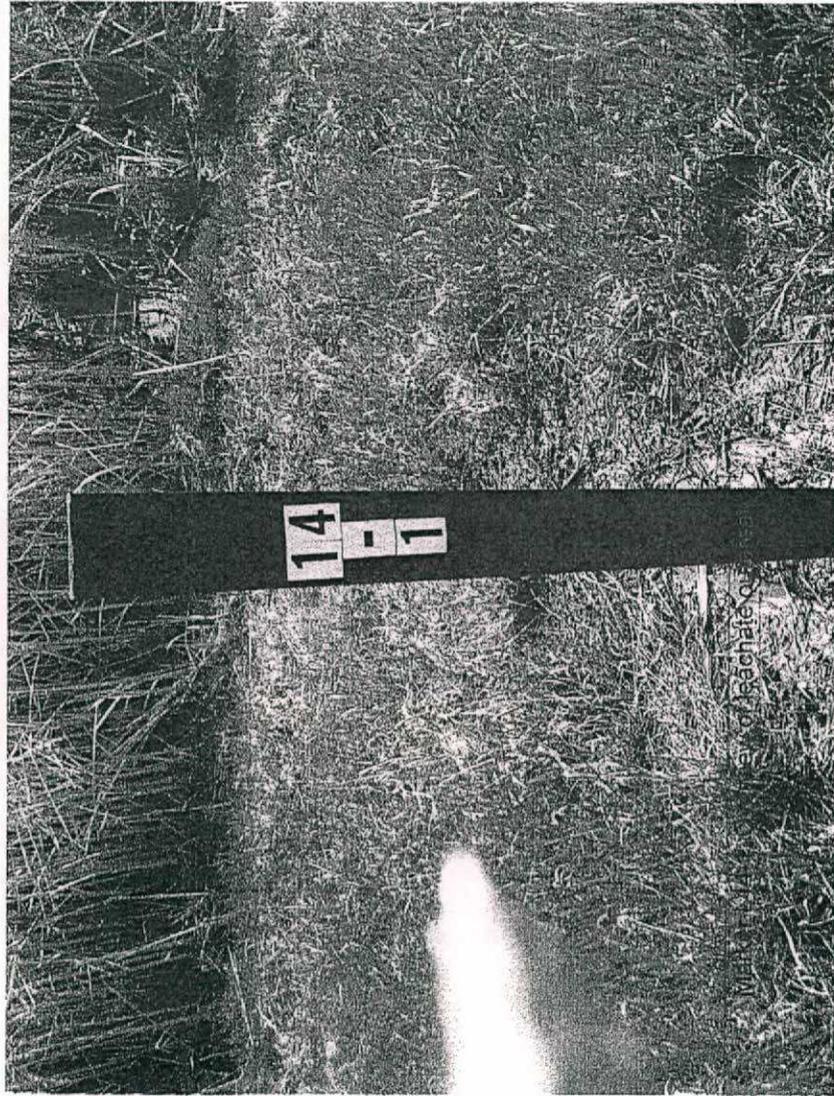
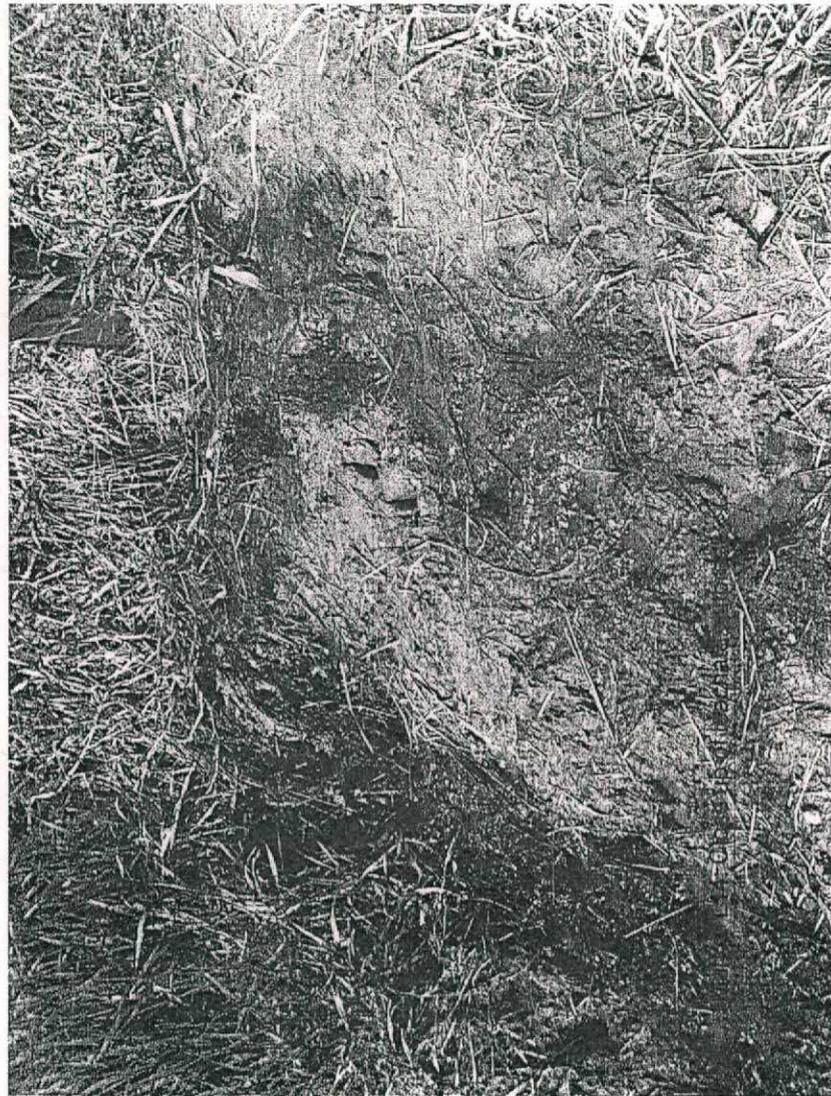
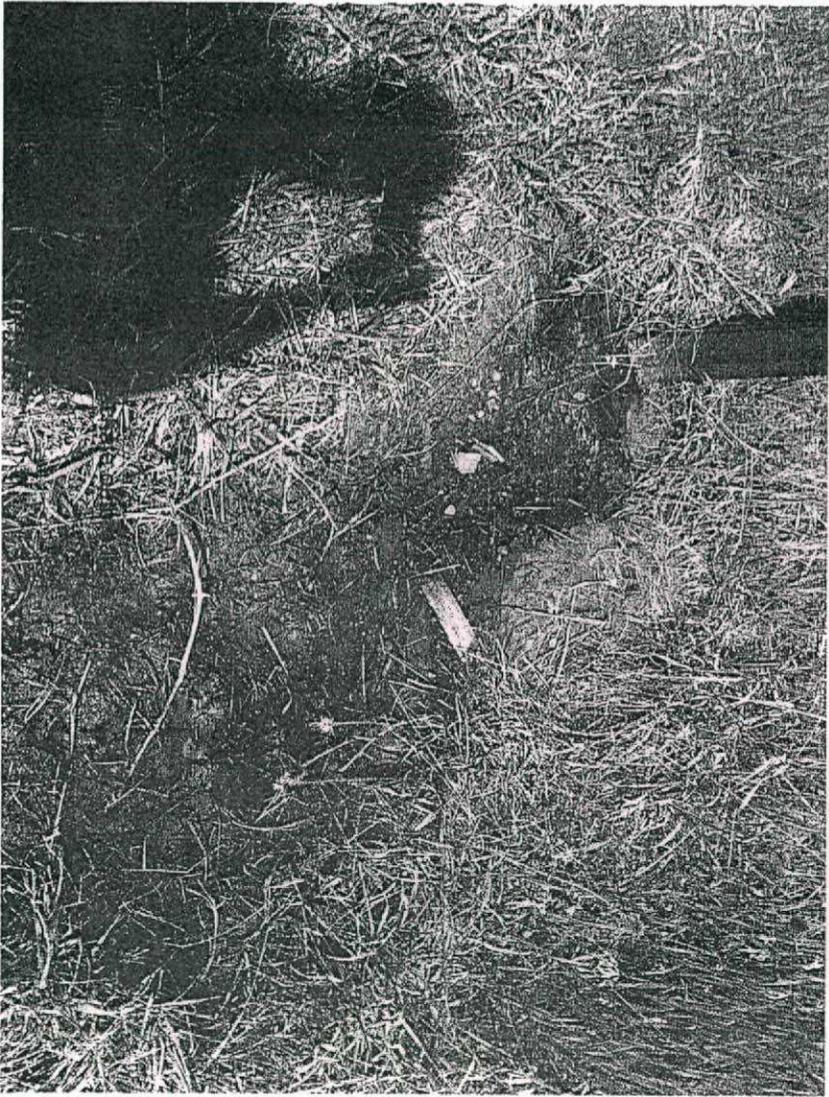
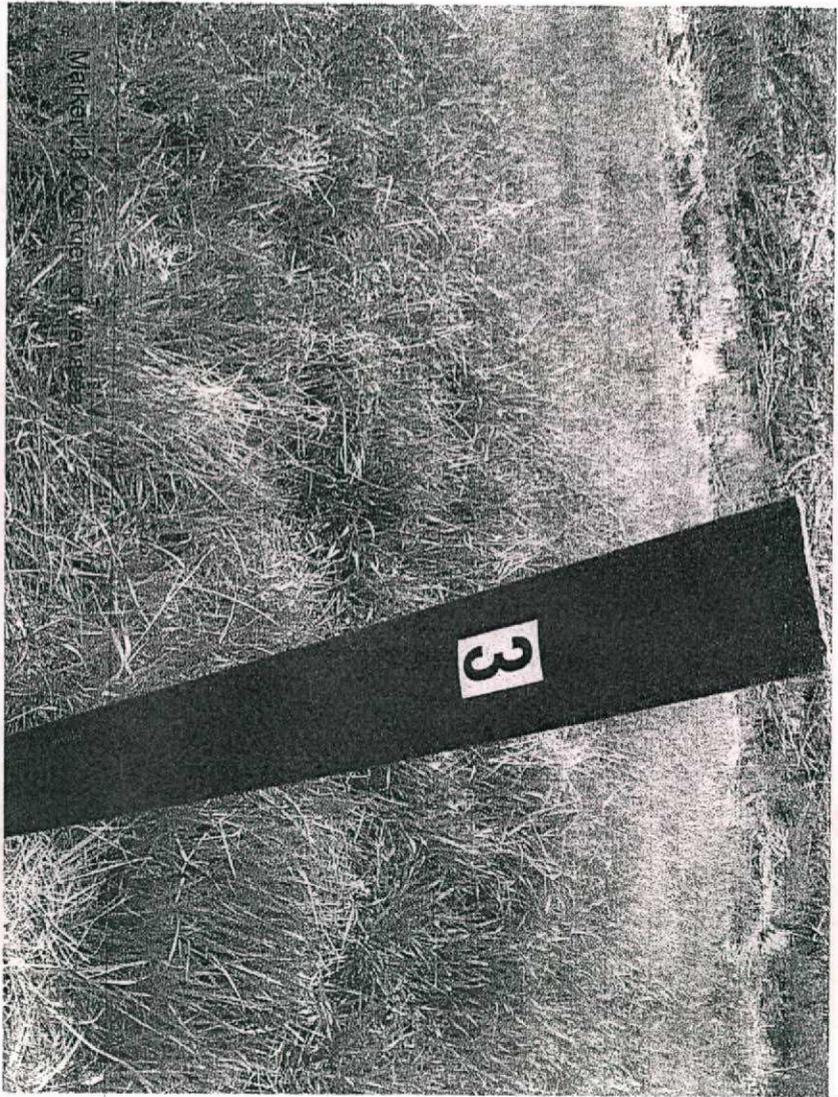
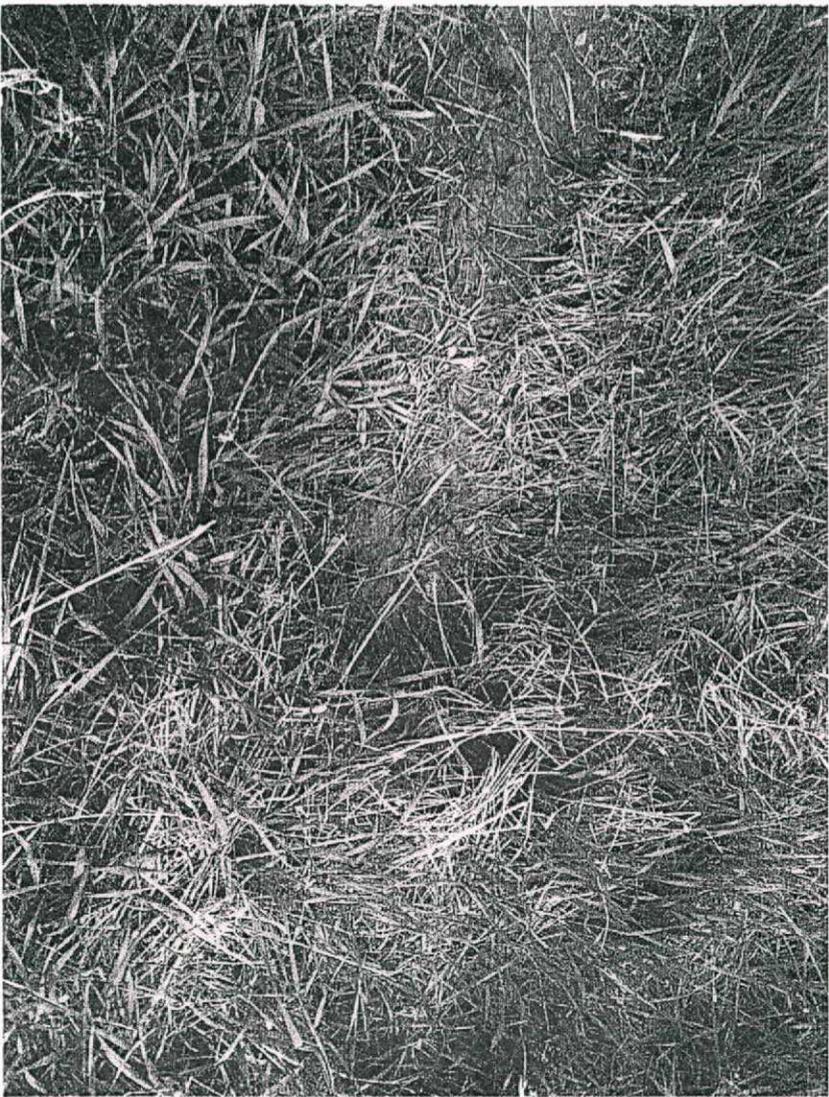
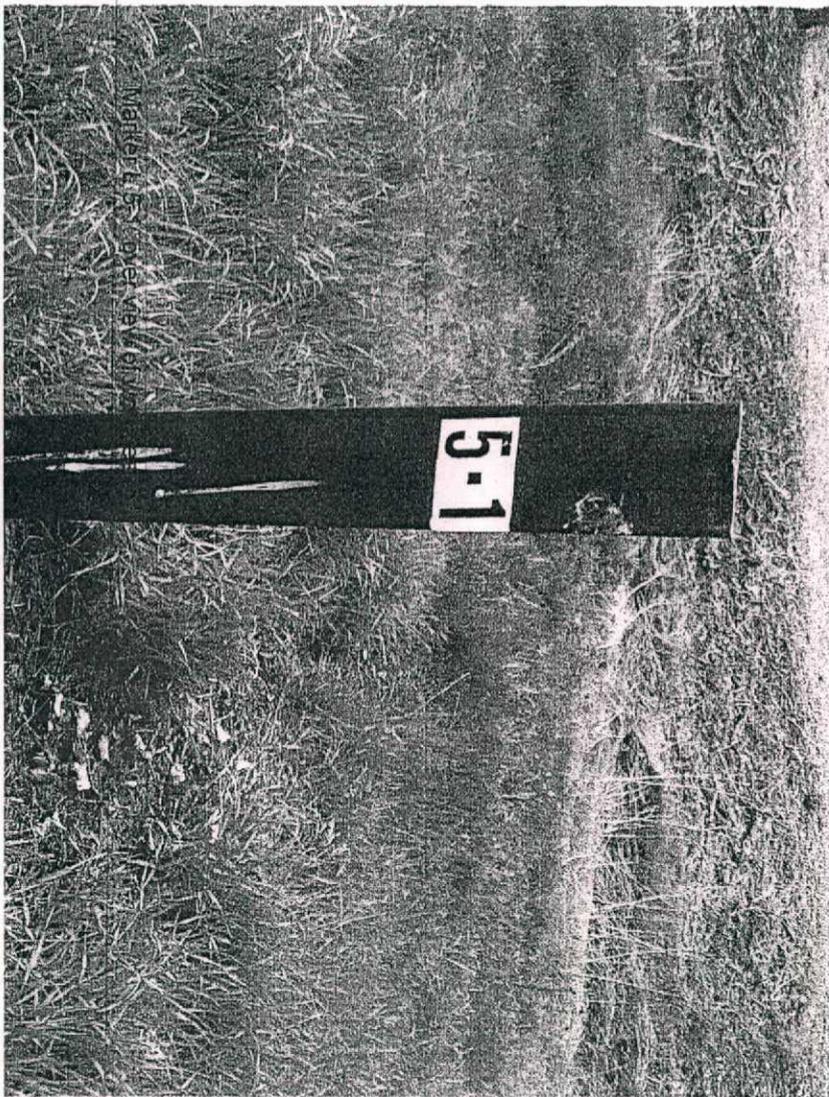
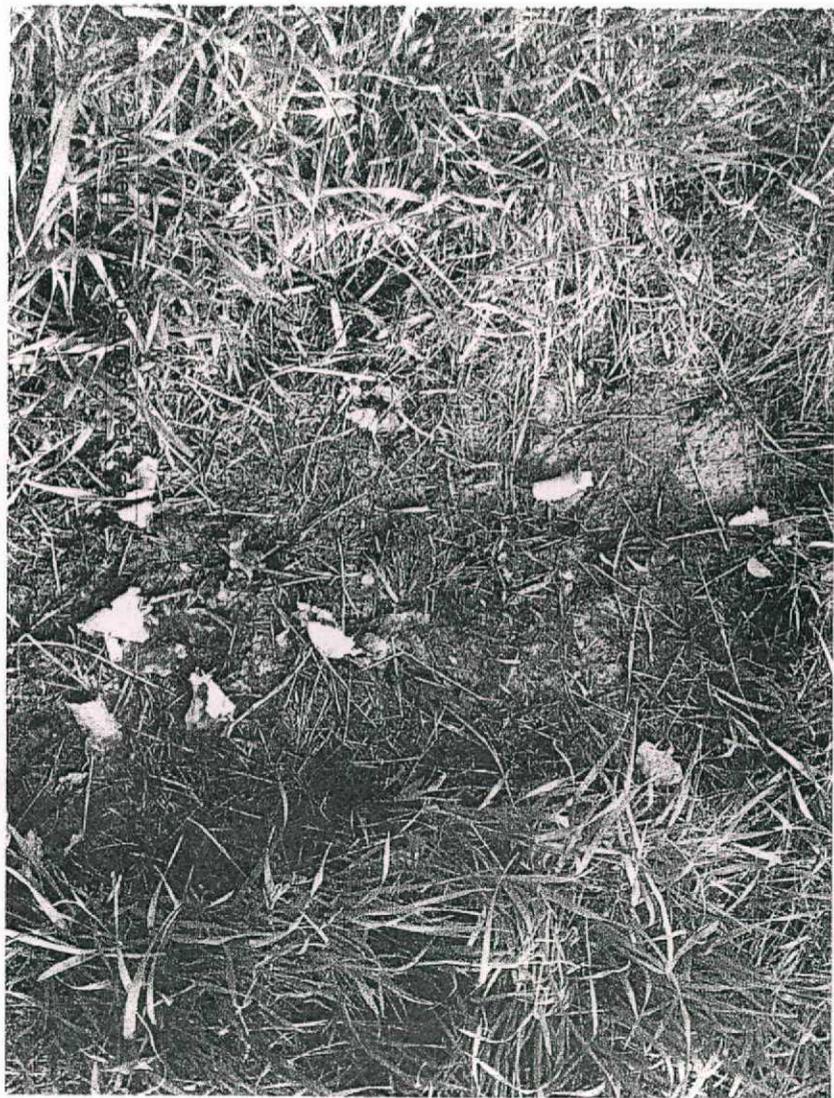
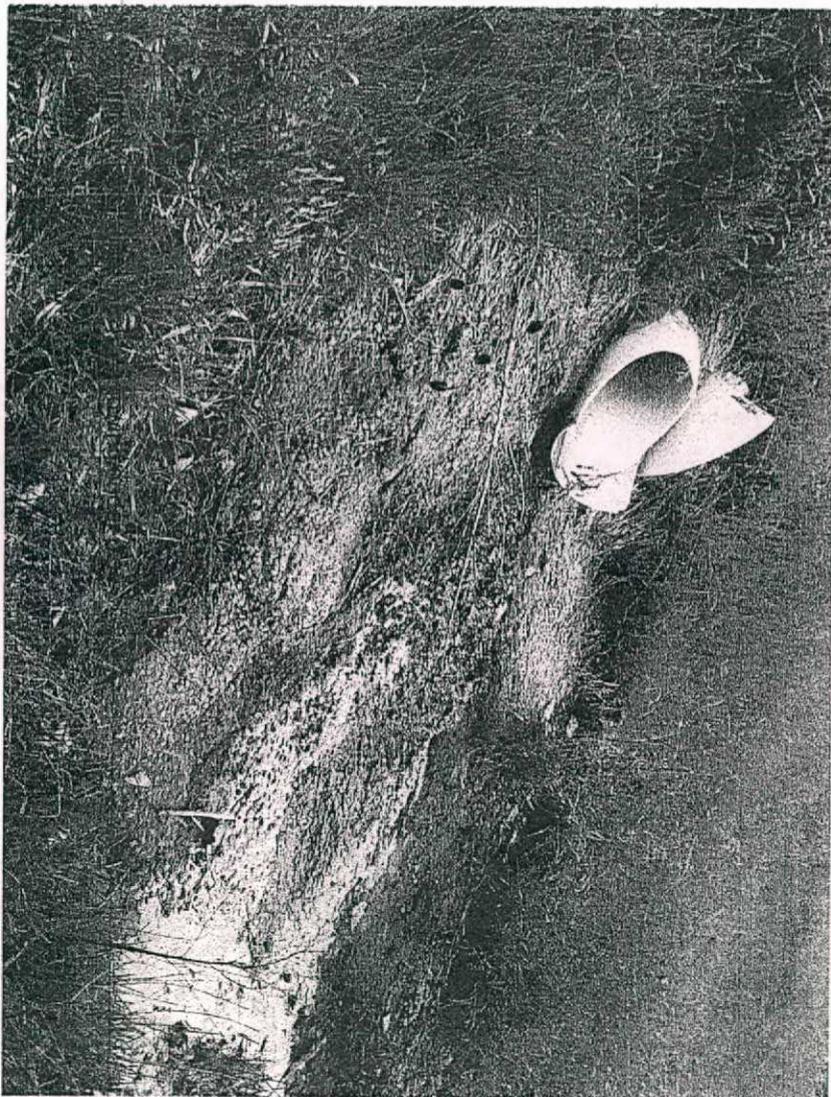
Leachate was again observed on the ground below the large, broken PVC pipe coming out of the southeast corner of the landfill. The leachate that was observed on the ground was again flowing into the ditch on the south side of the property. The ditch is considered Waters of the State and the flow of leachate to Waters of the State is an unauthorized discharge that is again prohibited by Ohio Revised Code Chapter 6111.04 and the DFFOs issued to you on July 9, 2002.

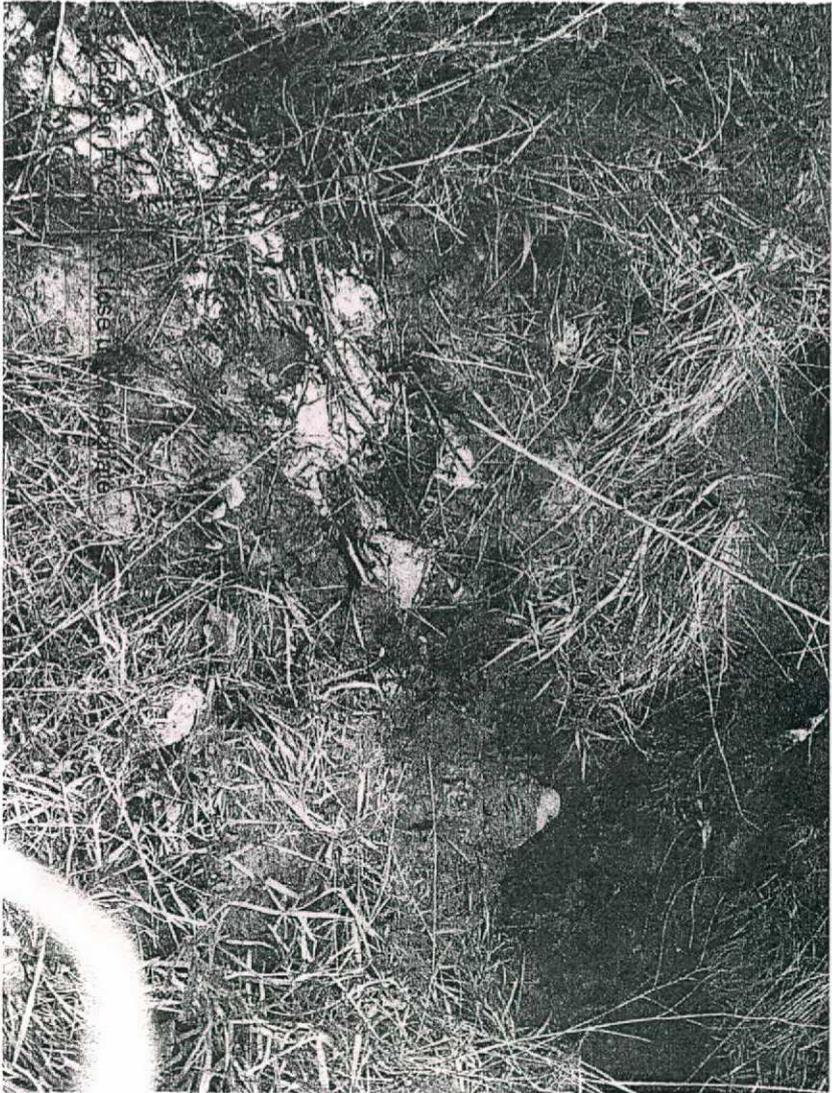
Broken Pipe - Close to Pipe

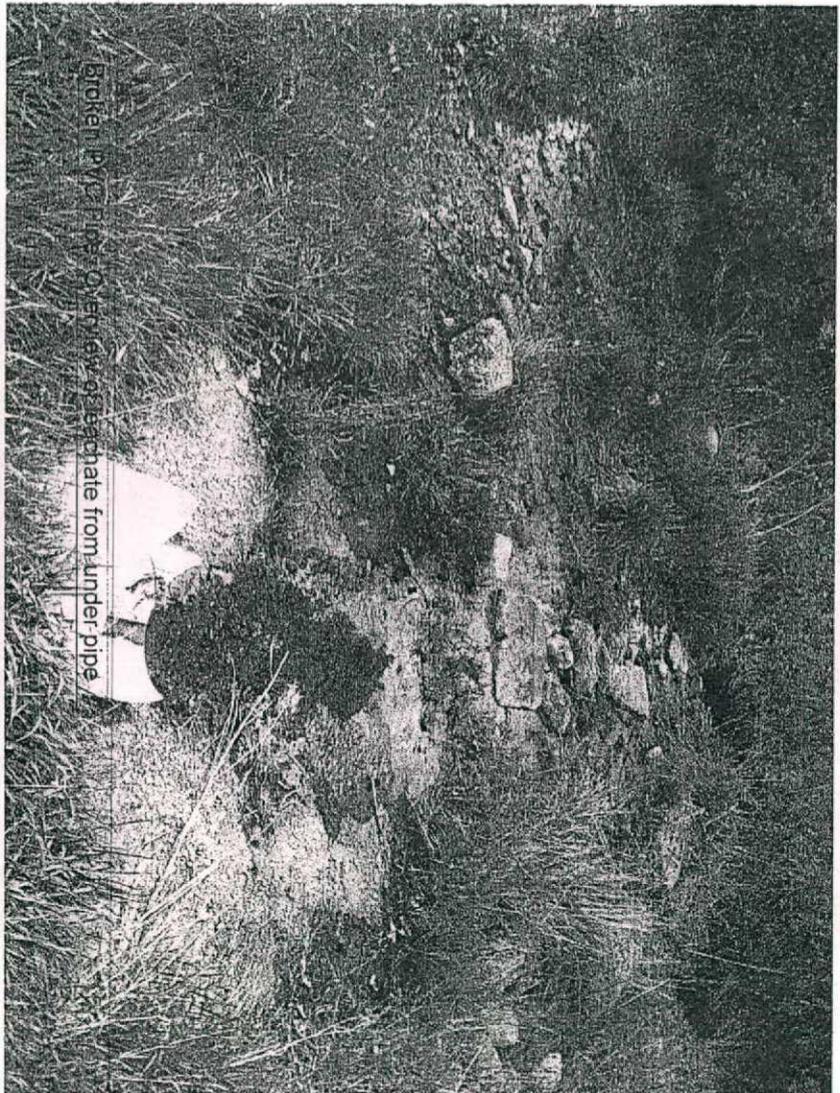
Broken Pipe - Close View of Fracture from under pipe
