**Environmental
Protection Agency**

August 9, 2011

RE: ASHTABULA COUNTY
JEFFERSON TOWNSHIP
DOLLAR GENERAL
NPDES PERMIT NO. OHC000003
OHIO EPA PERMIT NO. 3GC05416*AG
CONSTRUCTION STORM WATER

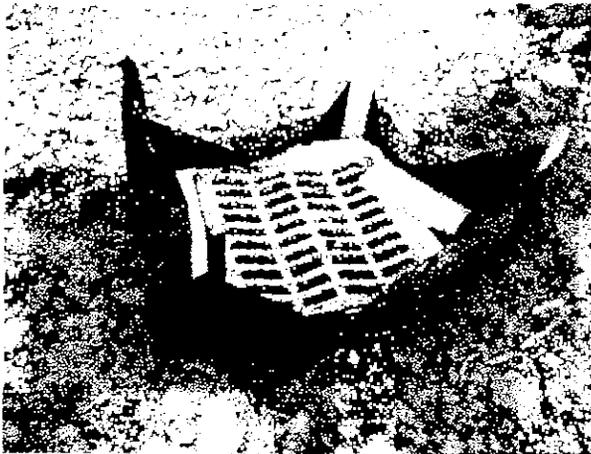
- **The inlet protection for the catch basin in the swale on the back side of the building is inadequate.**
 - Please stabilize the swale so that inlet protection can be removed from the catch basin. Until then, please block the orifice on the catch basin completely and reinstall adequate inlet protection for the catch basin (See Figure 3).

Figure 3. Please block the orifice and implement appropriate inlet protection until the site is stable.
