**Environmental
Protection Agency**

July 5, 2011

RE: CUYAHOGA COUNTY
CITY OF INDEPENDENCE
SELIG/ITC/BRECKSVILLE INTER.
CONSTRUCTION STORM WATER

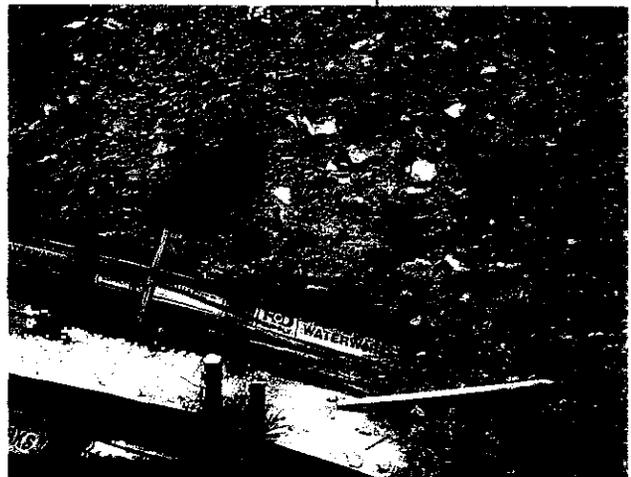
Figure 4. Silt fence is in bad shape along Selig Dr.

- The silt fence along Selig Drive by the stock piles is collapsing and needs to be maintained. Please be sure to replace any fence with signs of stress (i.e. tearing, holes, etc.), or any that has simply collapsed. Please install with respect to the specifications in the SWPPP (See Figure 4).
