Environmental
Protection Agency

May 20, 2011

RE: CUYAHOGA COUNTY
CUYAHOGA RIVER WATERSHED
CITY OF INDEPENDENCE
SELIG DRIVE/ITC/BRECKSVILLE RD
INTERSECTION

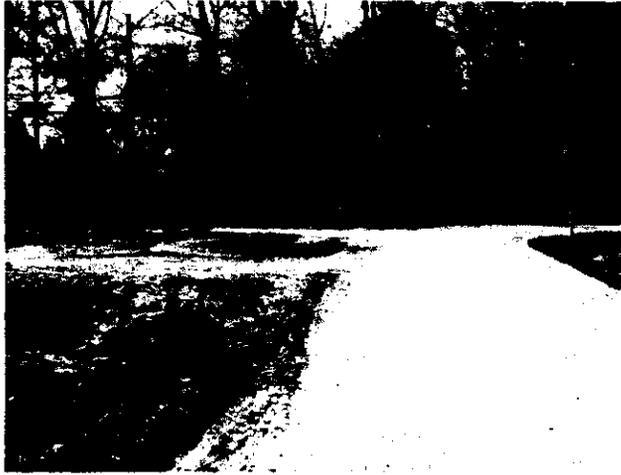
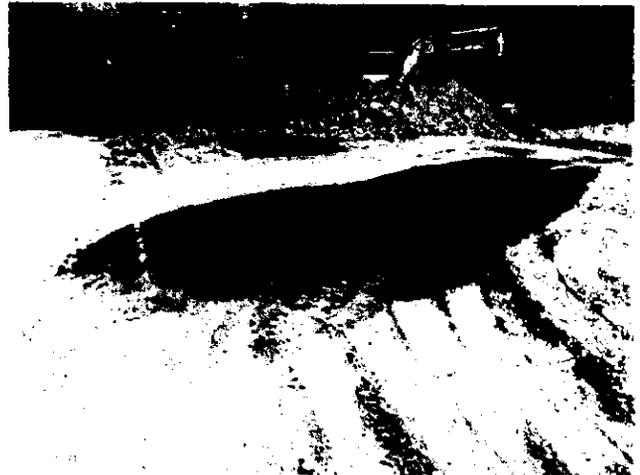
Fig 1 & 2. An appreciable amount of off-site tracking of sediment was observed on Selig Drive and the access road to the Police Department. The contractor added more asphalt grindings during the course of my inspection, but this is not an acceptable means of constructing a construction site entrance.

- The plan does not provide a detail drawing of a rock construction entrance. As a result, the contractor has not built a rock construction entrance per accepted standards and specifications found in *Rainwater and Land Development, Ohio's Standards for Stormwater Management, Land Development and Urban*

Stream Protection (Ohio Dept. of Natural Resources, 2006). This has resulted in an appreciable amount of off-site tracking onto Selig Drive. Sediment which is tracked onto Selig Drive will enter the MS4 when it rains. The location and detail drawing for the construction of a rock construction entrance must be added to the SWP3. The contractor must construct the rock construction entrance per those specifications.

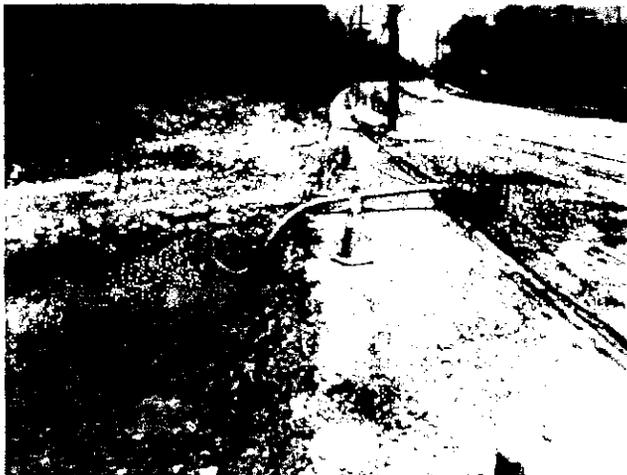
Fig 3 & 4. The contractor is pumping sediment-laden runoff from the construction site out toward Brecksville Road and the unnamed tributary to the Cuyahoga River.

- **The Storm Water Pollution Prevention Plan (SWP3) is inadequate.** It fails to provide appropriate BMPs during initial site grading. In particular:
 - No provisions have been made for excavation dewatering or the installation of a sediment-settling pond. As a result, the contractor is discharging sediment-laden runoff that collects within excavations on the site directly out onto Brecksville Road via a pump. Sediment-laden runoff flows down Brecksville Road into the municipal separate storm sewer system (MS4) and into the unnamed tributary of the Cuyahoga River. Please either add BMPs for the proper dewatering of sediment-laden runoff that collects on site or add a sediment-settling pond to the SWP3.

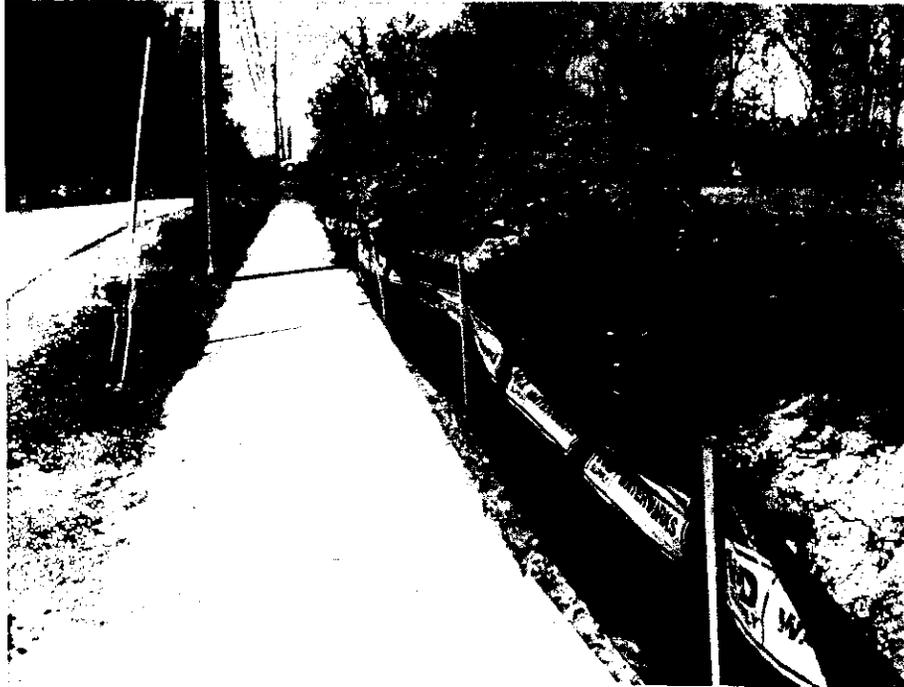
Fig 5. Silt fence along Selig Drive is not trenched in and backfilled. Thus, it is not functional.

- **Perimeter silt fence has not been installed per required specifications** in the *Rainwater and Development* manual and as shown in the detail drawing in the SWP3. In particular, silt fence has not been trenched and backfilled. As a result, as installed, the silt fence is not capable of ponding runoff. The NPDES permit requires sediment controls to pond runoff in order to be considered functional. Please install the silt fence as stipulated in the Rainwater manual and detail drawing contained in the SWP3.
