RE: Lorain County
Black River Watershed
Eaton Twp.
LORCO Wastewater Collection System
and Pump Station (Contracts 1-5)

Site Inspection

LORCO SEWER – CONTRACTS 1-5
Eaton Twp Lorain County
Operator: Avon Lake Municipal Utilities and Co-Permittees

Photos Taken: February 11, 2010
By: Dan Bogoevski, DSW-NEDO

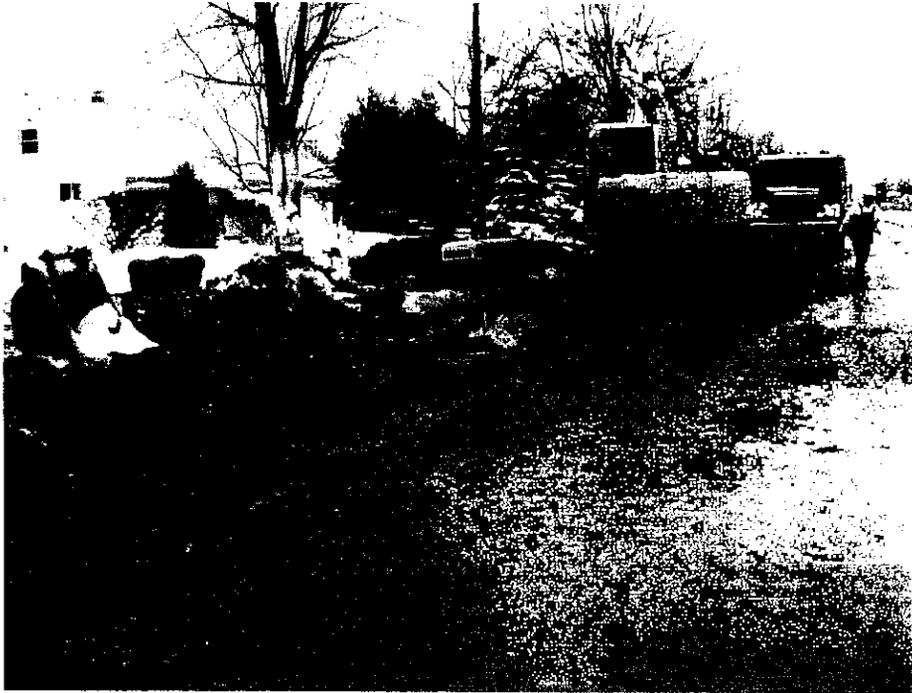
Fig 1. Tracking of mud onto Durkee Road by construction vehicles.

- **Contractors are not controlling off-site tracking as well as expected.** The NPDES permit requires the use of practices such as good housekeeping and rock construction entrances to minimize off-site tracking. In several instances, I noted construction crews accessing work areas where there is no rock construction entrance installed. Also, several contractors indicated that they had brooms available for their bobcats or front-end loaders to sweep streets, but streets such as Durkee Rd were muddy. Contractors need to perform street sweeping as needed to minimize off-site tracking. Further, contractors should consider using a street sweeper with the ability to also vacuum to pick up soil rather than just a simple broom that typically only transfers the soil from the road to the air and adjacent properties.

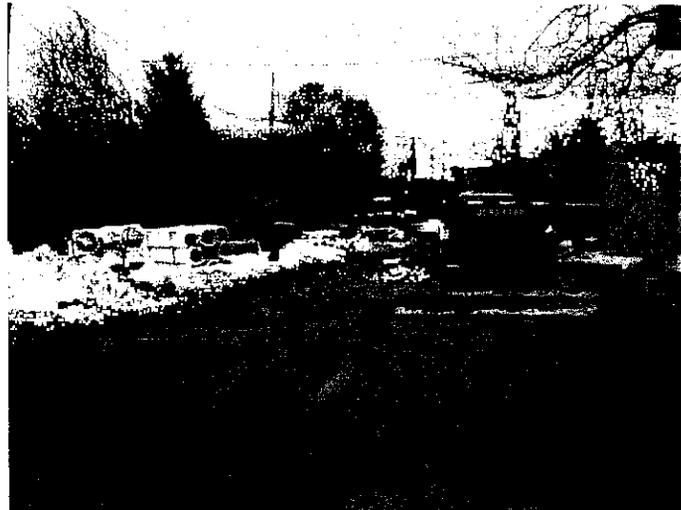
Fig 3 (RIGHT). Construction vehicles may remain on the road or access the site via rock construction entrances. At this DiGioia-Surburban workzone, no construction entrance was installed, resulting in off-site tracking.
