RE: MEDINA COUNTY  
ROCKY RIVER BASIN  
HINCKLEY TOWNSHIP  
MASON DEVELOPMENT PROJECT

**NOTICE OF VIOLATION**

On August 17, 2009, Ohio EPA conducted an inspection of the Richard A. Mason development project, located at 218 Ridge Road, Hinckley Township, Medina County (site). Ohio EPA records indicate that the site is covered by General National Pollutant Discharge Elimination System Permit for Storm Water Associated with Construction Activity (General Storm Water Permit), permit No. 3GC04462\*AG.

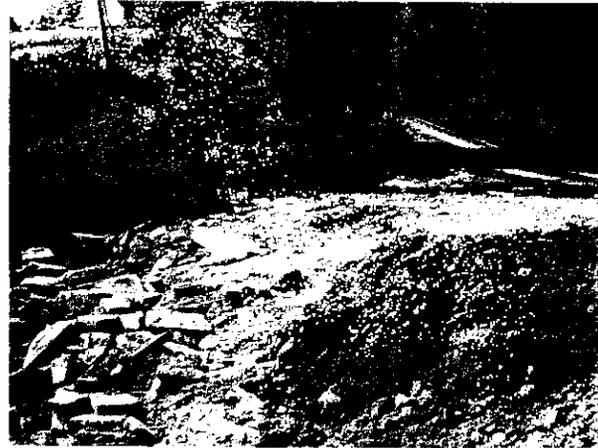
The inspection documented that the placement of additional fill materials (i.e. soil and concrete slabs) have impacted "waters of the state", as documented by the expansion of fill placement between Figure 1 and Figure 2. Via notice of violation (NOV), dated March 3, 2009, Ohio EPA requested a copy of the site's wetland delineation to be submitted within ten days of receiving the NOV. As of the date of this NOV, Ohio EPA has not received a copy of the wetland delineation. **A copy of the site's delineation report and any 401 permit issued to the site must be submitted to Ohio EPA.** Part V.E. of the General Storm Water Permit requires "the permittee shall furnish to the director, within 10 days of written request, any information which the director may request to determine compliance with this permit." **Failure to submit a copy of the site's delineation to Ohio EPA within ten days of a written request constitutes violations of Ohio Revised Code (ORC) Chapter 6111 and Part V.E. of the General Storm Water Permit.** The impacts to "waters of the state" have been forwarded to the U.S. Army Corps of Engineers and Ohio EPA's 401 Section for investigation.

**Figure 2** – A significant expansion of fill placement has occurred on the site.

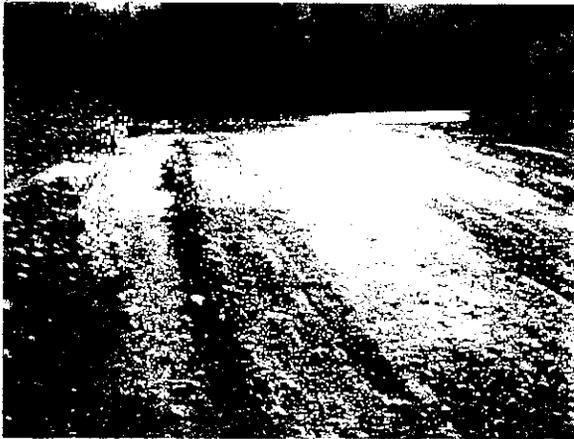
- Failure to have a properly designed and installed construction entrance to prevent off-site tracking of sediment (Figure 3). Please refer to Ohio Department of Natural Resources (ODNR) "Rainwater and Land Development" (RLD) manual (<http://www.dnr.state.oh.us/water/rainwater/default/tabid/9186/Default.aspx>) for the specifications regarding construction entrances;

**Figure 3** – Failure to have a construction entrance installed.

Within fourteen days of receiving this NOV, corrective actions must be initiated to address the above violations.

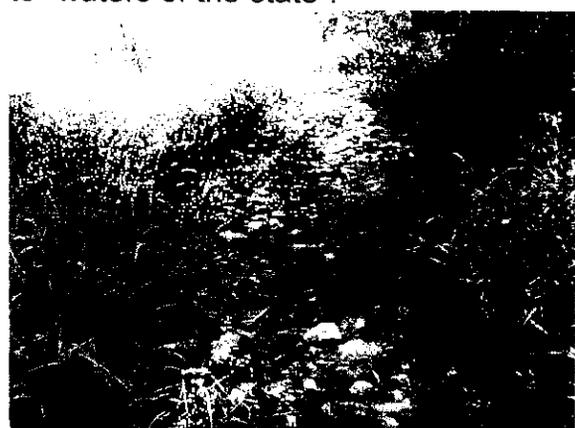
- Failure to have properly installed erosion and sediment best management practices installed to prevent discharges of sediment to "waters of the state". Silt fence was improperly installed in areas of the site that exceed its treatment capacity. In addition, the silt fence was not properly trenched into the ground and backfilled (Figure 5). Sediment-laden runoff discharged directly into "waters of the state" (Figure 6). Sediment settling ponds are required to be installed on the site to prevent discharges of sediment to "waters of the state".

**Figure 6** – Failure to prevent the discharge of sediment to "waters of the state".
