RE: MEDINA COUNTY  
CITY OF WADSWORTH  
VALLEY VIEW ELEMENTARY  
NPDES PERMIT NO. OHC000003  
OHIO EPA PERMIT NO. 3GC05132\*AG  
CONSTRUCTION STORM WATER

On June 9, 2011, Ohio EPA conducted an inspection of the Valley View Elementary project located at 160 West Good Avenue, City of Wadsworth, Medina County. Ohio EPA records indicate that the site is covered by the General National Pollutant Discharge Elimination System (NPDES) Permit for Storm Water Associated with Construction Activity (General Storm Water Permit), permit No. 3GC05132\*AG. The inspection documented the following:

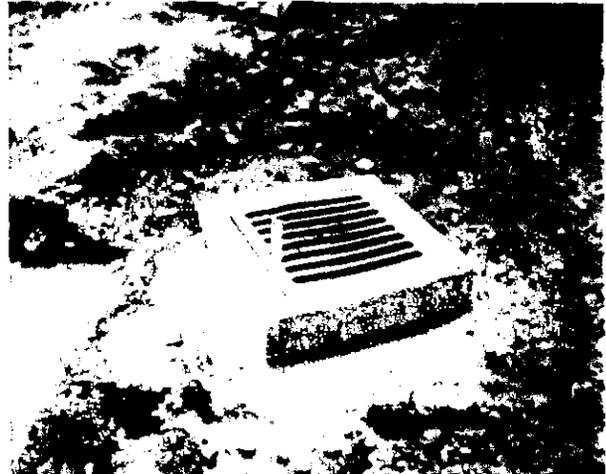
Figure 2. Unprotected inlet.

- There are multiple catch basins throughout the site with no inlet protection installed. Inlet protection must be installed to prevent the discharge of sediment-laden runoff to surface waters of the State (Figures 2 to 3), unless the storm sewers lead to the sediment settling pond located in front of the pre-existing school building.

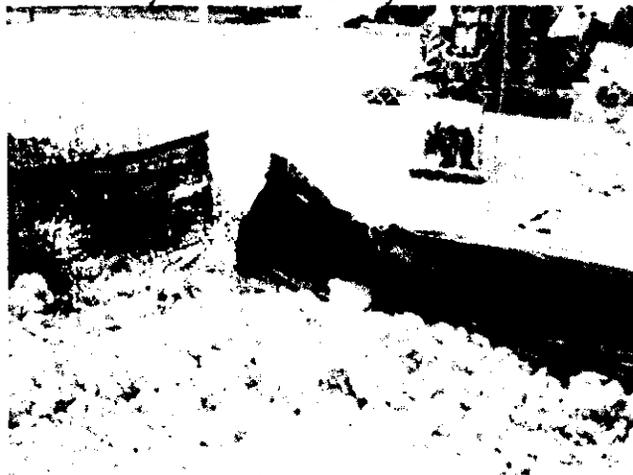
Figure 5. Silt fence is damaged and needs to be repaired.

- The silt fence around the perimeter of the site requires maintenance. Sediment must be removed from the portions of silt fence that are overwhelmed. In addition, the silt fence may require replacement or repair (Figures 4 to 5).

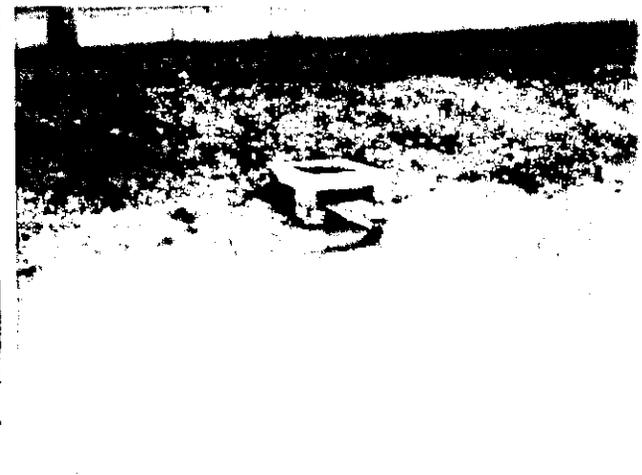
Figure 6. The skimmer is stuck on the bank and is not functioning properly.

- The skimmer for the sediment pond is not functioning properly (Figure 6). Guide wires or a guiding pole must be installed to ensure that the dewater skimmer will function correctly. Please refer to the enclosure excerpt from Ohio Department of natural resources *Rainwater and Land Development* manual entitled Sediment Basins for the design specifications of dewatering skimmers.
