**Environmental  
Protection Agency**

RE: MEDINA COUNTY  
VILLAGE OF WESTFIELD CENTER  
WESTFIELD CENTER COMM. PARK  
NPDES PERMIT NO. OHC000003  
OHIO EPA PERMIT NO. 3GC04973\*AG  
CONSTRUCTION STORM WATER

On July 20, 2011, Ohio EPA conducted an inspection of the Westfield Center Community Park project located at Leroy Rd. & US 224, Village of Westfield Center, Medina County. Ohio EPA records indicate that the site is covered by the General National Pollutant Discharge Elimination System (NPDES) Permit for Storm Water Associated with Construction Activity (General Storm Water Permit), permit No. 3GC04973\*AG. The inspection documented the following:

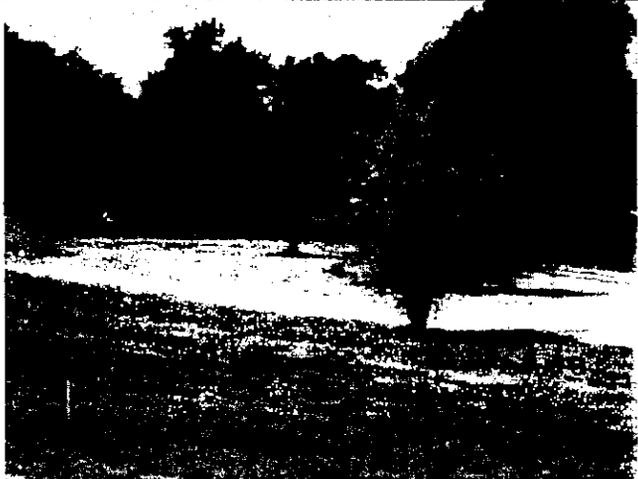
- **There appeared to be areas of the site that will remain idle for twenty one (21) days or greater.**
  - If this is the case, please stabilize these areas immediately with seeding and straw mulch (See Figure 3).

Figure 3. Please stabilize areas idle for greater than 21 days.
