**Environmental
Protection Agency**

RE: TRUMBULL COUNTY
EAGLE CREEK BASIN
SOUTHINGTON TOWNSHIP
SOUTHINGTON K-12 SCHOOL

On May 28, 2010, Ohio EPA conducted an inspection of the Southington K-12 School, located at 2482 State Route 534, Southington Township, Trumbull County (site). Ohio EPA records indicate that the site is covered by the General National Pollutant Discharge Elimination System (NPDES) Permit for Storm Water Associated with Construction Activity (General Storm Water Permit), permit No. 3GC04382*AG. I was accompanied by Chris Moody and Cory Harris of Ohio EPA and Jason Trapp of the Trumbull County Conservation District (Trumbull SWCD). The inspection documented the following:

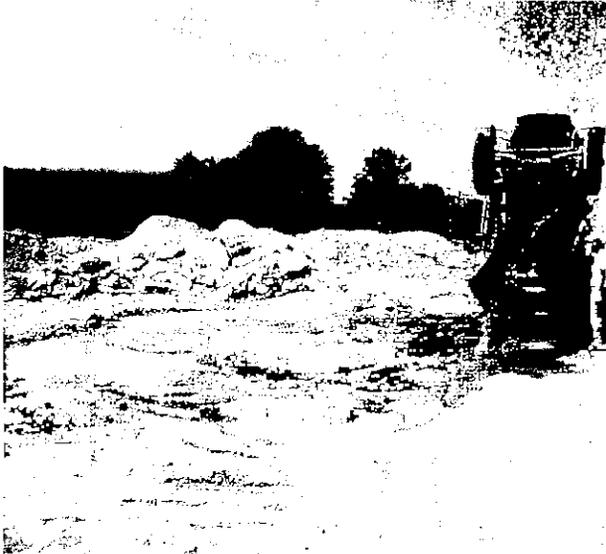
- No concrete washout pit was installed on-site. During the inspection a concrete truck was observed washing out into a pile of concrete and soil (Figure 1). Concrete washout was also found along a hillside adjacent to protected wetlands (Figure 2). This issue was raised with Mr. Innamorato who stated that there was a concrete washout pit near the entrance as specified, but it needed cleaned out. The concrete washout pit must be installed according to page C131, detail A-1 of the storm water pollution prevention plan (SWP3).

Figure 1. A concrete truck was witnessed washing out into a pile of concrete and soil. No signs of a concrete washout pit were evident.

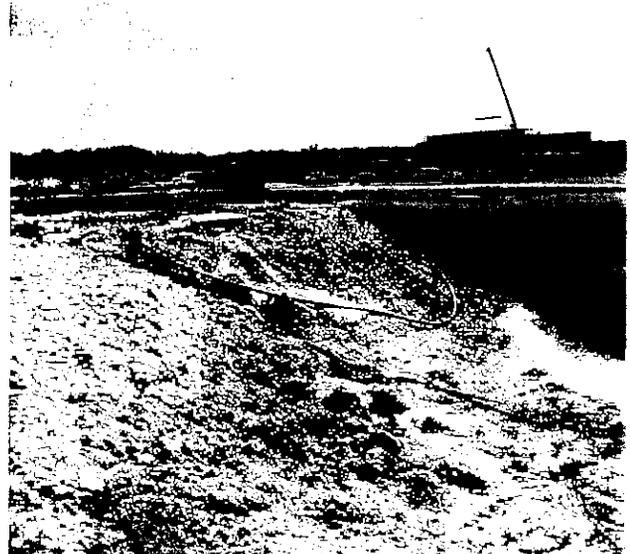
- All areas of the site that are to remain idle for twenty-one days or longer must be temporarily stabilized (Figures 2, 3, 5 and 7). In addition, areas that have been previously seeded and mulched, but germination did not occur, require additional temporary stabilization. John Innamorato of Foti Construction stated that all idle areas would be stabilized by June 4, 2010.

Figure 2. Concrete washout was also found on a back hillside adjacent to the protected wetlands.

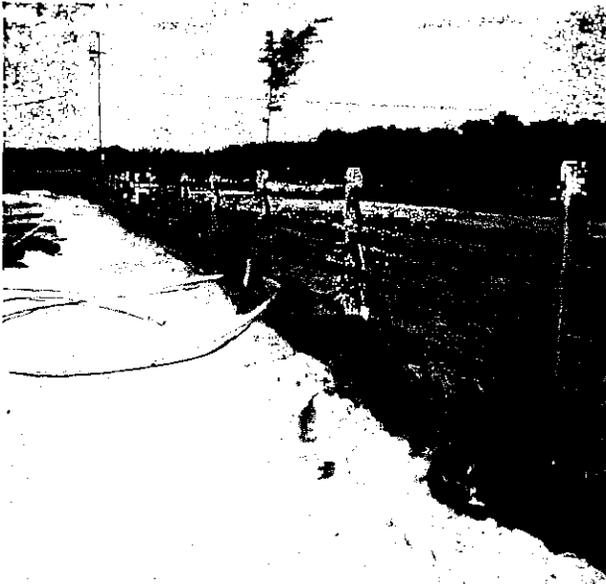
- The silt fence that has been installed on-site requires maintenance or must be reinstalled (Figure 3). Many segments have tears, holes, are falling down or have been breached.

Figure 3. Many stretches of silt fence are damaged or improperly installed.

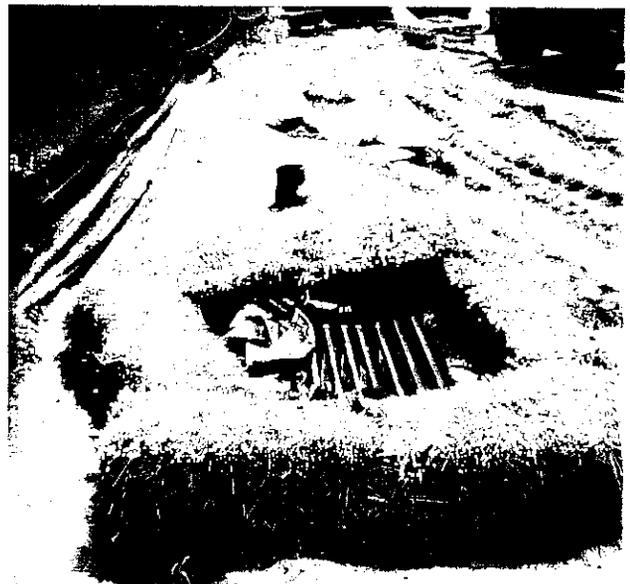
- Improperly constructed inlet protection has been installed on the site's storm sewer inlet (Figure 4). The existing inlet protection must be removed and reinstalled in accordance with the site's SWP3.

Figure 4. Improper inlet protect, please refer to your SWP3 or the *Ohio Rainwater and Land Development Manual*.

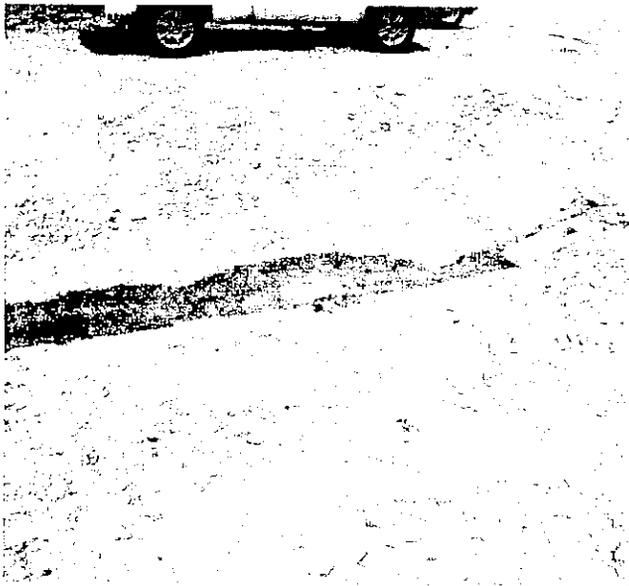
- Concentrated storm water runoff was discharging into areas of the site where BMPs have not been installed to prevent impacts to "waters of the State" (Figure 7). A level spreader must be installed on the outlet of the sediment basin that discharges into the onsite wetland.

Figure 7. Rock channel protection is needed at all points where concentrated flow discharges.
