**Environmental
Protection Agency**

June 8, 2010

RE: WAYNE COUNTY
KILLBUCK CREEK BASIN
CITY OF WOOSTER
CAMPUS CENTER RECREATION CENTER

On June 3, 2010, Ohio EPA conducted an inspection of the Campus Center Recreation Center, Phase 1, located at 1267 Beall Avenue, City of Wooster, Killbuck Township, Wayne County (site). Ohio EPA records indicate that the site is covered by the General National Pollutant Discharge Elimination System (NPDES) Permit for Storm Water Associated with Construction Activity (General Storm Water Permit), permit No. 3GC04852*AG. I was accompanied by Chris Moody of Ohio EPA, Paul Dawson of Mr. Excavator and Brent Chorey of BCMC Inc. The inspection documented the following:

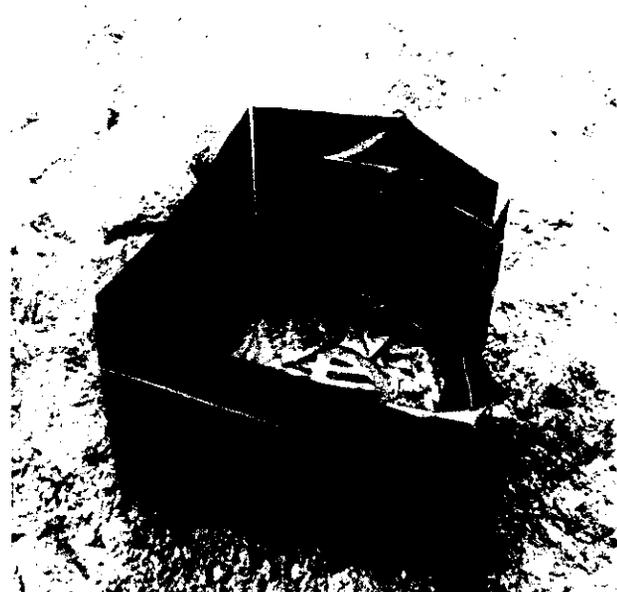
Figure 3. Improper inlet protection must be removed and the proper inlet protection installed.

Figure 4. Improper inlet protection must be removed and the proper inlet protection installed.

- Improperly constructed inlet protection has been installed on the site's storm sewer inlets (Figures 3 and 4). The existing inlet protection must be removed and reinstalled in accordance with the site's SWP3.

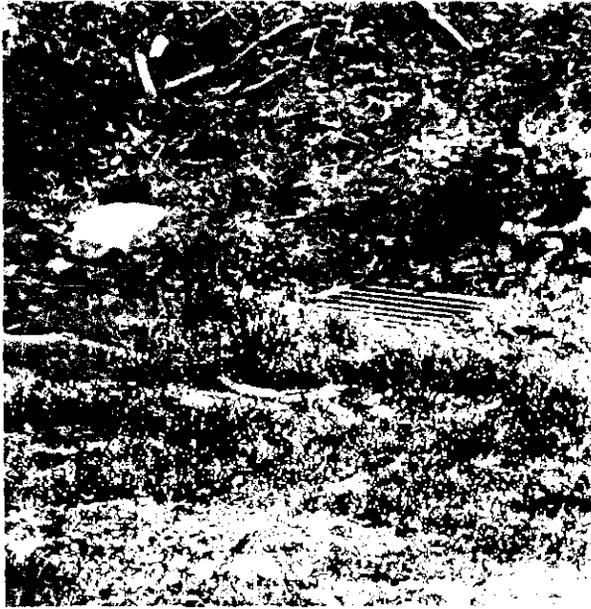
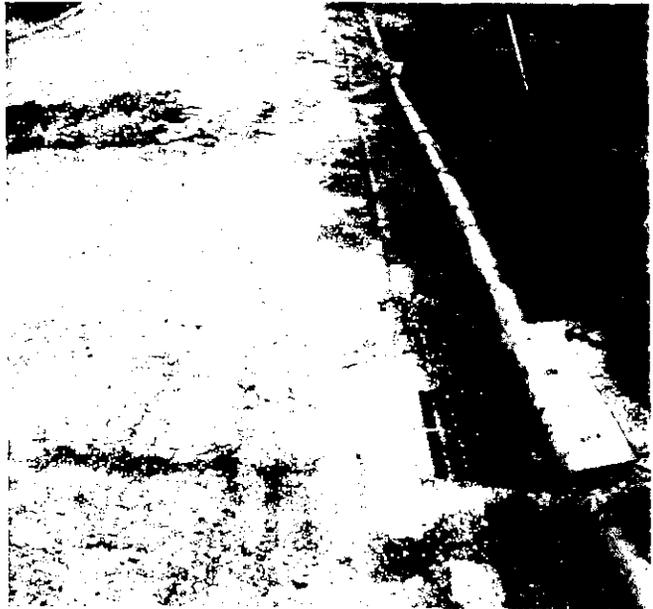
- Large amounts of sediment and debris were observed entering double inlet CB #17 (Figure 6). A revision must be made to the SWP3 to include these inlets.

Figure 5. A revision must be made to the site's SWP3 to address inlets where no protection has been called for.

Figure 6. A revision must be made to the site's SWP3 to address inlets where no protection has been called for.
