Environmental
Protection Agency

Re: Hancock County
P&A Industries
Industrial
Storm Water

July 7, 2011

On June 7, 2011, I inspected P&A Industries, located at 600 Crystal Avenue, Findlay (photos taken). The purpose of my visit was to evaluate compliance of the site with the National Pollutant Discharge Elimination System (NPDES) permit for storm water discharges associated with industrial activity, Facility ID No. 2GR01545. You were present to provide information. As a result of the inspection, I have the following comments:

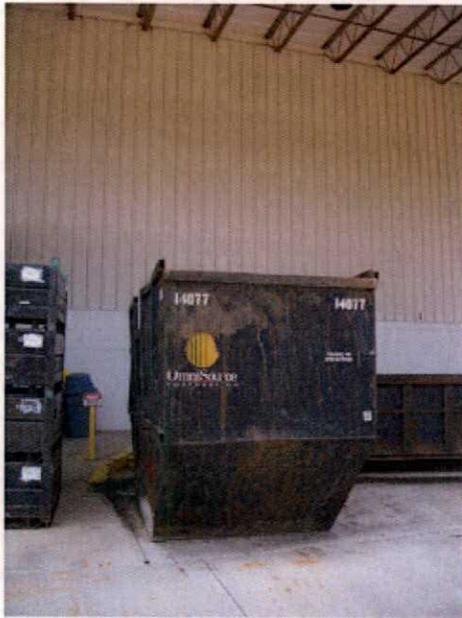
4. Industrial activities with potential exposure of pollutants to storm water include: material loading and unloading activities at the docking bay doors in the event of a spill, storage of metal parts racks, and fume collection systems. Metal scrap bins were located under an overhang on the north side of the building. Catch basins in this area are directed to the sanitary sewer.

6/7/2011 Hancock County, P&A Industries. Material storage under overhang on the north side of the building. Taken by Lynette Hablitzel. P&A_Industries_06072011_01.jpg

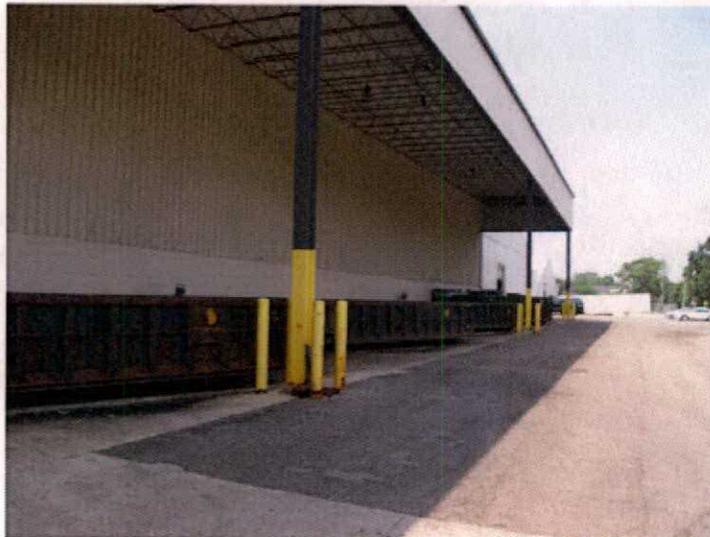
6/7/2011 Hancock County, P&A Industries. Material storage under overhang on the north side of the building. Drains in this area are connected to sanitary sewer. Taken by Lynette Hablitzel. P&A_Industries_06072011_03.jpg

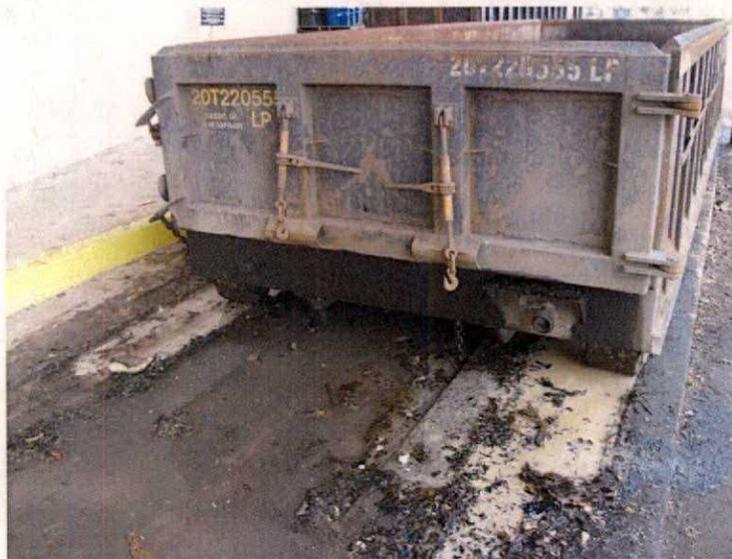
6/7/2011 Hancock County, P&A Industries. Empty metal parts containers on south side of building. Taken by Lynette Hablitzel. P&A_Industries_06072011_04.jpg and _05.jpg

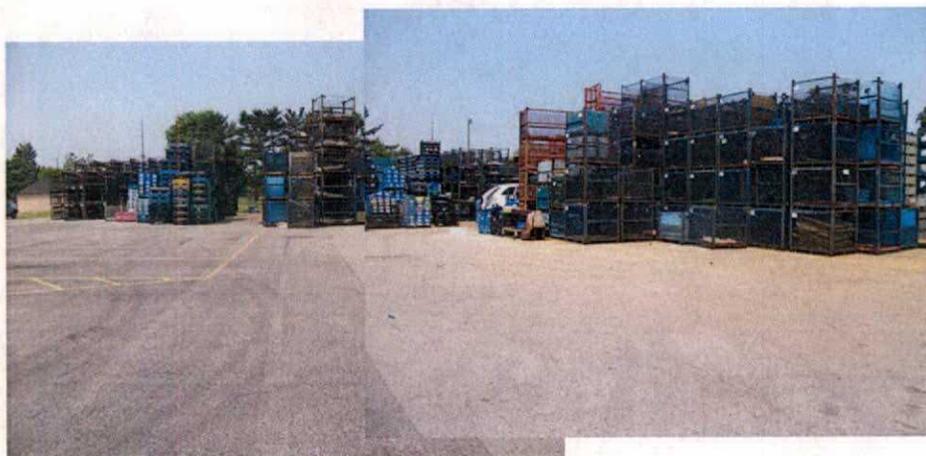
6/7/2011 Hancock County, P&A Industries. Empty metal parts containers on west side of building. Taken by Lynette Hablitzel. P&A_Industries_06072011_06.jpg

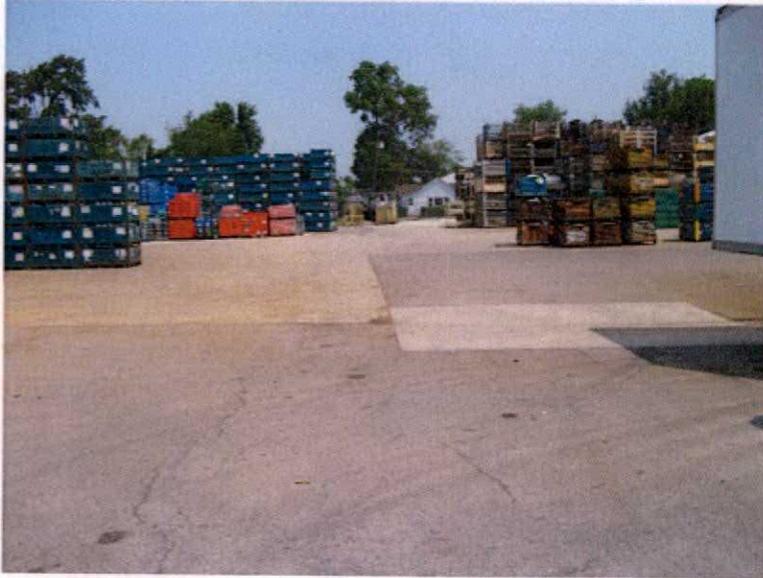
6/7/2011 Hancock County, P&A Industries. Catch basin in shipping dock. Taken by Lynette Hablitzel. P&A_Industries_06072011_07.jpg

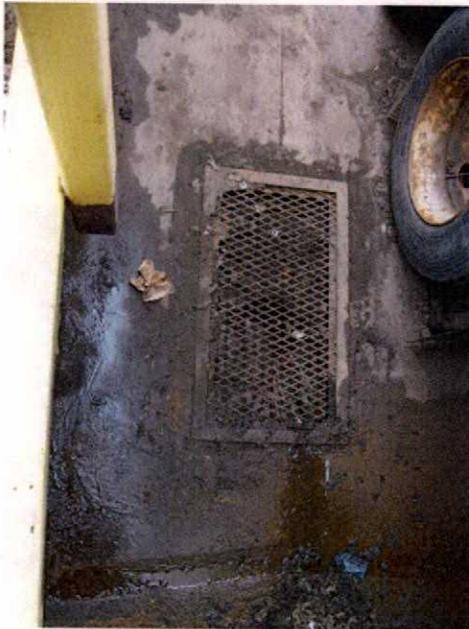
3. I did not observe any discharges during my inspection, although standing water near one of the shipping docks appeared to have a sheen. Facility sampling is not required and has not been performed.

6/7/2011 Hancock County, P&A Industries. Standing water near shipping dock. Taken by Lynette Hablitzel.
P&A_Industries_06072011_08.jpg

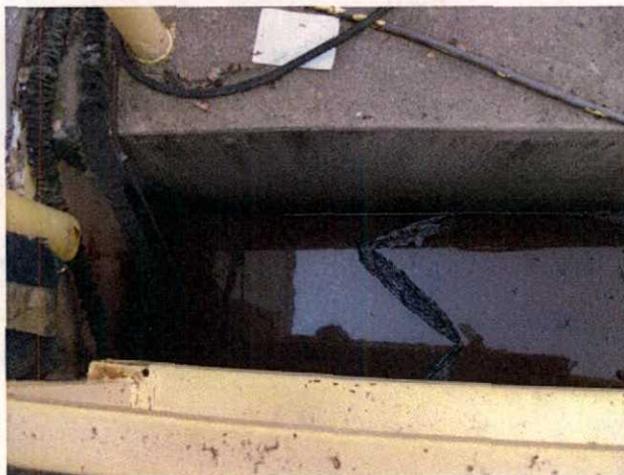
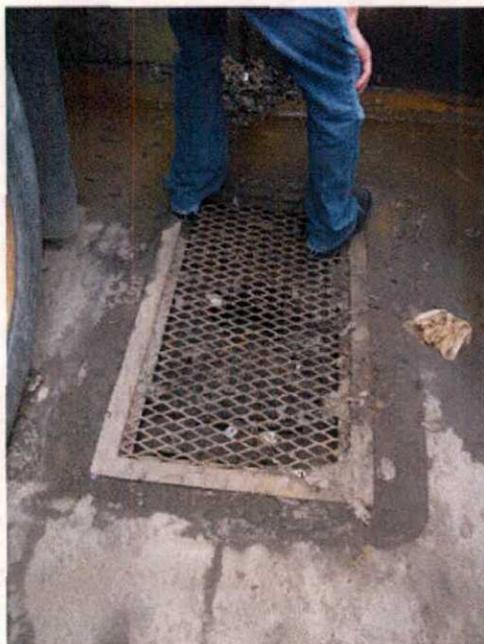
6. Good Housekeeping - I observed miscellaneous debris in the shipping dock and in other locations around the facility. The pavement had some orange staining around the storage areas for the metal parts bins. The permit requires BMPs that result in the maintenance of a clean, orderly facility. *This is a violation of Part IV. D.3.a. of the permit.*

6/7/2011 Hancock County, P&A Industries. Catch basin in shipping dock. Note litter around it. Taken by Lynette Hablitzel.
P&A_Industries_06072011_09.jpg

6/7/2011 Hancock County, P&A Industries. Catch basin in shipping dock. Note litter around it. Taken by Lynette Hablitzel. P&A_Industries_06072011_10.jpg

Within 30 days of the date on this letter, please submit to this office **written notification** as to the actions taken or proposed to address the compliance issues noted in Items 5, 6, and 8. Your response should include the dates, either actual or proposed, for the completion of the actions. If there are any questions, please contact me at (419) 373-3009.
