RE: CUYAHOGA COUNTY  
CHAGRIN RIVER WATERSHED  
VILLAGE OF GATES MILLS  
MUNICIPAL STORM WATER PROGRAM  
INSPECTION FINDINGS

# Municipal Storm Water Program Evaluation

**MS4 SWMP Evaluation**  
**MS4 Maintenance Facility Field Inspection Worksheet**  
**City Hall Municipal Complex**

**Village of Valley View  
Municipal Operation Photos  
City Hall Municipal Complex  
1470 Chagrin River Rd.**

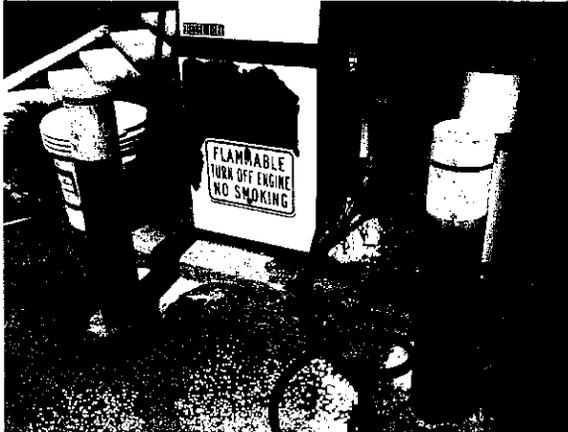
**Fig 1 (Left)** The fuel pump in this picture is leaking. A containment pad has been placed at the base of the pump to collect the leaking fuel. A storm drain is located on the left side of this picture about 6 feet from the pump. If the pump is replaced, look into moving this away from the storm drain or employing some type of inlet protection.

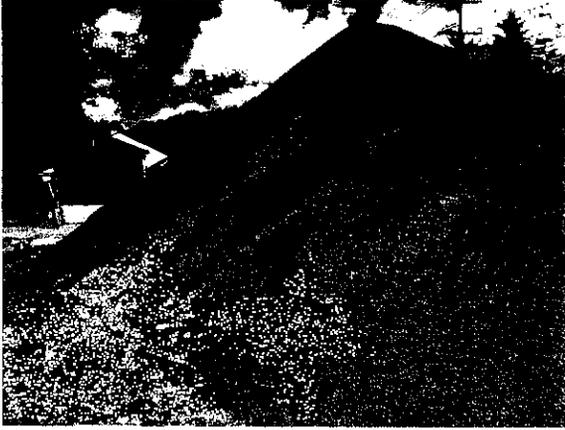
**Fig 5 (Left)** This limestone pile is where the salt and limestone are mixed and then put into the trucks. There is no containment around this pile of limestone. There should be at least some containment around the side of the pile that is not used for access to it.
