**Re: Construction Storm Water Inspection of Ridgeview Junior High School
Fairfield County
Permit Number: 4GC03246*AG**

This letter is written regarding a storm water inspection conducted by Stephen Riley of Ohio EPA at Ridgeview Junior High School located at 130 Hill Road South, in Pickerington Ohio on August 24, 2010. The purpose of the inspection was to evaluate compliance with the General Storm Water Permit Associated with Construction Activities. During the inspection, our staff noted the following issues associated with construction activities at this site:

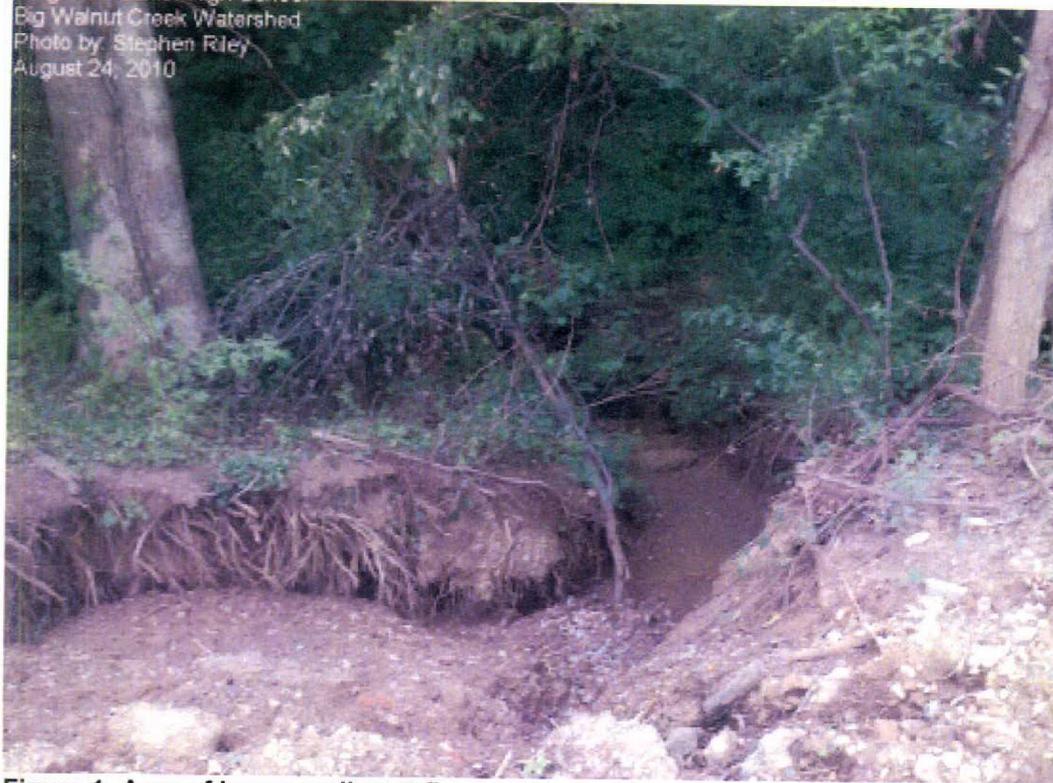
- Our staff observed an area on the backside of the school leading down to the stream where sediment discharges were evident (Figure 1). Please be aware, according to your permit conditions, sediment traps are required for areas of concentrated flow. Please emplace such measures within three days upon receipt of this letter.
- The silt fence on this site along Hill Road (Figure 2) will require maintenance or reinstallation to ensure a proper functioning condition. This general permit states that all sediment controls will be inspected and maintained every seven days or within 24 hours of a precipitation event equal to or greater than 0.5 inches. A log of inspection must be maintained on site for the agency to review.

Figure 1: Area of heavy sediment flow

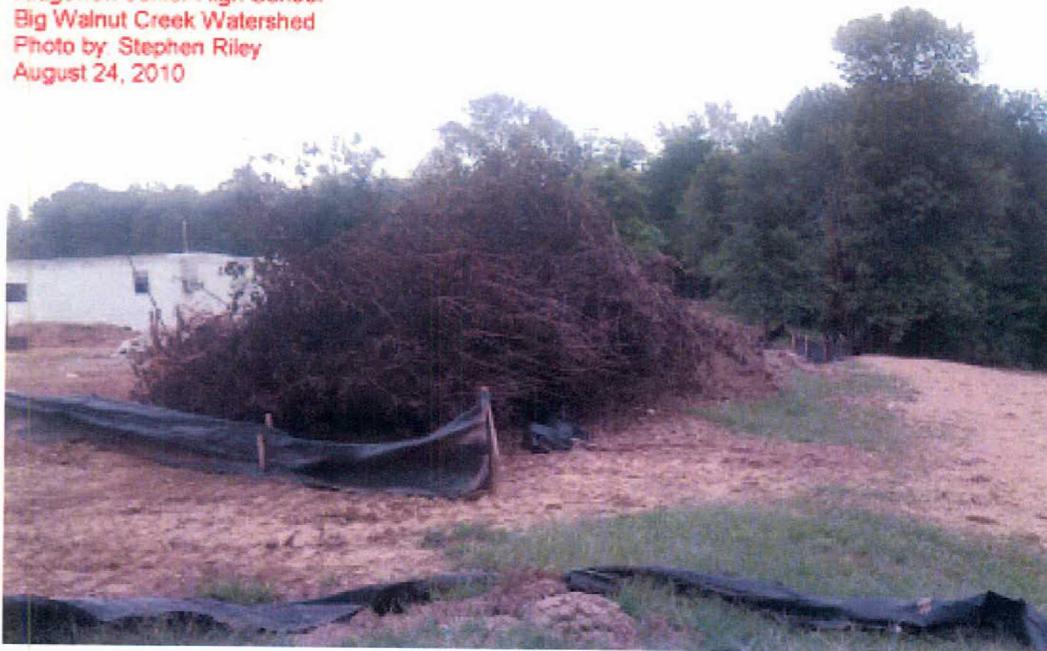
Figure 2: Silt fence along Hill Road in disrepair
