**Re: Construction Storm Water Inspection at Samuel Strapping Systems / Licking County  
Permit Number: 4GR00552\*DG**

This letter is written regarding a storm water inspection conducted by Daelann Farnlacher and Greg Mann of the Ohio EPA at Samuel Strapping Systems located at 1455 James Parkway, Heath, Ohio 43056 on June 24, 2011. The purpose of the inspection was to evaluate compliance with the General Storm Water Permit Associated with Construction Activities. During the inspection, our staff noted the following issues associated with construction activities at this site:

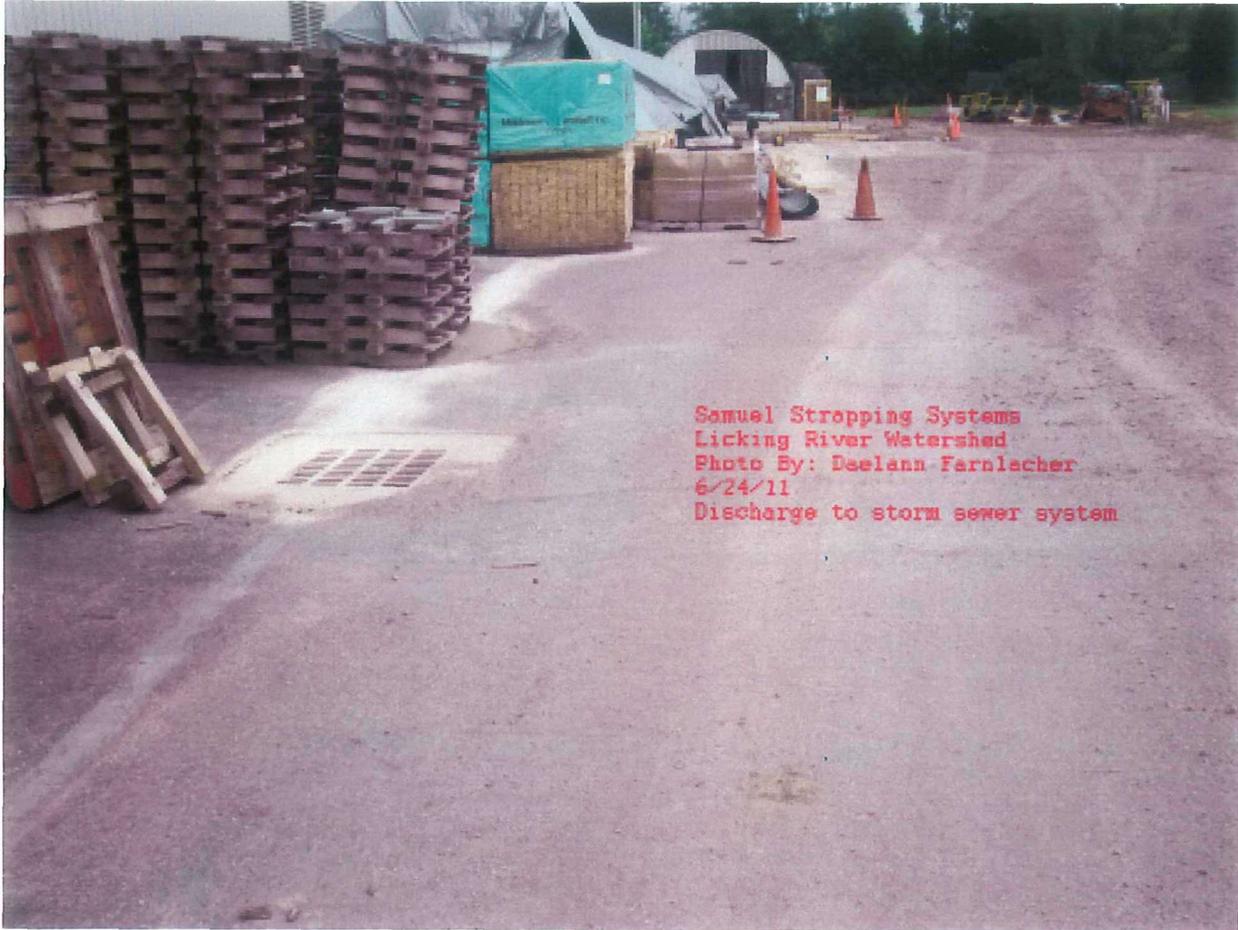
Figure 1: Concrete waste discharge

Samuel Strapping Systems  
Licking River Watershed  
Photo By: Deelann Farnlecher  
6/24/11  
Discharge to storm sewer system

- During the inspection, our staff indicated that barren areas are currently routed to large impoundment. Please verify in your response letter.
- Please ensure a concrete washout waste area is established that does not result in discharges to storm sewer systems or waters of the state (See Figure 1).
