Environmental
Protection Agency

**RE: Wilmington Sanitary Landfill
Notice of Violation**

On March 29, 2010, I conducted an inspection of Wilmington Sanitary Landfill (Facility) located in Clinton County. During the inspection, I was accompanied by Don Maher, Superintendent of Sanitation for the City of Wilmington. This inspection was conducted to determine compliance with Ohio EPA's Solid Waste Regulations and the Revised Alternative Daily Cover Temporary Approval letter from Ohio EPA, dated October 13, 2009. The working face during this inspection was located in the central portion of the west expansion area. The findings observed were also documented by photographs. Ohio EPA records show that construction and operation of the Facility is authorized by Permit to Install #645474, issued January 8, 2009.

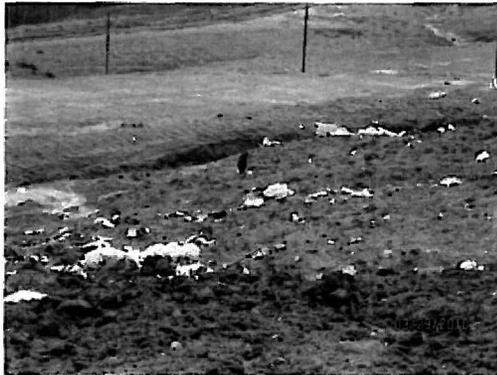
1. Inadequate cover was placed over the municipal solid waste in the northern section of the phase 1 vertical expansion area (see Figure 1), resulting in several pieces of flagging waste. Therefore, despite efforts to return to compliance, **the current condition of the northern section of the Facility and the surrounding area was in violation of OAC Rule 3745-27-19(F)** which states:

Figure 1: Flagging waste in northern section of Facility

The Facility addressed the use of daily cover in the PTI #645474 Narrative, page 16. **Therefore, the failure to cover exposed waste by the end of the working day is in violation of the PTI, which states in part:**

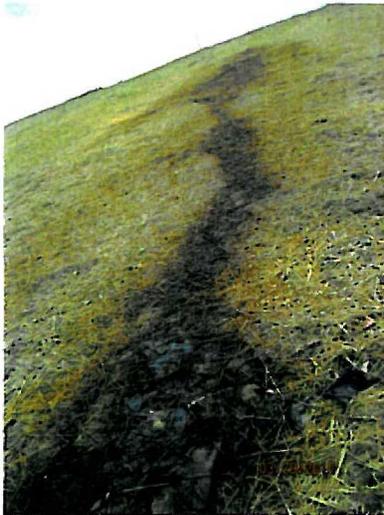
2. Leachate outbreaks were observed on the southern and western slopes of the west expansion area (see Figures 2 and 3). Prior to the inspection, the operator indicated that he had been working to correct an outbreak on the southern slope the previous week. Despite his efforts to correct this problem, **the failure to properly contain, manage, investigate and correct the outbreaks was in violation of OAC Rule 3745-27-19(K)(1), which states:**

Figure 2: Leachate running down southern exterior slope

Additionally, leachate outbreaks are addressed in the PTI #05-3708 Narrative, section 8.5.2 (page 51). **Failure to properly manage and correct a leachate outbreak is a violation of the PTI which states in part:**

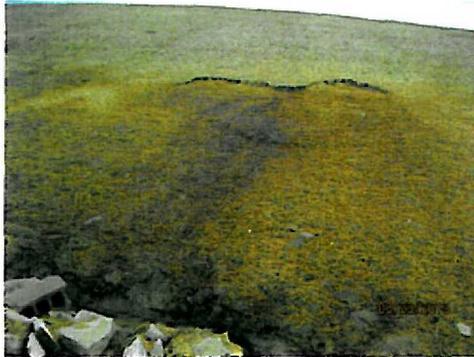
Figure 3: Leachate running down the western exterior slope
