April 13, 2010

**RE: Wilmington Sanitary Landfill
Notice of Violation**

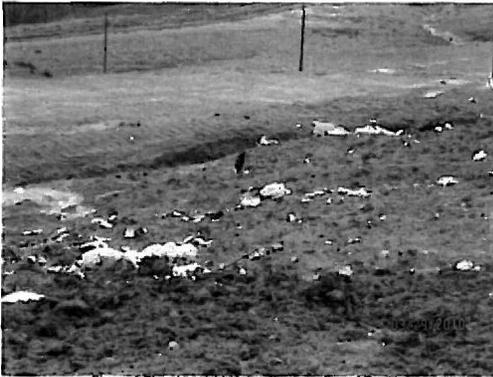
1. Inadequate cover was placed over the municipal solid waste in the northern section of the phase 1 vertical expansion area (see Figure 1), resulting in several pieces of flagging waste. Therefore, despite efforts to return to compliance, **the current condition of the northern section of the Facility and the surrounding area was in violation of OAC Rule 3745-27-19(F)** which states:

Figure 1: Flagging waste in northern section of Facility

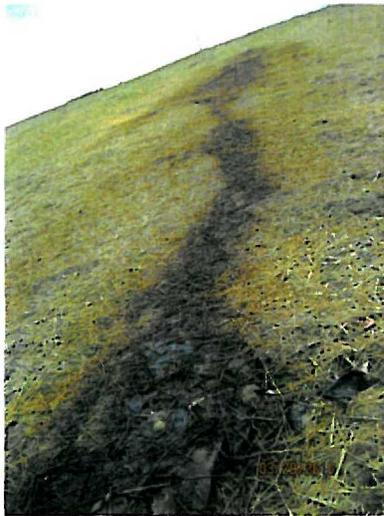
2. Leachate outbreaks were observed on the southern and western slopes of the west expansion area (see Figures 2 and 3). Prior to the inspection, the operator indicated that he had been working to correct an outbreak on the southern slope the previous week. Despite his efforts to correct this problem, **the failure to properly contain, manage, investigate and correct the outbreaks was in violation of OAC Rule 3745-27-19(K)(1), which states:**

Figure 2: Leachate running down southern exterior slope

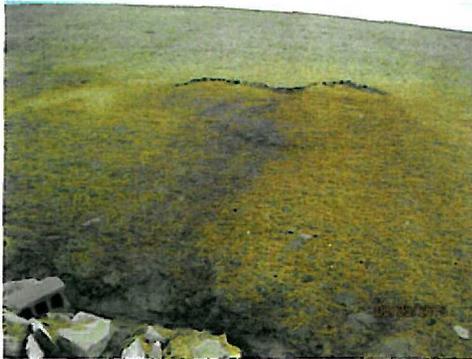
Figure 3: Leachate running down the western exterior slope
