RE: TRUMBULL COUNTY
VILLAGE OF YANKEE LAKE
YANKEE LAKE
NPDES PERMIT NO: OHC000003
OHIO EPA PERMIT NO: 3GC04773*AG
CONSTRUCTION STORM WATER INSPECTION

Notice of Violation

Storm Water Inspection

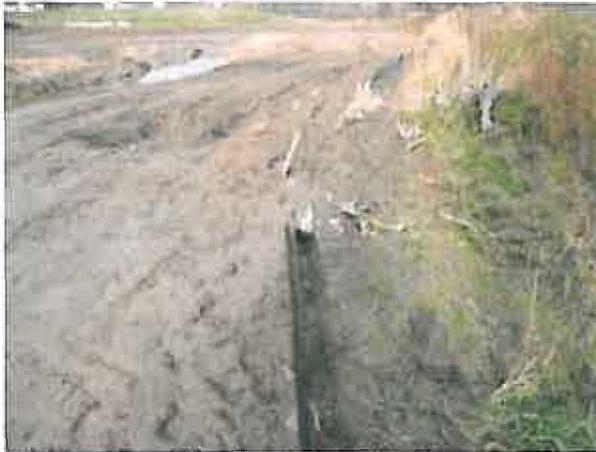
- i. The silt fence that has been installed on the site requires maintenance (Figures 1 to 2). Silt fence must be trenched six inches into the ground with ends of silt fence segments rolled together;
- ii. The northern sediment basin is not functioning as sediment-laden runoff is bypassing the outlet structure and discharging directly into Yankee Run (Figure 3);
- iii. The sediment basin located on the southern portion of the site has not been installed as sediment-laden storm water runoff is discharging directly to Yankee Run (Figure 4);
- iv. No BMPs have been installed on the eastern portion of the site to treat sediment-laden runoff from the roadways. Sediment-laden runoff was discharging directly into possible onsite wetlands and streams throughout the site (Figure 5).

Figure 1 - The installed silt fence requires maintenance.

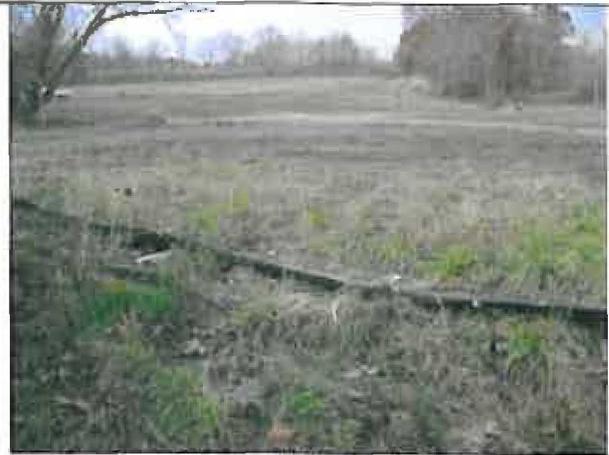
Figure 2 - The installed silt fence requires maintenance.

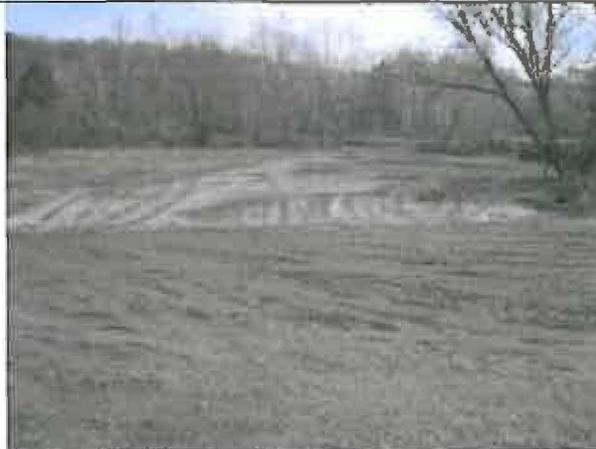
Figure 3 - The northern sediment basin is not functioning as sediment-laden runoff is bypassing the outlet structure and discharging directly into Yankee Run.

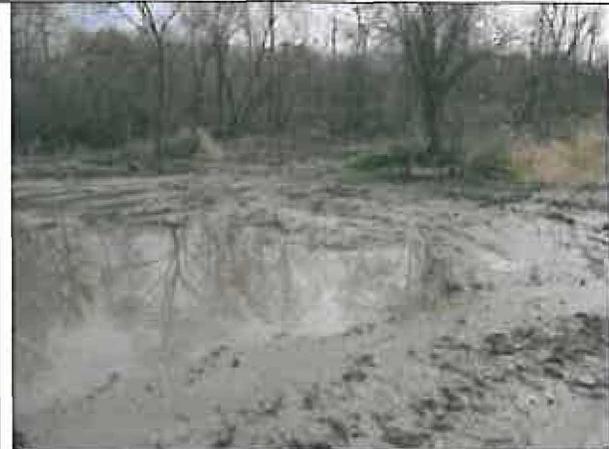
Figure 4 - The sediment basin located on the southern portion of the site has not been installed.

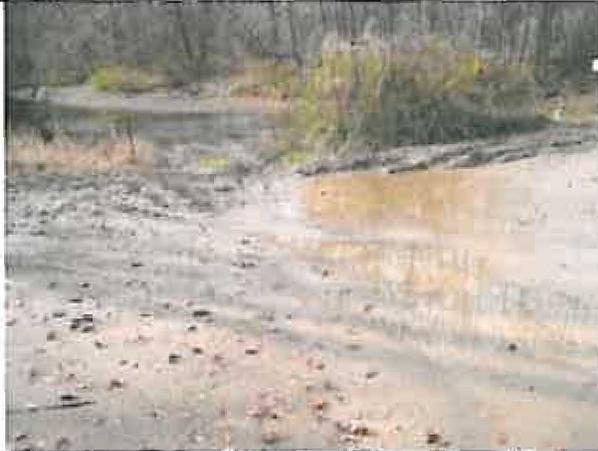
Figure 5 - Sediment-laden runoff was discharging directly into possible onsite wetland and streams throughout the site.

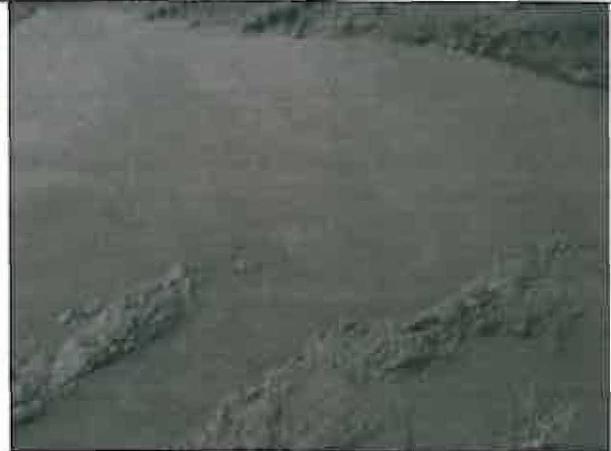
- Part III.G.2.g requires provide BMPs for pollutant sources other than sediment.
 - i. An oil sheen was documented on the surface of ponded water located on the eastern portion of the site (Figure 6). The oil sheen was discharging directly into Yankee Run.

The discharge of oil to “waters of the State” constitutes violations of ORC 6111.07, Ohio Administrative Code rule 3745-1-04(B), and Part III.G.2.g of the General Storm Water Permit.

Figure 6 - An oil sheen was discharging directly into Yankee Run.

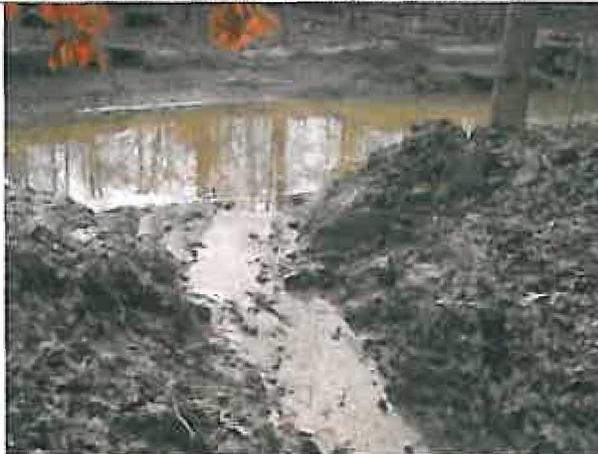
- Part III.G.2.g.iv of the General Storm Water Permit requires that there shall be no turbid discharges to surface waters of the State resulting from dewatering activities. If trench or ground water contains sediment, it must pass through a sediment settling pond or other equally effective sediment control device, prior to being discharged from the construction site. Alternatively, sediment may be removed by settling in place or by dewatering into a sump pit, filter bag or comparable practice.
 - i. Numerous diversion channels have been constructed to dewater the roadways located on the eastern portion of the site. Sediment-laden runoff was being discharged directly into “surface waters of the State” (Figures 7 to 9).

Figure 7 - Sediment-laden runoff was being discharged directly into "surface waters of the State" via numerous diversion channels.

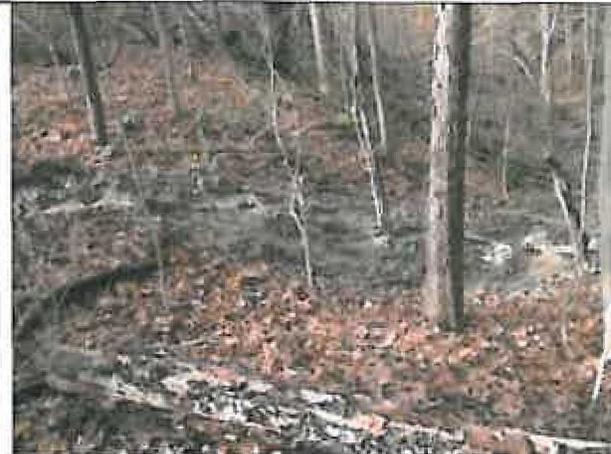
Figure 8 - Sediment-laden runoff was being discharged directly into "surface waters of the State" via numerous diversion channels.

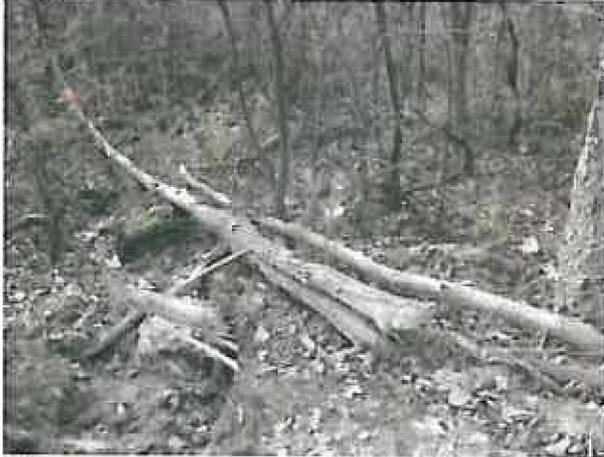
Figure 9 - Sediment-laden runoff was being discharged directly into "surface waters of the State" via numerous diversion channels.

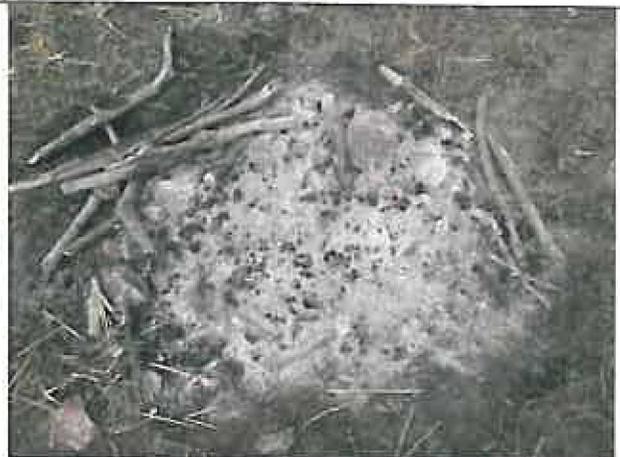
- Open burning of solid waste is occurring on-site and must be terminated (Figure 10);

Figure 10 - Open burning of solid waste is occurring on-site and must be terminated.

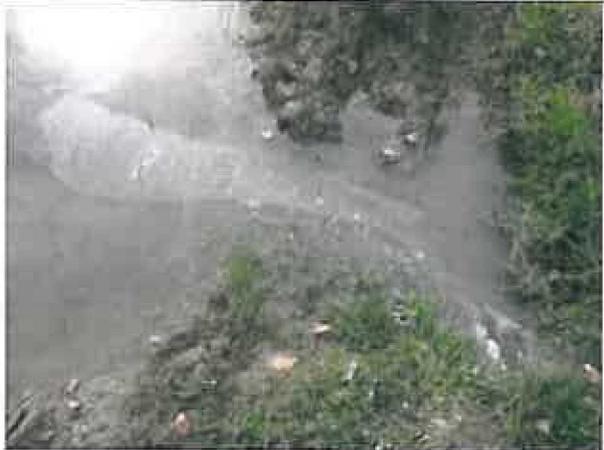
Figure 11 - Sewage appeared to be discharging from a pipe into "waters of the State"

During the inspection, sewage appeared to be discharging from a pipe into "waters of the State" (Figures 11 to 12). Please contact Tomas Parry, Ohio EPA, to discuss the proper treatment and monitoring of discharging sewage treatment systems. For your convenience, Mr. Parry can be contacted at (330) 963-1120.

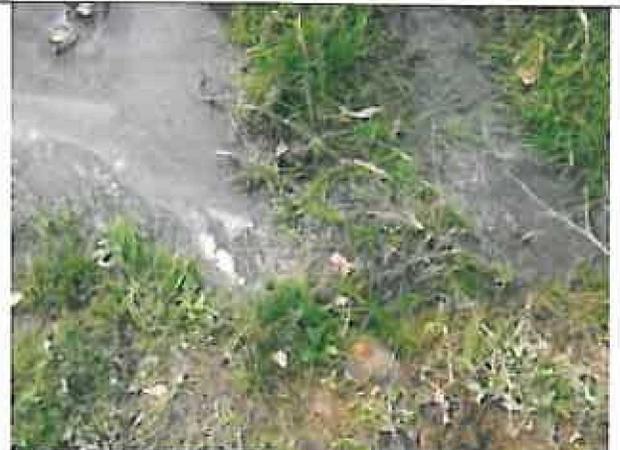
Figure 12 - Sewage appeared to be discharging from a pipe into "waters of the State"
