RE: MAHONING COUNTY
SOIL REMEDIATION, INC.
NPDES PERMIT NO. OHR000004
OHIO EPA PERMIT NO. 3GR01022*DG
INDUSTRIAL STORM WATER INSPECTION

NOTICE OF VIOLATION

Site Inspection

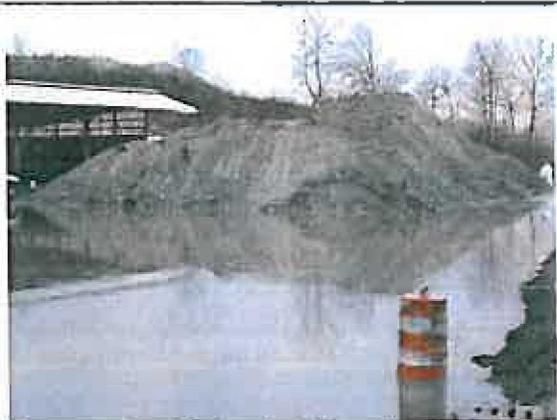
1. Section 3.5.2, Outdoor Storage, of the Storm Water Pollution Prevention Plan (SWP3) states petroleum contaminated soil piles will be staged within the constructed shelter with a roof and that "petroleum contaminated soils will not be stored outside of the shelter." Contaminated soil was stored outside of the shelter in an area that was exposed to precipitation (Figure 1). **The failure to store contaminated soil in accordance with the SWP3 constitutes violations of Ohio Revised Code, Chapter (ORC) 6111.07 and Part IV of the General Storm Water Permit.**

Figure 1 - Contaminated soil was stored outside of the shelter in an area that was exposed to precipitation.

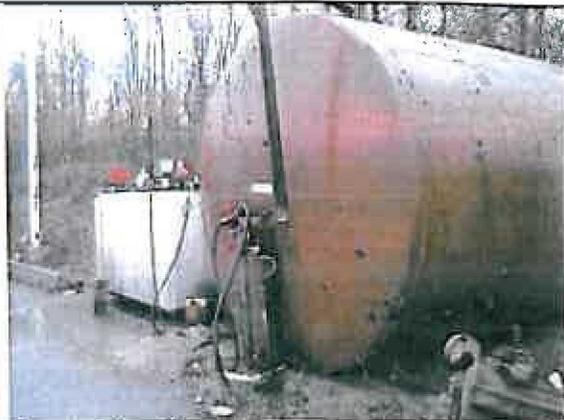
2. Section 3.5.2, Outdoor Storage, and Section 4.3, Spill Prevention and Response, of the SWP3 state that the storage of fuel occurs in two aboveground storage tanks south of the maintenance building and that the facility will construct "secondary containment dikes that will hold 110% of the capacity of the largest tank." The aboveground storage tank area has not been modified to include the secondary containment dikes (Figure 2). **The failure to install secondary containment dikes with 110% capacity of the largest tank in accordance with the SWP3 constitutes violations of ORC 6111.07 and Part IV of the General Storm Water Permit.**

4. Section 4.1, Item (4), Good Housekeeping, of the SWP3 states that "SRI should maintain spill control equipment adjacent to its fuel storage tanks." Spill kits were not observed at the fuel storage tanks (Figure 2). **The failure to maintain spill control equipment adjacent to the fuel storage tanks in accordance with the SWP3 constitutes violations of ORC 6111.07 and Part IV of the General Storm Water Permit.**

5. Section 4.2, Preventative Maintenance, of the SWP3 states that "all storage tanks for fuels and oils should be maintained to prevent corrosion of the tank shell or tank components (i.e. valves, stems, & hoses)." Corrosion of the large fuel tank was observed (Figure 2). **The failure to prevent corrosion of the tank shell in accordance with the SWP3 constitutes violations of ORC 6111.07 and Part IV of the General Storm Water Permit.**

Figure 2 - The aboveground storage tank area has not been modified to include the secondary containment dikes.

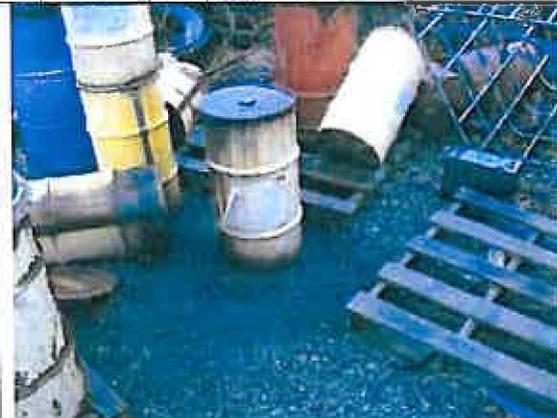
3. Section 4.1, Item (3), Good Housekeeping, of the SWP3 states that "prompt cleanup of any fuels or oils that have been spilled or released from SRI's fuel tanks, oil drums, or equipment" shall be implemented." Numerous oil spills and leaks were documented from fifty-five gallon tanks and five gallon pails located in the vehicle/equipment outdoor storage area located east of the maintenance building (Figures 3 to 6). All drums and pails must be properly sealed to prevent storm water runoff from becoming contaminated (Figure 6). **The failure to perform good housekeeping in accordance with the SWP3 constitutes violations of ORC 6111.07 and Part IV.D.3.a of the General Storm Water Permit.**

Figure 3 - Numerous oil spills and leaks were documented from fifty-five gallon tanks and five-gallon pails.

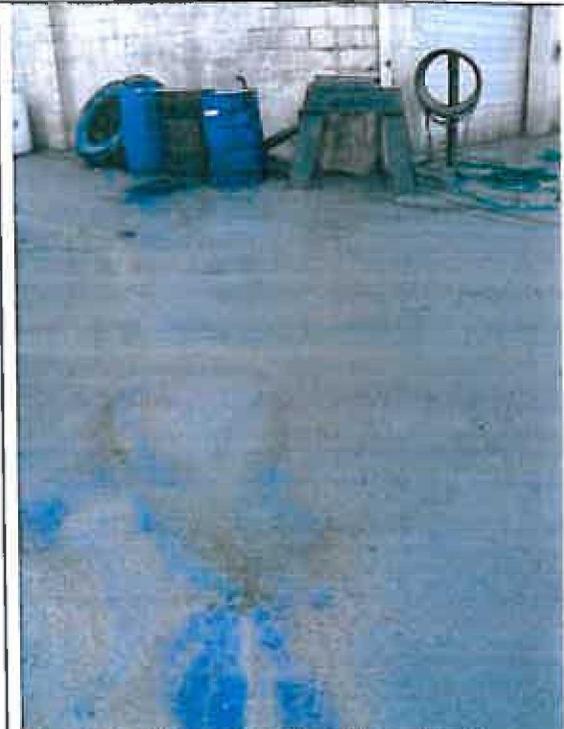
Figure 4 - Numerous oil spills and leaks were documented from fifty-five gallon tanks and five-gallon pails.

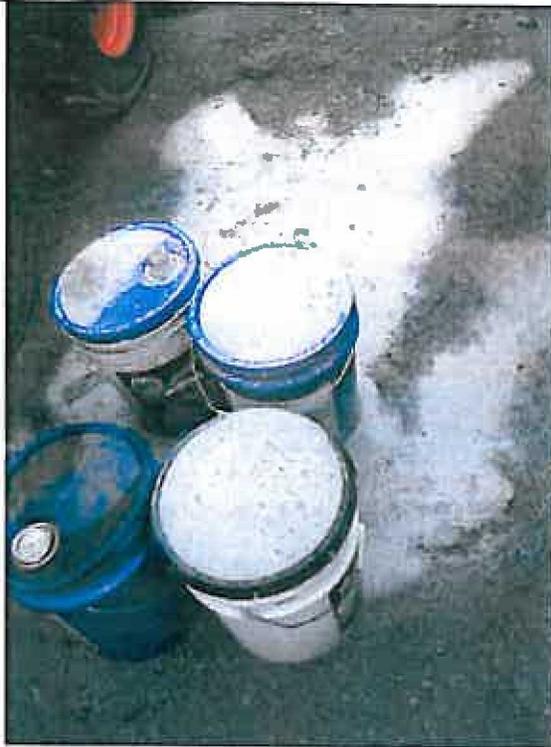
Figure 5 - Numerous oil spills and leaks were documented from fifty-five gallon tanks and five-gallon pails.

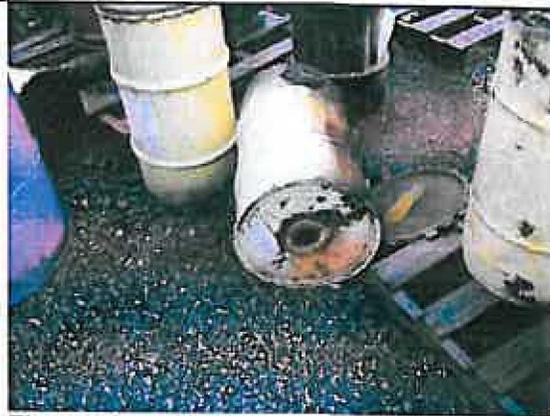
Figure 6 - All drums and pails must be properly sealed to prevent precipitation from contacting open containers.

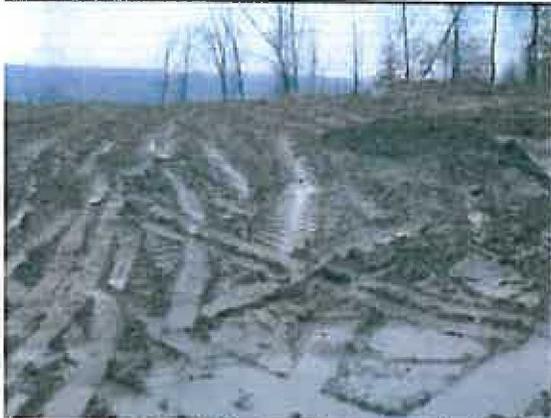
No erosion or sediment best management practices (BMP) have been installed within the recent excavating and grading activities located east of the "slag reclamation," as depicted on the site map provided within Appendix B of the SWP3, and around the various stockpiles of materials throughout the facility that do not discharge into the sediment pond (Figures 7 to 11). Strong odors were present throughout the areas where recent excavating grading activities had occurred. **The failure to prevent erosion and discharge of sediment constitutes violations of ORC 6111.07 and Part IV of the General Storm Water Permit.**

Figure 7 - No BMPs have been installed within the recent excavating and grading activities to prevent discharges of sediment.

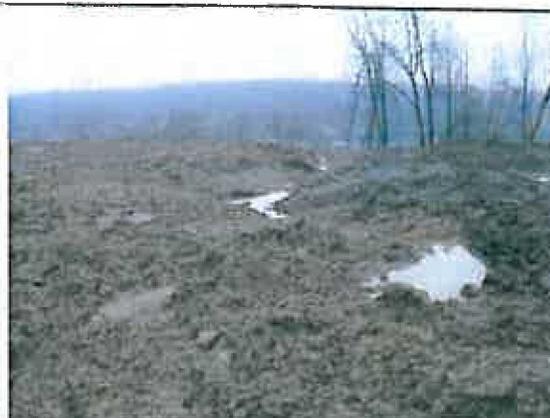
Figure 8 - No BMPs have been installed within the recent excavating and grading activities to prevent discharges of sediment.

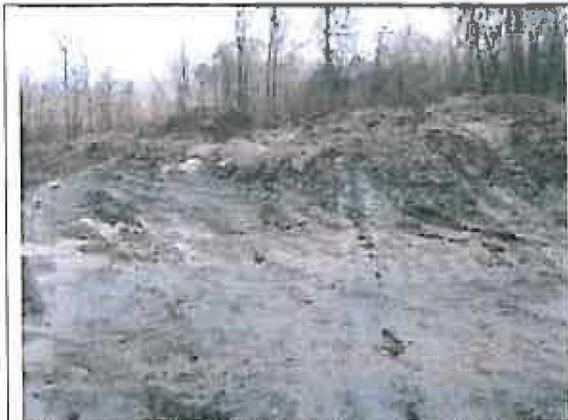
Figure 9 - No BMPs have been installed within the recent excavating and grading activities to prevent discharges of sediment.

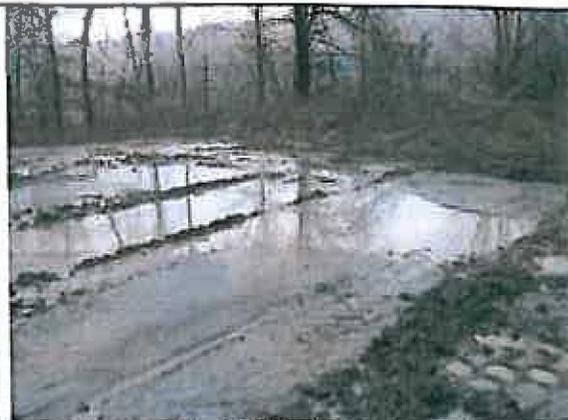
Figure 10 - No BMPs have been installed around the various stockpiles of materials throughout the facility that do not discharge into the sediment pond.

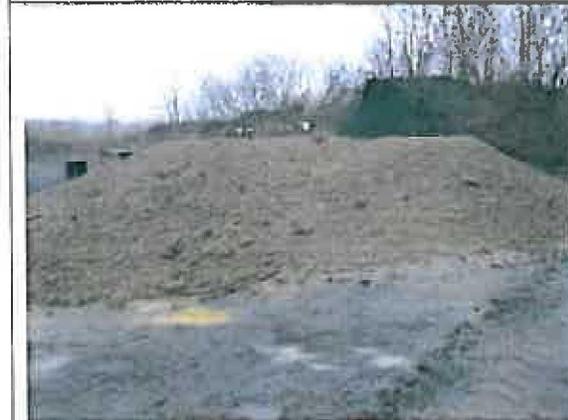
Figure 11 - No BMPs have been installed around the various stockpiles of materials throughout the facility that do not discharge into the sediment pond.

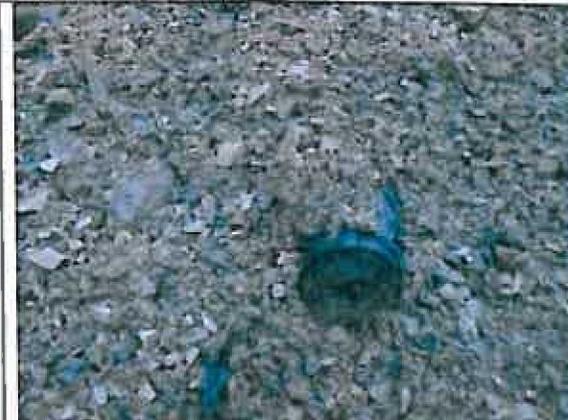
It appeared that solid waste materials (i.e. plastic liners) had been buried within the areas where recent excavating and grading activities had occurred (Figures 12 to 13). In addition, a stockpile of tires was located east of the maintenance building (Figure 14). Please contact Katharina Snyder of Division of Materials and Waste Management (formerly the Division of Solid and Infectious Waste Management) (DMWM) at (330) 963-1257 regarding the proper management of solid waste materials.

Figure 12 - It appeared that solid waste materials (i.e. plastic liners) had been buried within the areas where recent excavating and grading activities had occurred.

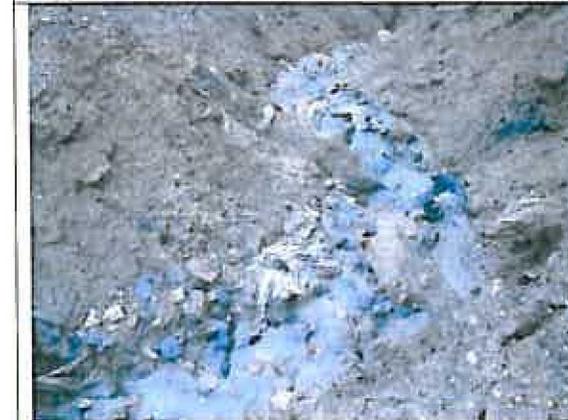
Figure 13 - It appeared that solid waste materials (i.e. plastic liners) had been buried within the areas where recent excavating and grading activities had occurred.

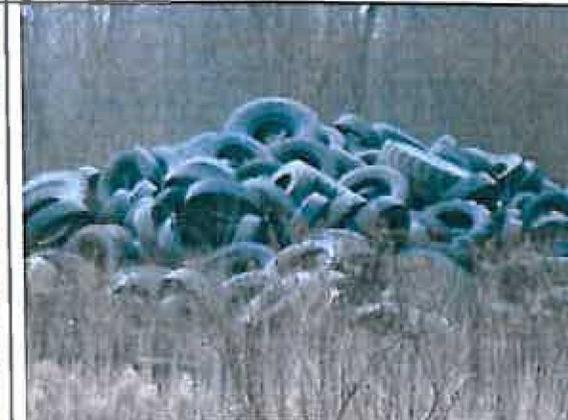
Figure 14 - A stockpile of tires was located east of the maintenance building.

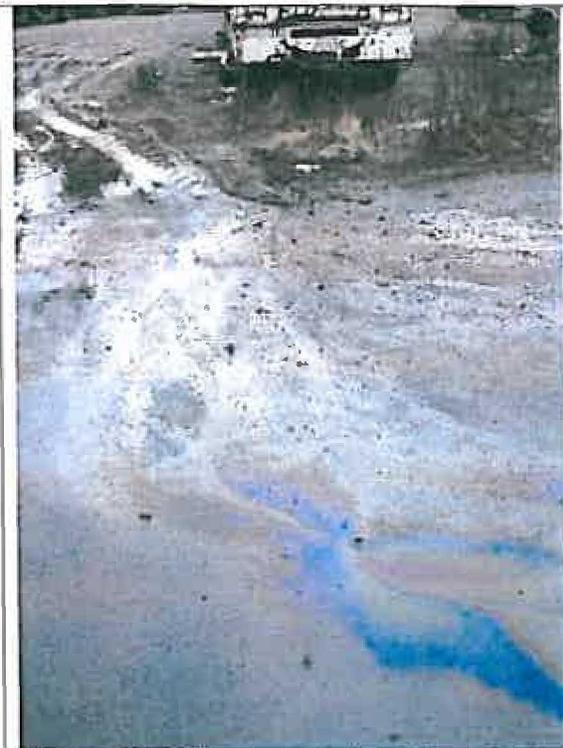
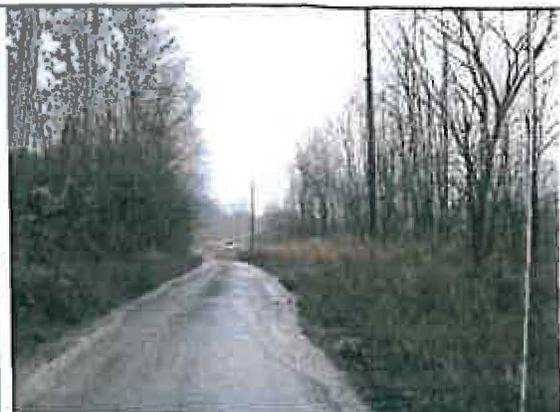
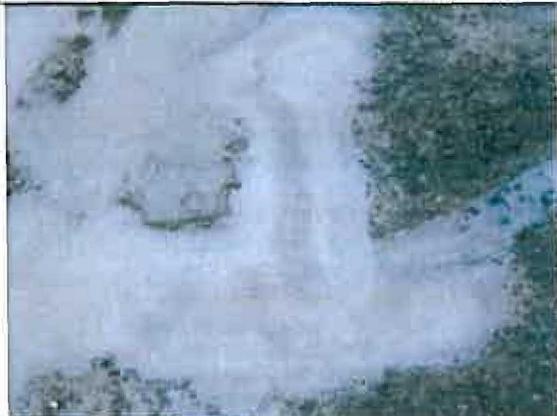
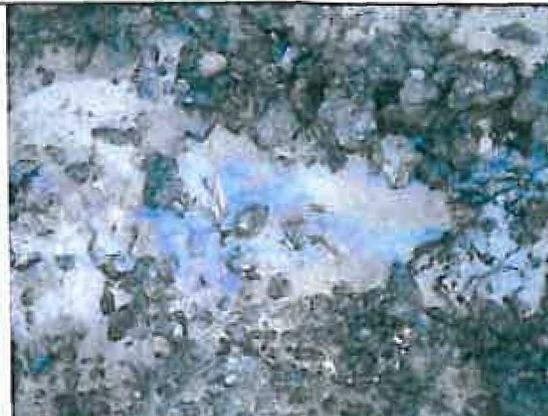
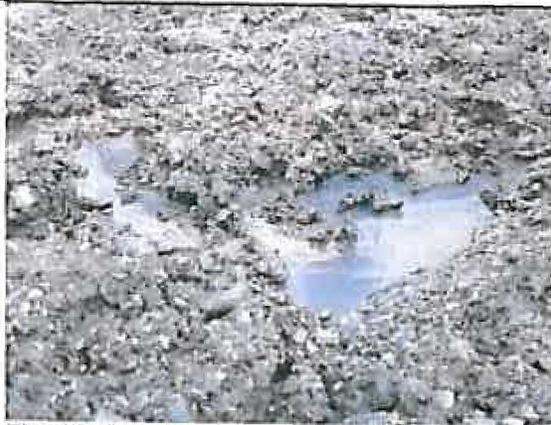
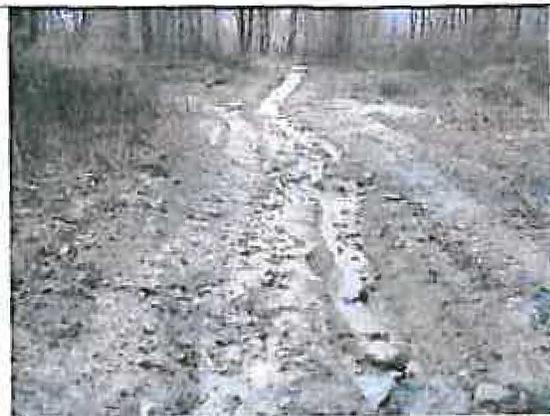
7. Contaminated storm water runoff was discharging to "waters of the state" in many locations throughout the facility (Figures 1 and 5). Oils, suspended solids, and other black colored materials were being discharged via storm water runoff to "waters of the state" from the areas where recent excavating and grading activities had occurred (Figures 15 to 20). **The unpermitted discharge of contaminated storm water runoff to "waters of the state" constitutes violations of ORC 6111.07, Ohio Administrative Code rule 3745-1-04(A), (B), and (C).**

Figure 15 - Oils, suspended solids, and other black colored materials were being discharged via storm water runoff to "waters of the state."

Figure 16 - Oils, suspended solids, and other black colored materials were being discharged via storm water runoff to "waters of the state."

Figure 17 - Oils, suspended solids, and other black colored materials were being discharged via storm water runoff to "waters of the state."

Figure 18 - Oils, suspended solids, and other black colored materials were being discharged via storm water runoff to "waters of the state."

Figure 19 - Oils, suspended solids, and other black colored materials were being discharged via storm water runoff to "waters of the state."

Figure 20 - Oils, suspended solids, and other black colored materials were being discharged via storm water runoff to "waters of the state."

- All unauthorized discharges of contaminated storm water runoff must be immediately eliminated.
- Within 14 days of receiving this NOV, a written report must be submitted to Ohio EPA that details how the above violations have been or will be addressed. The written report must also include dates detailing when each corrective action (i.e. BMP) was or will be implemented and completed.
- Within 30 days of receiving this NOV, the facility's SWP3 must be revised to address the above violations. A copy of the revised SWP3 must be submitted to Ohio EPA for review.
- Within 30 days of receiving this NOV, an application for an individual industrial NPDES storm water permit must be submitted, in accordance with the instructions, to Ohio EPA.
