**Environmental
Protection Agency**

April 26, 2012

RE: WAYNE COUNTY
WOOSTER TOWNSHIP
TRIWAY LANES
NPDES # 3PR00312

On April 20, 2012, this writer conducted an inspection of the sewage treatment plant serving Triway Lanes. The intent of the inspection was to evaluate the facility's compliance with respect to the terms and conditions of the National Pollutant Discharge Elimination System (NPDES). The information gathered during the inspection will be utilized in determining the renewal status of the NPDES permit

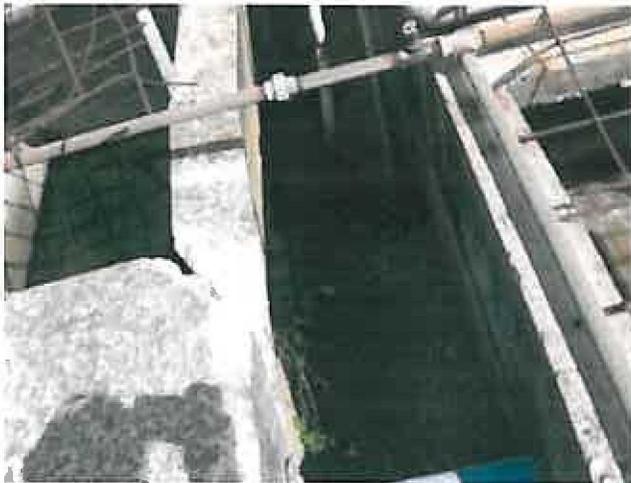
- 1) The wall of the sludge holding tank was collapsed. The sludge holding tank cannot be used for its intended purpose due to the condition. See photo 1.

Photo 1: Sludge holding tank

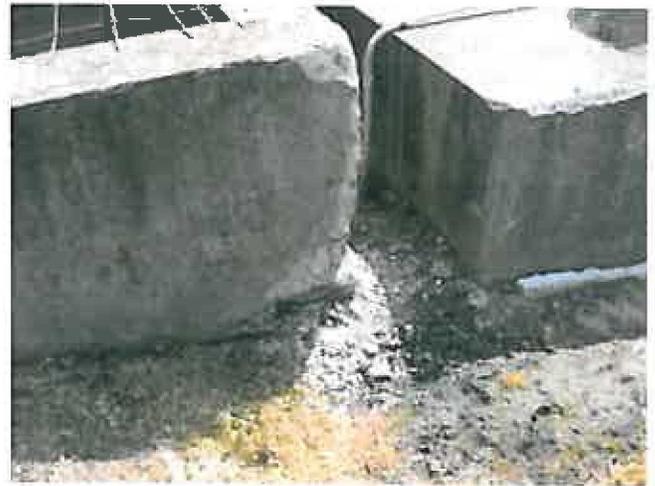
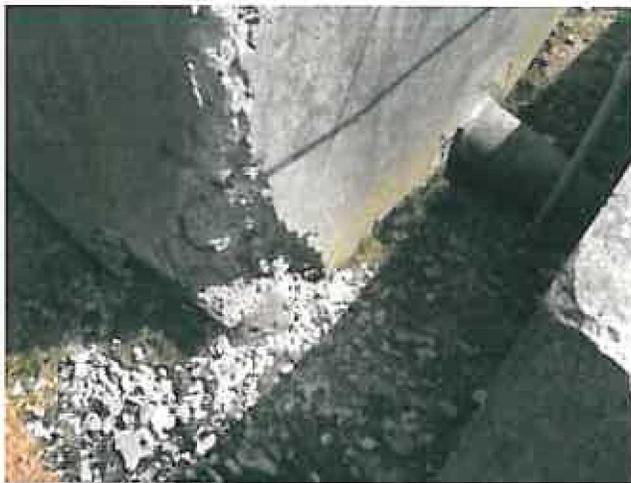
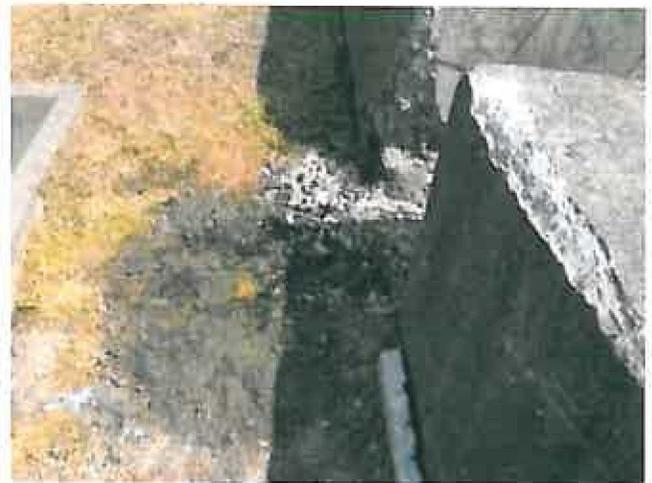
- 2) The south side of the final settling tank is crumbling. The rebar is visible and water could be seen seeping through this area. A large wet spot is visible on the ground below the area. Additionally, the piping from the final settling tank to the dosing chamber is leaking and resulting in a wet area between the tanks. Bypassing around any portion of your treatment system violates the conditions of your NPDES permit, specifically Part III, item 11. See photos 2, 3, and 4.

Photo 2: Settling tank

Photo 3: Settling tank.

Photo 4: Settling tank.

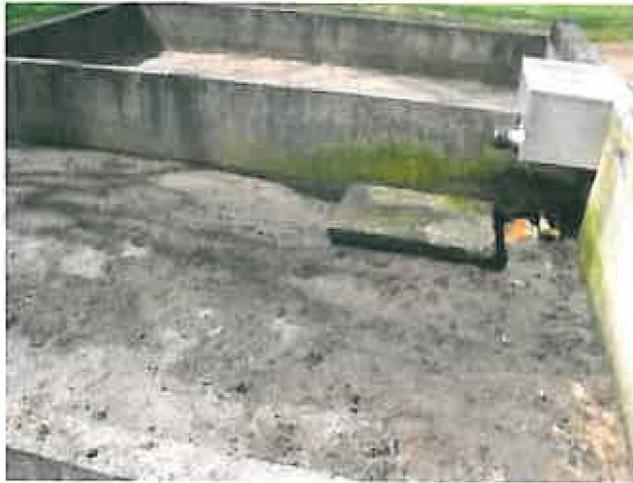
- 3) The sand in the sand filter beds is old and should be replaced. See photo 5.
- 4) The disinfection tank was 1/3 unsupported due to erosion. The disinfection tank was leaking. This was evident by exposed ground under the tank being saturated. Bypassing around any portion of your treatment system violates the conditions of your NPDES permit, specifically Part III, item 11. See photos 6 and 7.

Photo 5: Sand filter bed.

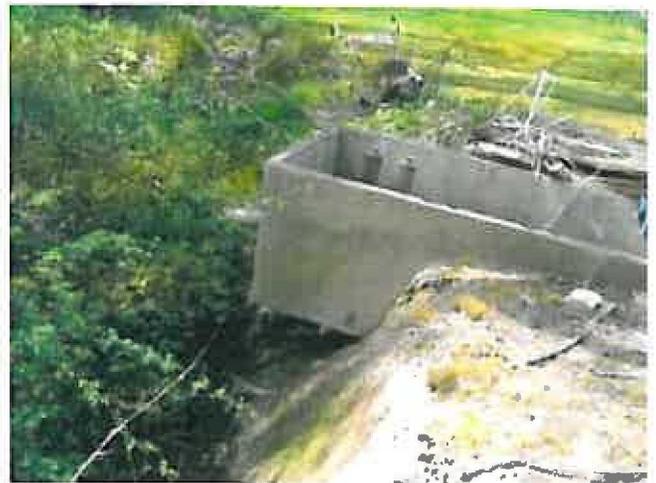
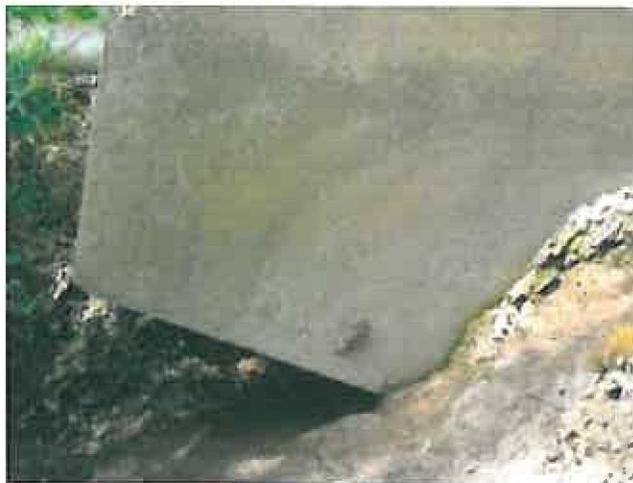
Photo 6: Disinfection tank.

Photo 7: Disinfection tank.

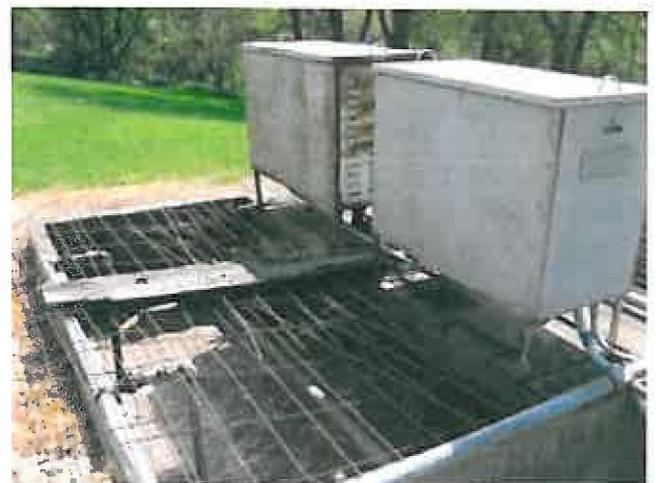
- 5) The color of the extended aeration tank was light brown. The blowers were functioning and the skimmer return line from the final settling tank was operating. The concrete supporting the blowers appeared to be weathering. See Photo 8.

Photo 8: Blowers atop of aeration tank.
