Re: **Notice of Violation**
Putnam County
Ottoville WWTP
NPDES Permit

NPDES Compliance Inspection Report

Section B: Facility Data		
Name and Location of Facility Inspected	Entry Time	Permit Effective Date
Ottoville WWTP 200 Utility Drive, Ottoville, Ohio P.O. Box 488	1:00 pm	December 1, 2011
	Exit Time	Permit Expiration Date
	2:15 pm	November 30, 2016
Name(s) and Title(s) of On-Site Representatives	Phone Number(s)	
Steve Wittler, Utilities Director	419-453-3147	
Name, Address and Title of Responsible Official	Phone Number	
Village of Ottoville 150 Park Drive Ottoville OH 45876	419-453-3147

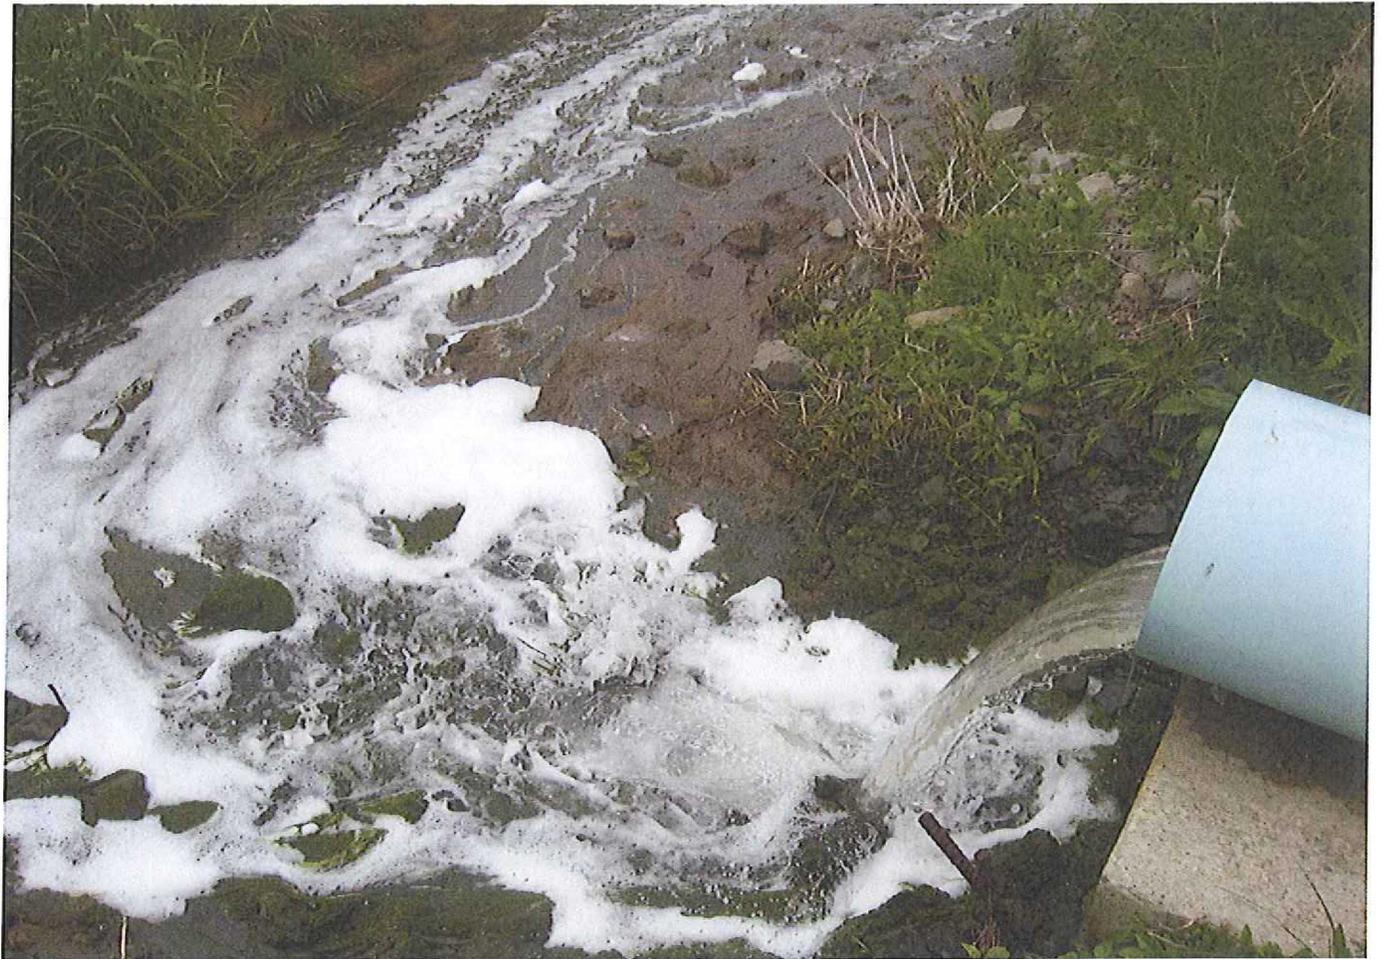
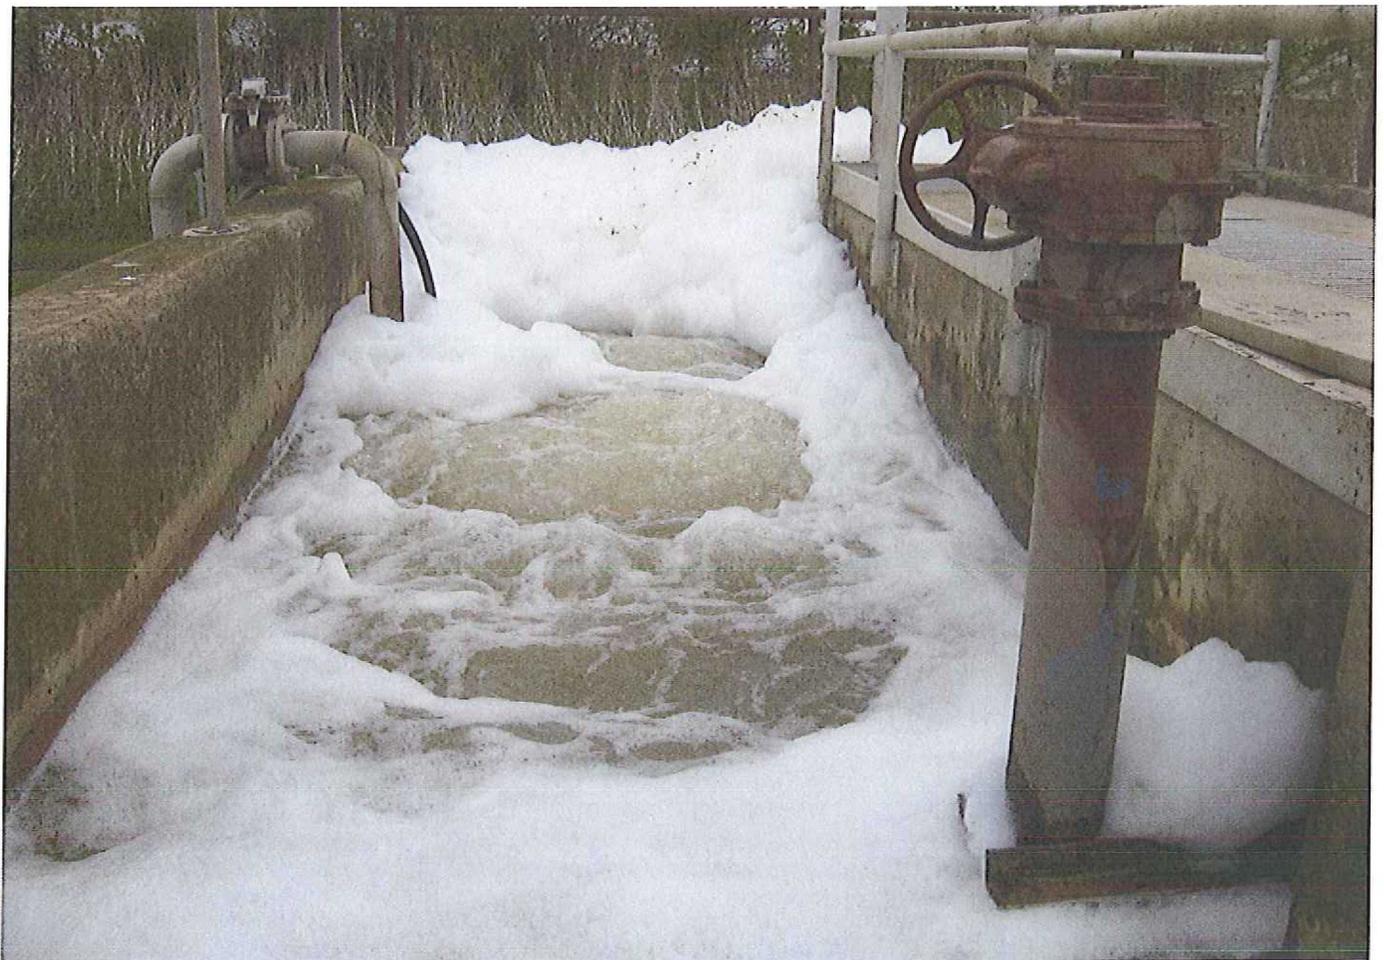
At the time of inspection, all treatment units were in operation and the discharge from the WWTP to an unnamed tributary of the Little Auglaize River was clear with white foam and had no noticeable odor. The presence of foam in the receiving stream is a violation of Part III, Item 2. of your NPDES permit and Ohio Administrative Code (O.A.C.) 3745-1-04. A picture of the discharge is enclosed.

Section D: Summary of Findings (Attach additional sheets if necessary)	
<p>It was noted that an upset occurred at the plant on Sunday April 29th 2012. An extensive amount of white foam was observed in the aeration tanks and in the post aeration tank. The foam overflowed the post aeration tank. It was noted that a yellow tinted influent was coming into the plant that was disrupting settling at the plant. During the inspection white foam was still observed in the post aeration tank but the aeration tanks appeared to be working properly. The foam was observed entering the receiving stream but appeared to be dissipating downstream from the discharge. The foam was believed to be from the local fire departments training. It was noted that the plant has improved since Sunday and the received slug load was making its way out of the plant. The discharge entering the stream appeared clear with no noticeable odor and had the white foam. It is recommended that you work with the fire department to reduce/eliminate the discharge of foam to your treatment facility.</p>
