May 31, 2012

**Re: Storm Water Inspection at Menards-Columbus / Franklin County
Permit Number: 4GC03513*AG**

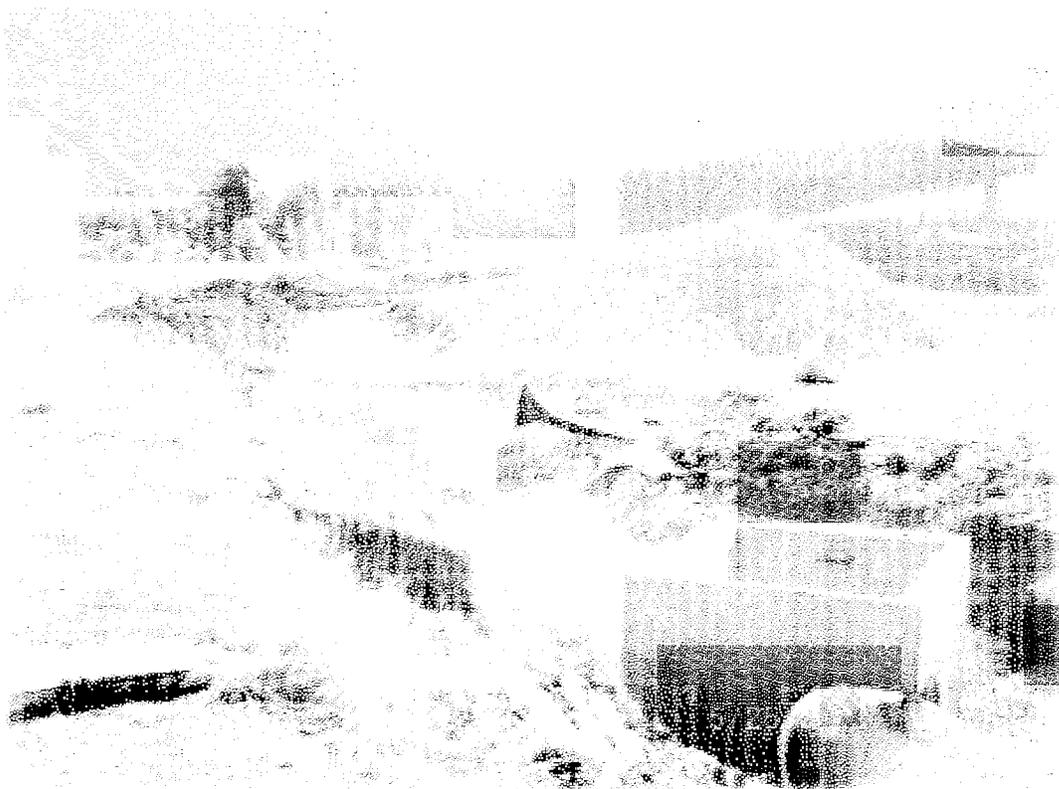
Figure 3: Please submit the plans indicating where this apparent storm sewer discharges

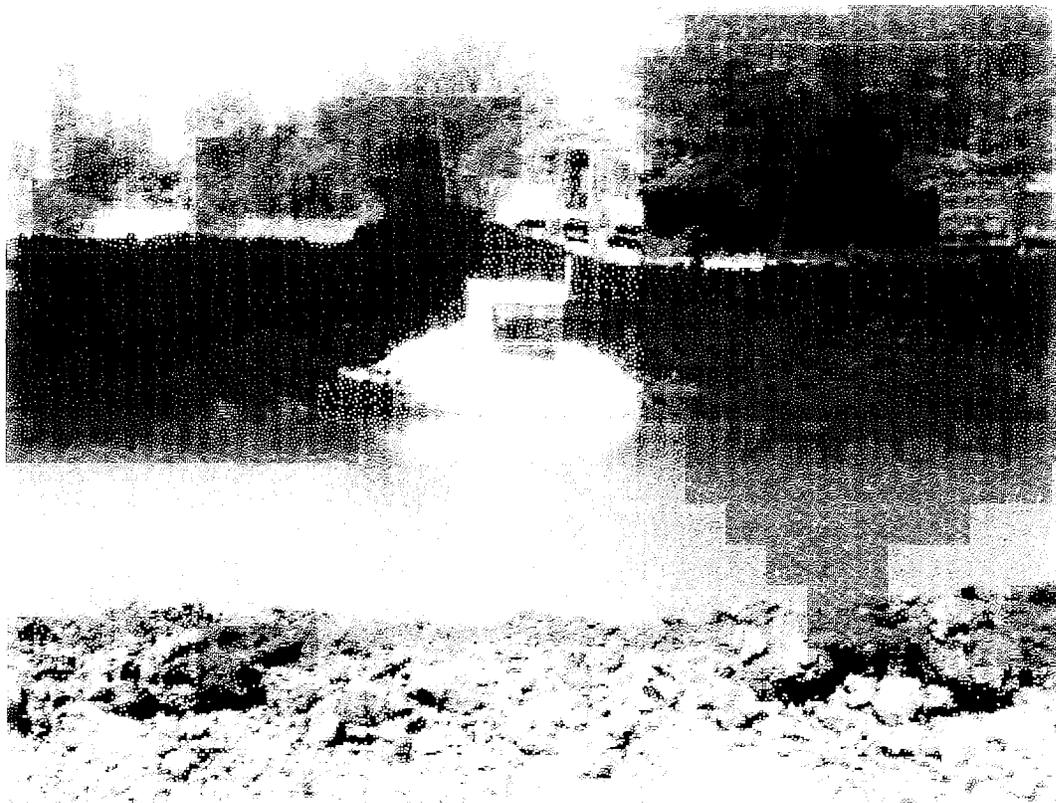
- The centralized sediment basin is installed and currently receiving drainage from the majority of the site. The basin is modified to address sediment control (SEE photo figure 4).

Figure 4: Majority of site directed to sediment basin
