**Re: Storm Water Inspection at John Miller Poultry Farm
Permit Number: 4GC03730*AG**

This letter is written in follow-up to a construction storm water inspection by Alicia Rector and Abigail Tamkin of the Ohio EPA, at John Miller Poultry Farm located at 1700 Martinsburg Road in Utica, Ohio on June 28, 2012. The purpose of the inspection was to evaluate compliance with Ohio EPA's General Storm Water Permit Associated with Construction Activities. During the inspection, we noted the following:

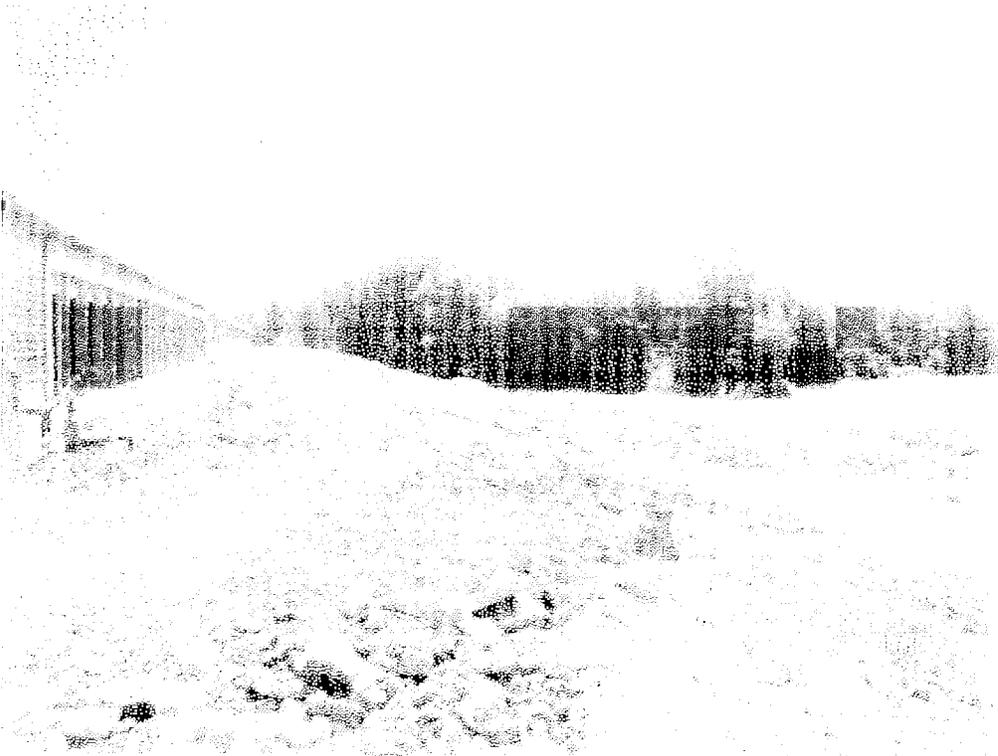
- It appears the majority of the site is draining to a centralized sediment basin with the exception of a few outlying areas. All outlying areas which are disturbed and not draining to the basin intended for treatment must be addressed with perimeter silt fence or an acceptable alternative as noted in Figure 1.

Figure 2: Void of silt fence, and does not appear to be draining to the centralized sediment basin
