RE: LAKE COUNTY  
CITY OF WILLOUGHBY  
ARBOR RIDGE SUBDIVISION  
CONSTRUCTION STORM WATER  
PERMIT NO: 3GC05550

**NOTICE OF VIOLATION**

**INSPECTION PHOTOS**

**Arbor Ridge Subdivision**

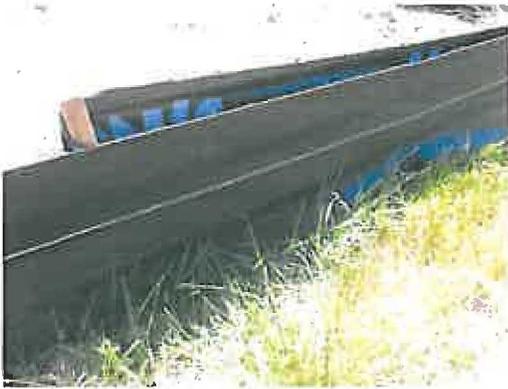
**Figure 1:** Stakes not twisted together at the joint of two silt fences.

2. Sections of the silt fence are loose and sagging. They need to stay taught to be able to pond the water. In addition, the two stakes at the end of two silt fence pieces need to be twisted together prior to staking to ensure a tight seal has been made.

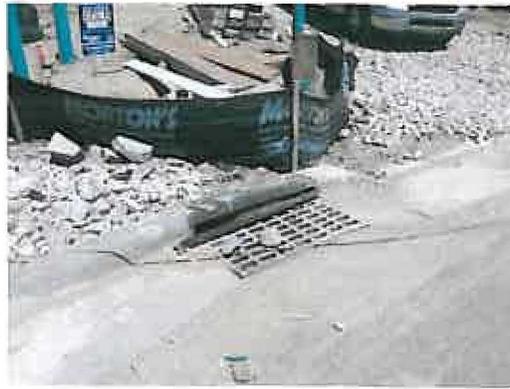
**Figure 2:** Improper curb inlet protection. Bulging silt fence needs to be maintained

3. Storm drain inlet protection was not constructed per the detail drawings provided in the SWP3. The construction methods used are not acceptable. Please follow the specifications contained in the SWP3, implement a proprietary storm drain inlet protection device suitable for the types of inlets on your site, or implement one of the enclosed specifications contained in *Rainwater and Land Development, Ohio's Standards for Stormwater Management, Land Development and Urban Stream Protection* (Ohio Department of Natural Resources, 2006). Amend the SWP3, if needed, to show the method of storm drain inlet protection you choose to implement.

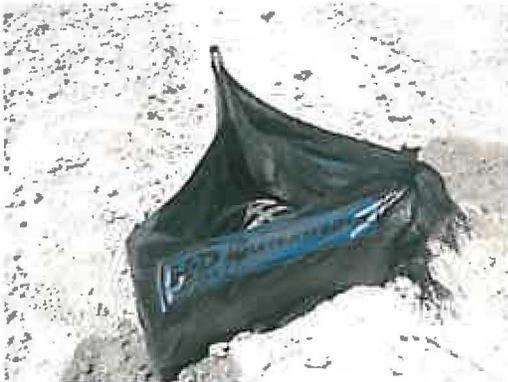
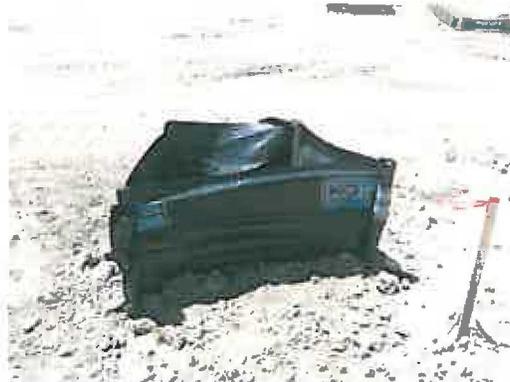
**Figures 3 & 4:** Incorrectly build yard inlet protection

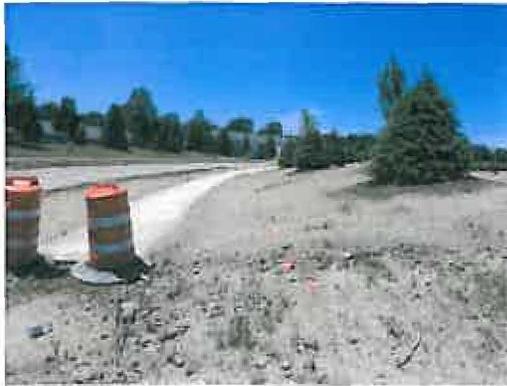
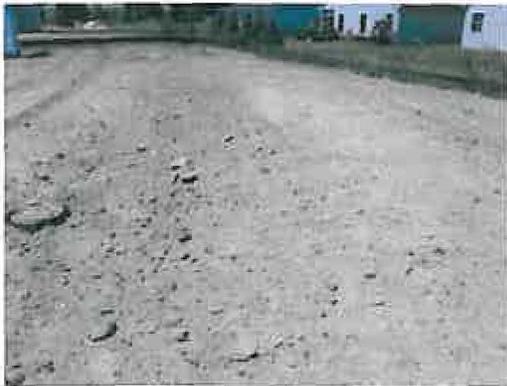
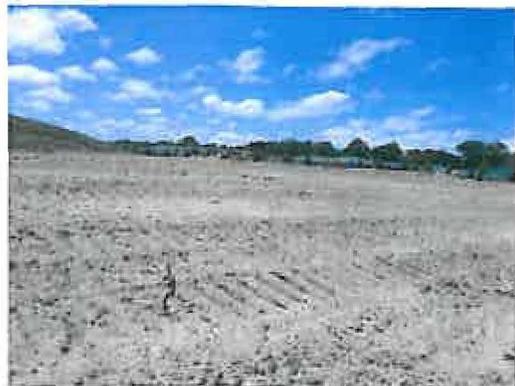
**Figures 5, 6 & 7:** Locations where stabilization needs to be done

4. There are many areas of the site that have been disturbed by construction activity and have been idle for over 21 days. These areas must be stabilized. The NPDES permit and notes on your SWP3 indicate that temporary stabilization of disturbed areas is to be initiated within seven days of last disturbance if an area will remain idle for 21 days or longer. Permanent stabilization is to be initiated within seven days of reaching final grade on areas at final grade. Due to the hot, dry weather, watering of the seed may be required to achieve germination and subsequent grass growth.

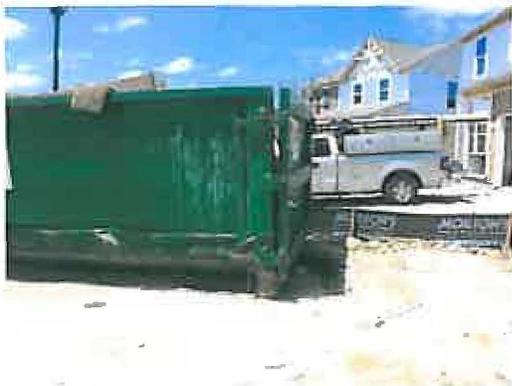
**Figure 8:** Uncovered dumpster is prone to leaks and, if not covered, will allow leachate to discharge from this site.

6. Dumpsters are a potential source of unauthorized discharges at construction sites. Storm water that contacts solid waste or construction and demolition debris, if discharged into storm water drainage systems, is an unauthorized discharge of wastewater, i.e., leachate. To prevent this runoff from reaching the storm drains, the dumpster should either be covered with a tarp or lidded. It is also important that dumpsters are in good condition so that no pollutants, such as paints or varnishes, leak from them.
