**RE: LAKE COUNTY  
CITY OF EASTLAKE  
WAL-MART SUPERCENTER  
#1863-10  
CONSTRUCTION STORM WATER  
PERMIT NO: 3GC05531**

**INSPECTION PHOTOS**

**Wal-Mart Supercenter #1863-10**

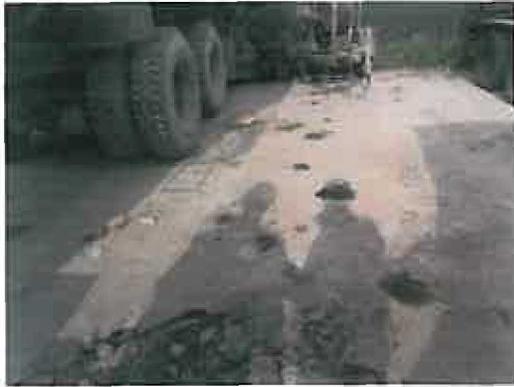
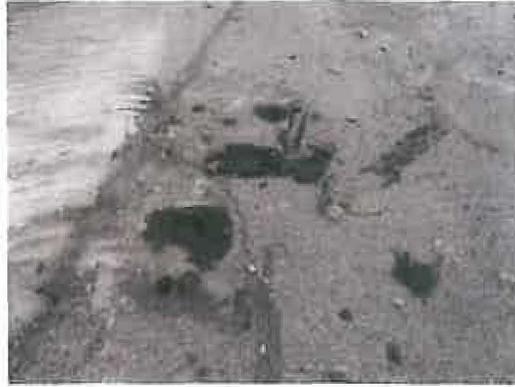
**Figures 1&2: Oil and grease spills**

1. There were many spills of oil and grease on the ground. These spills need to be cleaned up immediately after they occur. To prevent spills, conduct regular checks of equipment to ensure they are leak proof and functioning properly. If a leak does occur, place a drip pan underneath to contain the oil.

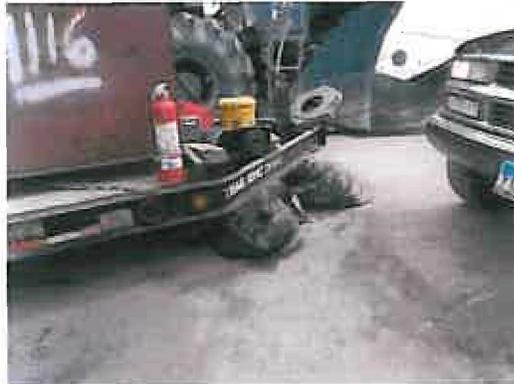
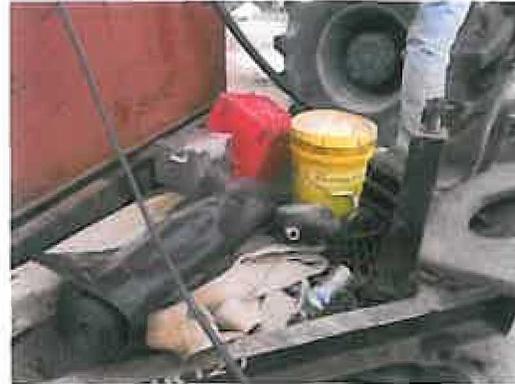
**Figures 3&4: Garbage and chemicals being stored outside. One bottle did not have a cap**

2. There are garbage bags, chemicals, and drums of oil sitting outside on the ground. Garbage must be disposed of in a solid waste dumpster. Oil and other chemicals should be kept inside to prevent contact or contamination with water. If the drums are too large to store inside, they may be placed in secondary containment.

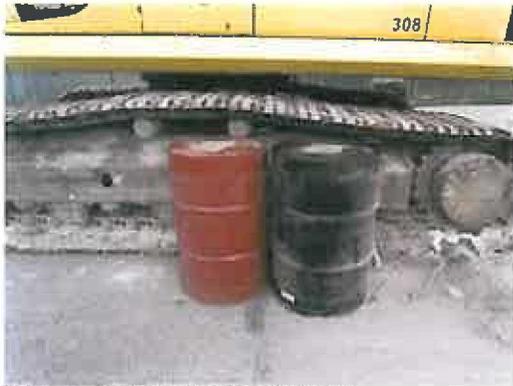
**Figure 5:** Drums of oil kept outside without secondary containment or a spill kit

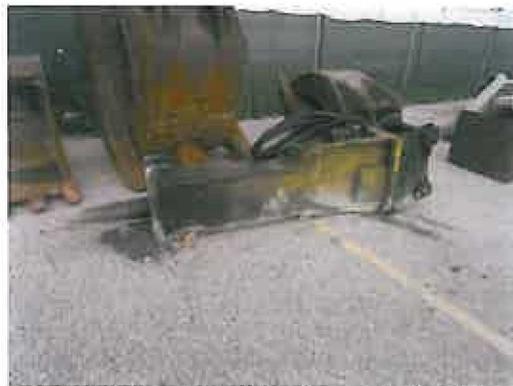
**Figure 6:** Greasy machinery

3. There was a greasy equipment attachment lying on the ground. This should be taken off site if it will not be used again. If it needs to stay on site, a tarp should be placed over and around it to avoid contact with water.

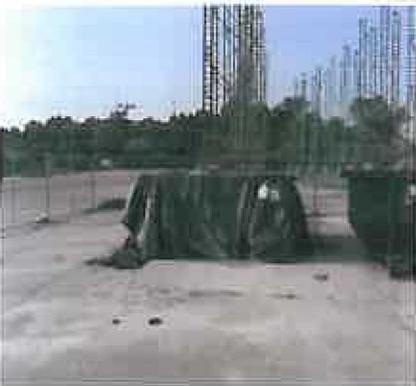
**Figure 7:** Concrete washout dumpster with runoff on ground

4. The concrete washout dumpster appears to be leaking leachate onto the ground. To prevent this runoff from reaching the storm drains, the dumpster should either be covered with a tarp or lidded. It is also important that dumpsters are in good condition so that no pollutants leak from them.

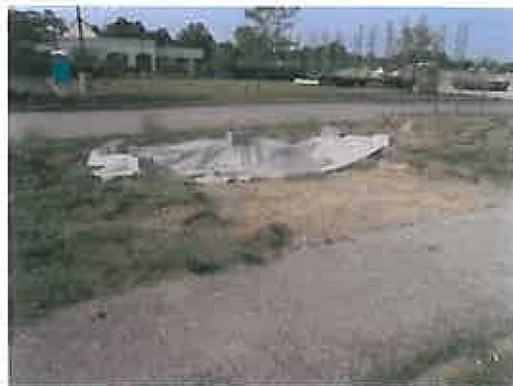
**Figure 8:** Bricklayer's pit

5. The liner of the bricklayer's pit needs to be extended to the sidewalk so all the washwater is contained.
