RE: CUYAHOGA COUNTY
MAYFIELD VILLAGE
MAYFIELD HIGH SCHOOL
CONSTRUCTION STORM WATER
PERMIT NO: 3GC05697

INSPECTION PHOTOS

Mayfield High School

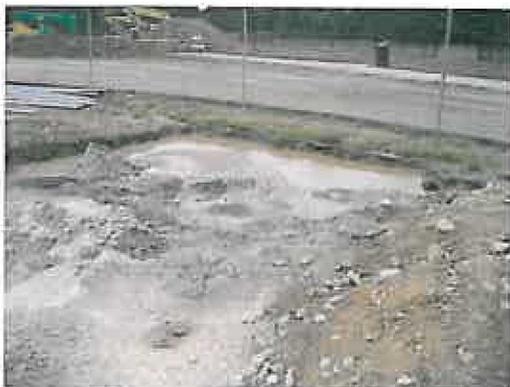
1. The concrete washout pit located on the gravel next to the construction trailers did not have a liner. Please review the enclosed specifications for concrete washout pits from **Stormwater Best Management Practice: Concrete Washout** (U.S. EPA) and modify/install as necessary to comply with these standards.

Figure 1: Concrete washout area without a liner

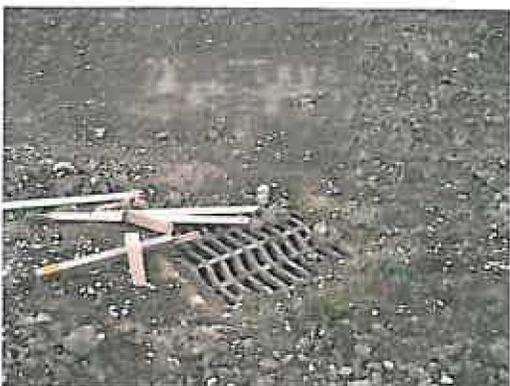
2. The catch basins around the baseball field need inlet protection as specified in the SWP3. The other catch basins on site are currently above grade, but there are holes on the side of the basins that dirt is being pushed into. Please clear the dirt away from these structures. Once dirt must be pushed up against it, install the inlet protection per the plan.

Figure 2: Catch basin without inlet protection

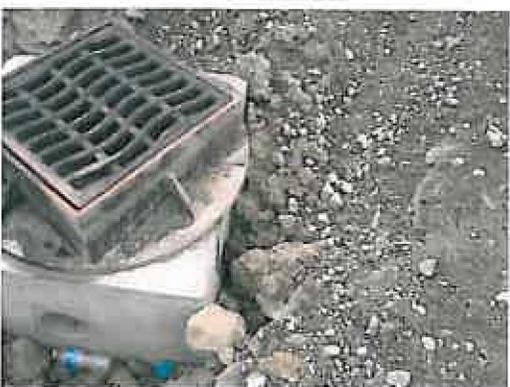
Figure 3: Catch basin with dirt falling into the holes on the sides

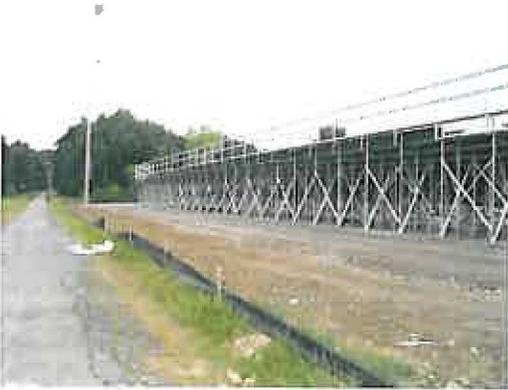
3. The silt fence was installed backwards at several locations. The stakes must be on the opposite side of the disturbed ground. The silt fence needs to be repaired or replaced in areas where it has been knocked down, buried, or where holes have formed. The joint stakes of the silt fence should be twisted together prior to staking.

Figure 4: Silt fence is falling down; possible area where temporary stabilization is needed

4. If areas disturbed by construction activity will not be reworked within 21 days of the last date they were disturbed, the NPDES permit requires temporary stabilization to be initiated within 7 days of last disturbance. There appear to be areas of the site where temporary stabilization is appropriate.

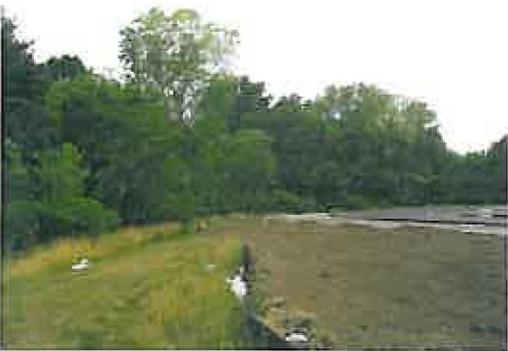
Figure 5: Silt fence has been buried; possible area where temporary stabilization is needed

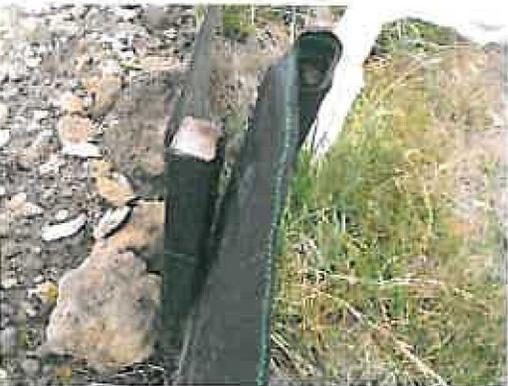
Figure 6: Joint stakes not twisted together prior to staking
