**Environmental
Protection Agency**

**RE: CUYAHOGA COUNTY
CITY OF BEACHWOOD
BEACHWOOD REHABILITATION
HOSPITAL
CONSTRUCTION STORM WATER
PERMIT NO: 3GC05751
NOTICE OF VIOLATION**

INSPECTION PHOTOS

Beachwood Rehabilitation Hospital

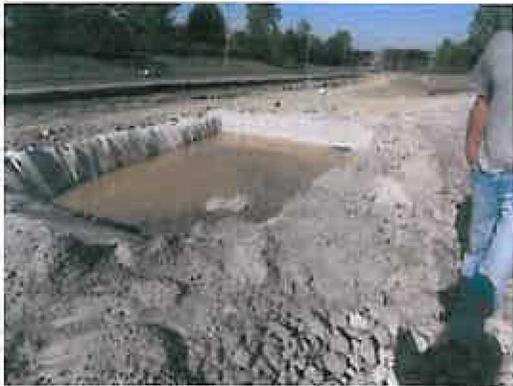
Figure 3: Concrete washings are missing the concrete washout pit

3. Concrete washings are missing the concrete washout pit. Please ensure all concrete washings are disposed of in the pit.
4. The SWP3 is a "living document"; this means that everything on site must be shown on the plans and everything shown on the plans should be found on site. If changes to the site occur, mark this on the SWP3. In particular, the SWP3 should show the 2nd construction entrance, the type of inlet protection being used, and the concrete washout pit.
