RE: CUYAHOGA COUNTY
CITY OF BRECKSVILLE
CLINICAL TECHNOLOGY BUILDING
CONSTRUCTION STORM WATER
PERMIT NO: 3GC05881

On July 6, 2012 I performed a compliance inspection for storm water best management practices (BMPs) at the above referenced site. I was accompanied by Gregory Modic, Engineer with Donald G. Bohning & Associates, Inc. While on site I met with John Vinton, Superintendent of the site, and Brian Uhlenbrock, Inspector for the site. Our records indicate that Clinical Technology Inc has obtained coverage under the Ohio EPA General Storm Water National Pollutant Discharge Elimination System (NPDES) Permit for Construction Activities #3GC05881*AG.

INSPECTION PHOTOS

Clinical Technology Building

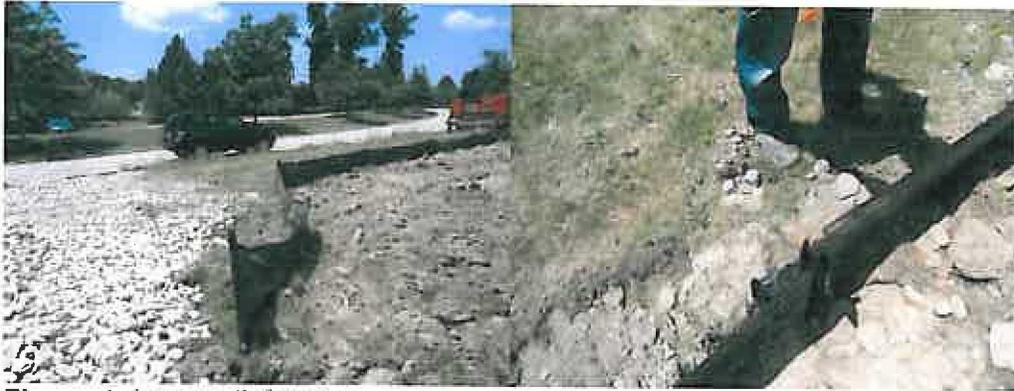
Figure 1: Loose silt fence

Figure 2: Joint stakes not twisted together prior to staking

- The silt fence was loose in several places, and soil had been pushed on top of the fence in other locations. Please tighten the silt fence and pull the soil away from the silt fence. Also, the joint stakes of the silt fence must be twisted together prior to staking. The silt fence along the front and side of the site has not been trenched and backfilled; soil has just been set on top of the bottom of the fencing. Proper trenching and backfilling techniques must be used when installing silt fence. Please fix these deficiencies.

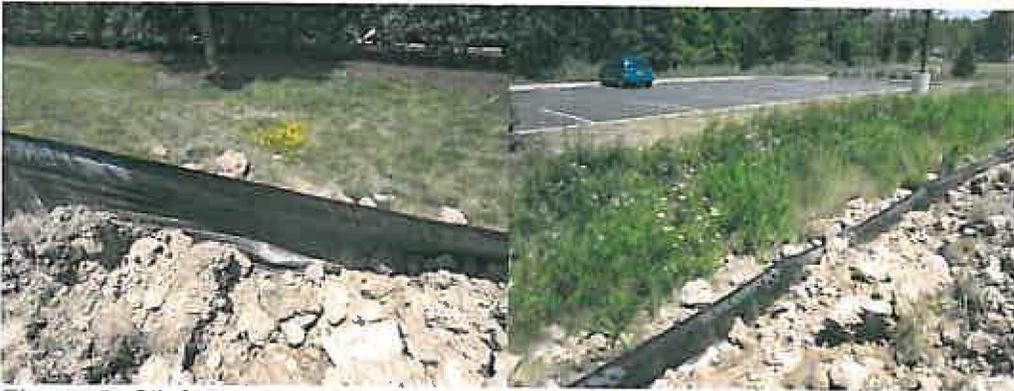
Figure 3: Silt fence not properly trenched and backfilled

Figure 4: Soil covering silt fence
