**Environmental
Protection Agency**

August 14, 2012

RE: CUYAHOGA COUNTY
CITY OF WESTLAKE
WESTLAKE HIGH SCHOOL
CONSTRUCTION STORM WATER
PERMIT # 3GC05330

INSPECTION PHOTOS

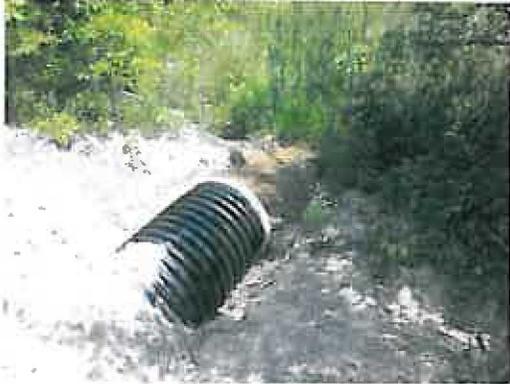
8. The outlet of the stormwater management basin discharges directly to the protected wetlands. A level spreader has not been provided to diffuse runoff before it discharges to these wetlands as required by Part III.G.2.f of the NPDES permit. Please amend the SWP3 and reconstruct the basin outlet as needed to comply with this requirement. See enclosed specifications for level spreaders found in *Rainwater and Land Development, Ohio's Standards for Stormwater Management, Land Development and Urban Stream Protection* (Ohio Department of Natural Resources, 2006).

Figure 1: Outlet to the wetlands. No level spreader has been provided.

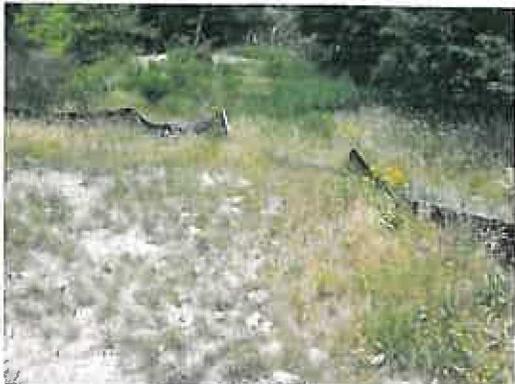
1. The silt fence has holes in a few places. The joints of the fence need to be connected by twisting the stakes together prior to staking, not overlapping them. In addition, silt fence requires maintenance in a crucial part by wetlands (Fig 2).

Figure 2: Silt fence is down along the wetlands.

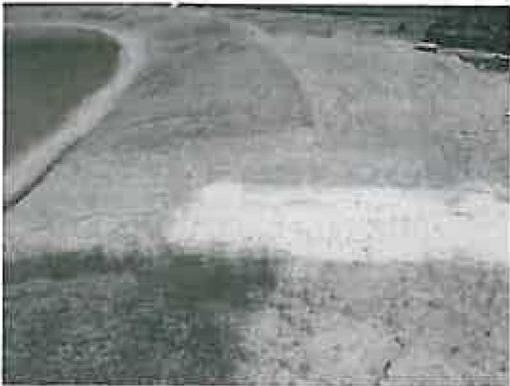
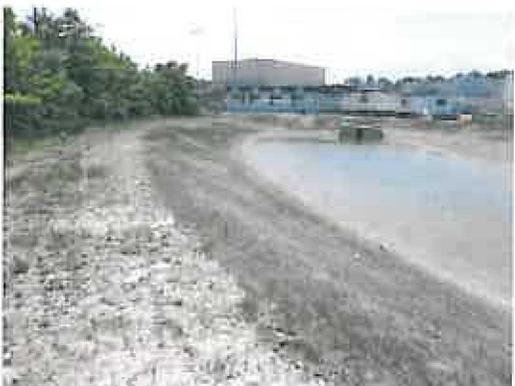
3. The stockpile has been stabilized, but not to 70% growth density. Measures must be taken to ensure vegetation establishes. Because of this hot, dry weather, grass may need to be watered. If it still does not grow, another round of seeding needs to take place or soil amendments may be required. Stabilization is also required around the sediment basin.

Figures 3&4: Areas of the sediment basin where seed needs to be planted.

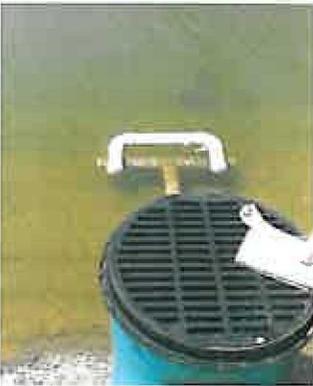
4. A skimmer has been installed on the outlet of the stormwater management pond to establish a sediment basin for this site. However, we noted that a guide post with wire has not been provided. We recommend that this feature be added to ensure the skimmer remains in place (see enclosed specifications on Sediment Basins found in *Rainwater and Land Development, Ohio's Standards for Stormwater Management*,

Figure 5: Skimmer in the sediment basin

Land Development and Urban Stream Protection (Ohio Department of Natural Resources, 2006).

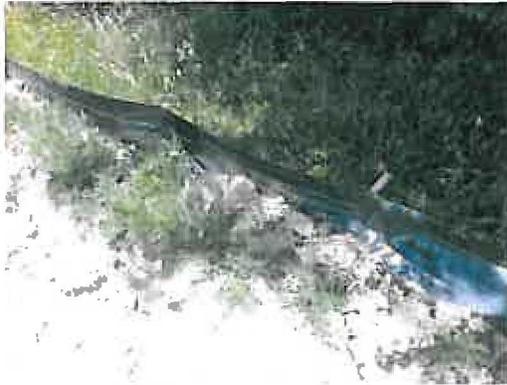
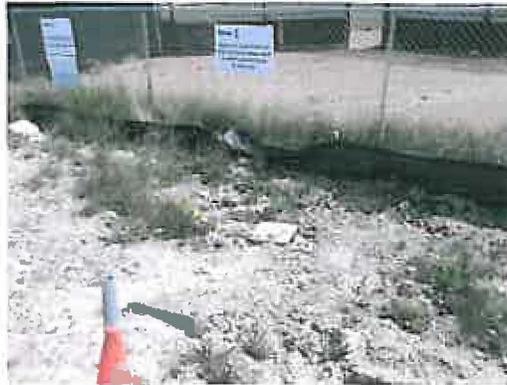
Figures 6&7: Silt fence has fallen into disrepair

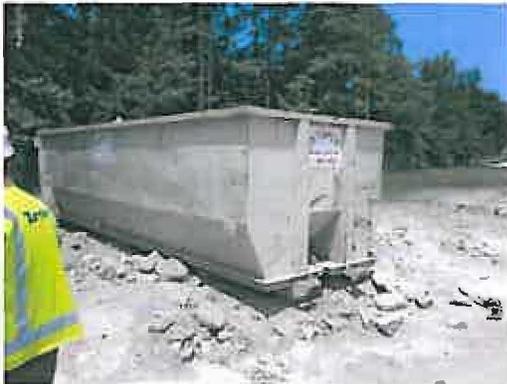
5. The waste dumpster did not have a cover or lid. A tarp or other such cover should be provided to minimize storm water contact with solid waste and the formation of leachates.
6. The contractor has installed concrete washout pit. however, we noted that some of the concrete washings are not making it into the washout pit. Please provide direction to concrete delivery drivers on proper washout procedures and implement good housekeeping to clean up any spills that may occur accidentally.
7. We also noted some concerns with the mortar mix area. Please refer to the enclosed copy of my e-mail correspondence with Mark Zuk on June 14, 2012 regarding this matter.

Figure 8: Dumpster needs to be covered

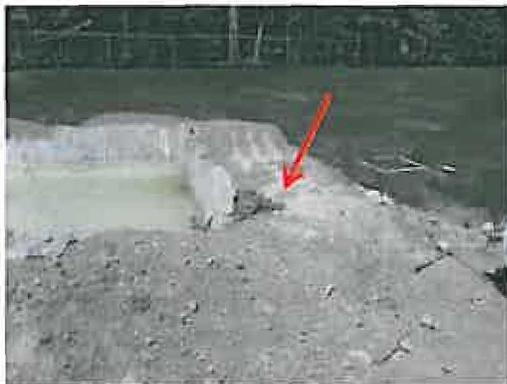
Figure 9: Concrete is missing the concrete washout pit

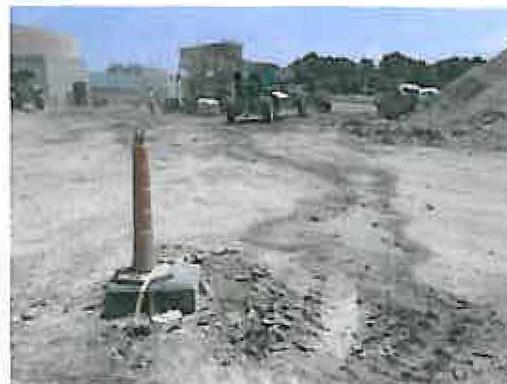
Figure 10: Mortar mixing and dumping area
