RE: ASHTABULA COUNTY  
MORGAN TOWNSHIP  
GLENBEIGH-NEW DORMITORY BUILDING  
NPDES PERMIT NO: OHC000003  
OHIO EPA PERMIT NO: 3GC05889\*AG  
CONSTRUCTION STORM WATER INSPECTION

**Storm Water Inspection**

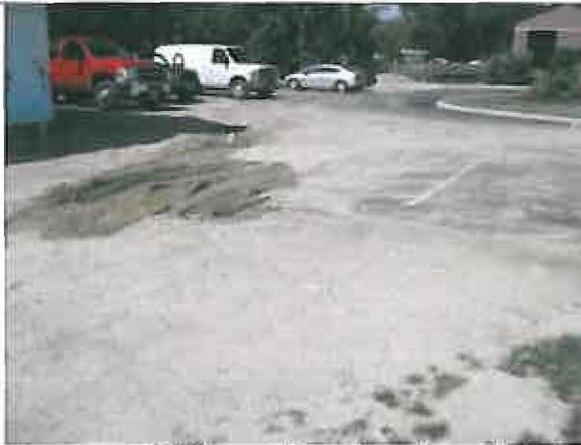
- Offsite tracking of sediment into the roadway and parking area serving Glenbeigh is occurring (Figure 1). A properly designed construction entrance must be installed to prevent the offsite tracking of sediment.

**Figure 1** - Offsite tracking of sediment into the roadway and parking area serving Glenbeigh is occurring.

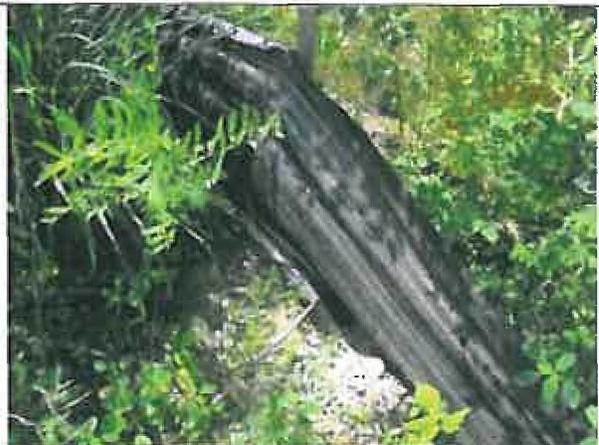
- No functioning erosion and sediment best management practices (BMP) have been installed to prevent the discharge of sediment-laden storm water runoff to "waters of the State." Although silt fence was observed adjacent to the onsite stream, it has not been properly installed to pond sediment-laden storm water runoff (Figure 2). The silt fence must be reinstalled or repaired to allow sediment-laden storm water to be treated prior to being discharged to "waters of the State."

**Figure 2** - Silt fence was not properly installed to pond sediment-laden storm water runoff.

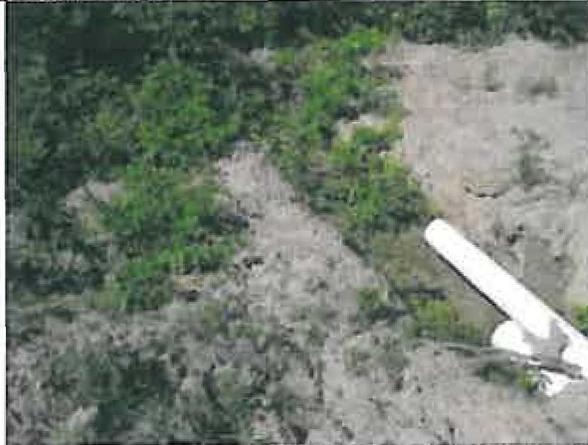
- The roof drains and downspouts serving the new dormitory discharge directly into the onsite stream (Figure 3). Ohio EPA could not determine how the site will satisfy the post-construction storm water management requirements established with Part III.G.2.e of the General Storm Water Permit. A copy of the site's storm water pollution prevention plan and information (i.e. water quality volume calculations, engineered plans, etc.) regarding the post-construction storm water BMPs must be submitted to my attention within ten days of receiving this notification.

**Figure 3** - The roof drains and downspouts serving the new dormitory discharge directly into the onsite stream.
