Re: Hardin County
Alger WWTP
NPDES Permit

NPDES Compliance Inspection Report

Name and Location of Facility Inspected	Entry Time	Permit Effective Date
Village of Alger WWTP State Route 235 Alger, Hardin County	10:30 AM	April 1, 2010
	Exit Time	Permit Expiration Date
	11:00 AM	March 31, 2015
Name(s) and Title(s) of On-Site Representatives	Phone Number(s)	
No one was present during inspection		
Name, Address and Title of Responsible Official	Phone Number	
Mayor and Council, Village of Alger 207 Angle Street Alger, Ohio 45812	419-757-4321

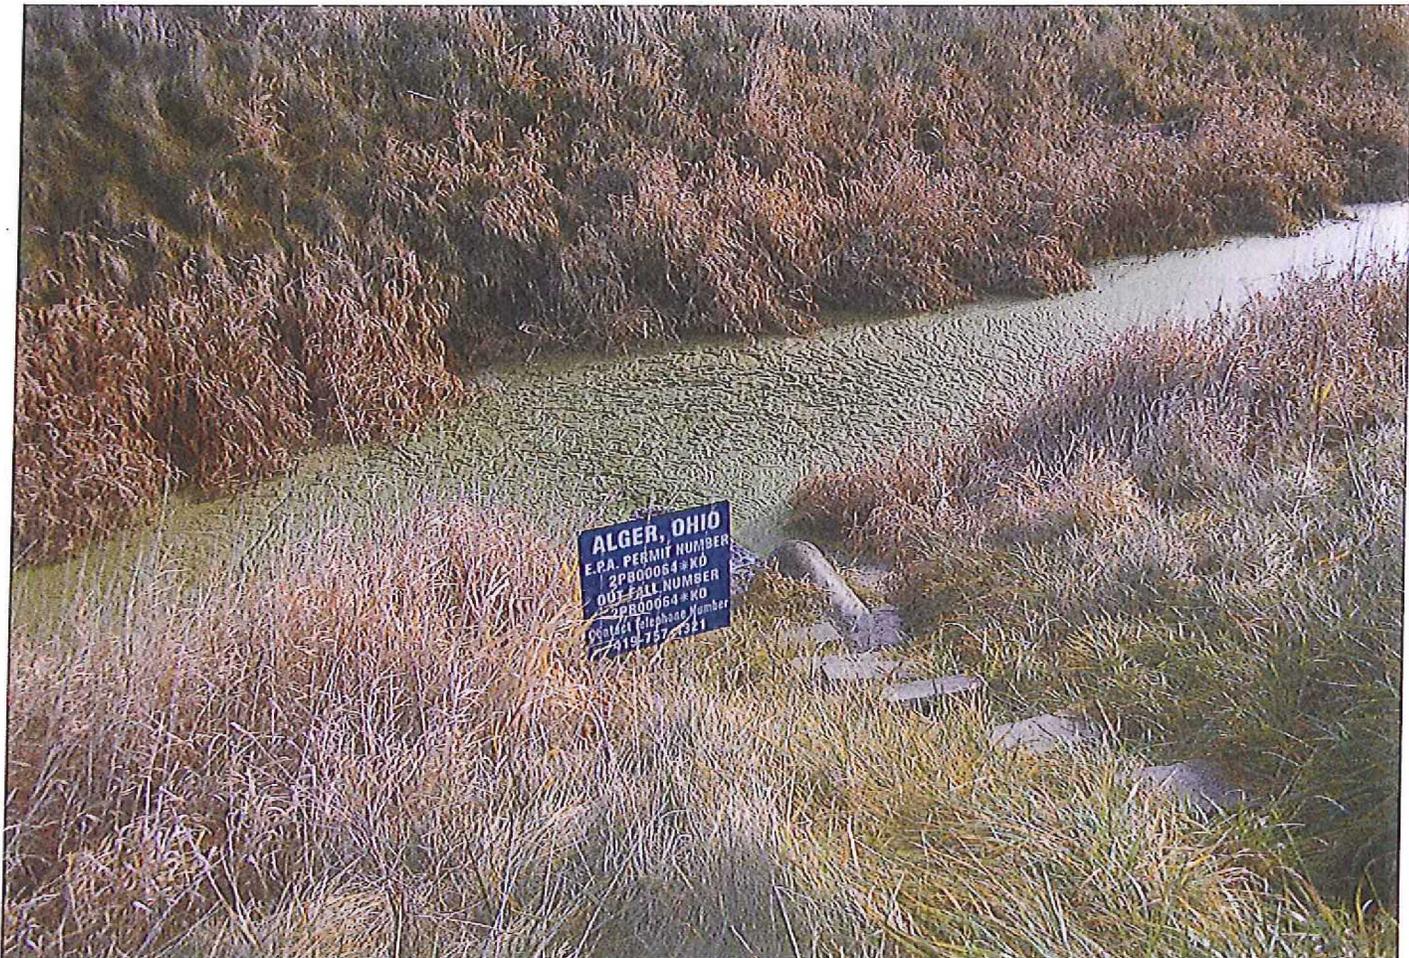
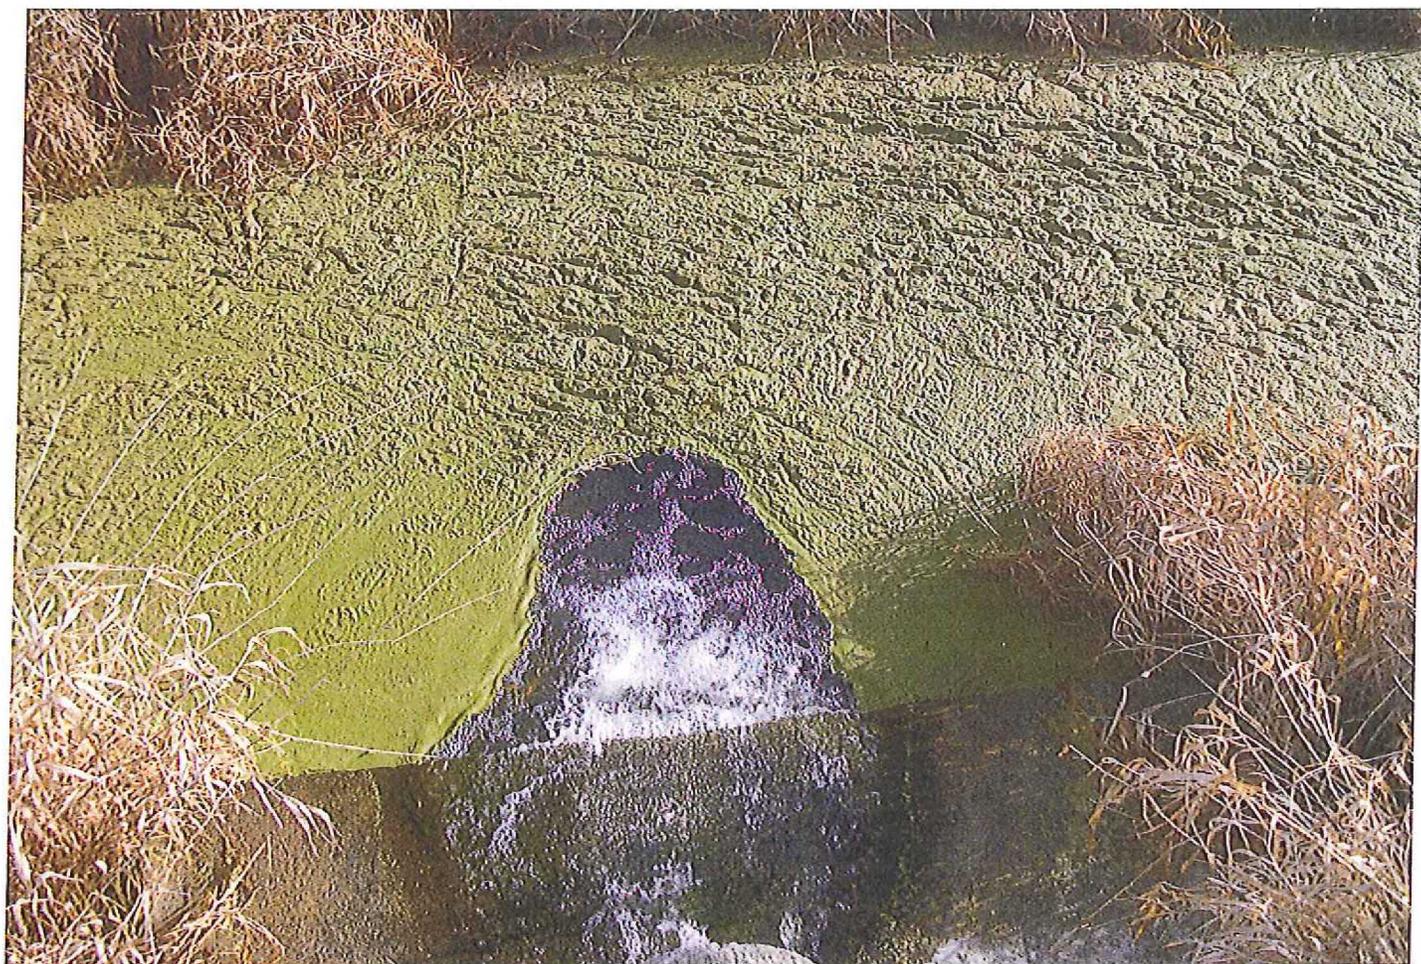
An extensive amount of duckweed was observed in the receiving stream (pictures enclosed). In discussion with Mr. Ron Polen, Operator, duckweed growth was a continuous problem in the final lagoon through the summer season. Heavy winds and a broken baffle board caused the duckweed to flow into the receiving stream.

An extensive amount of duckweed was observed in the receiving stream.
